Report

Accident on **29 March 2013**
at **Lyon Saint-Exupéry Airport (France)**
to the **Airbus A321**
registered **SX-BHS**
operated by **Hermes Airlines**
chartered by **Air Méditerranée**

BEA

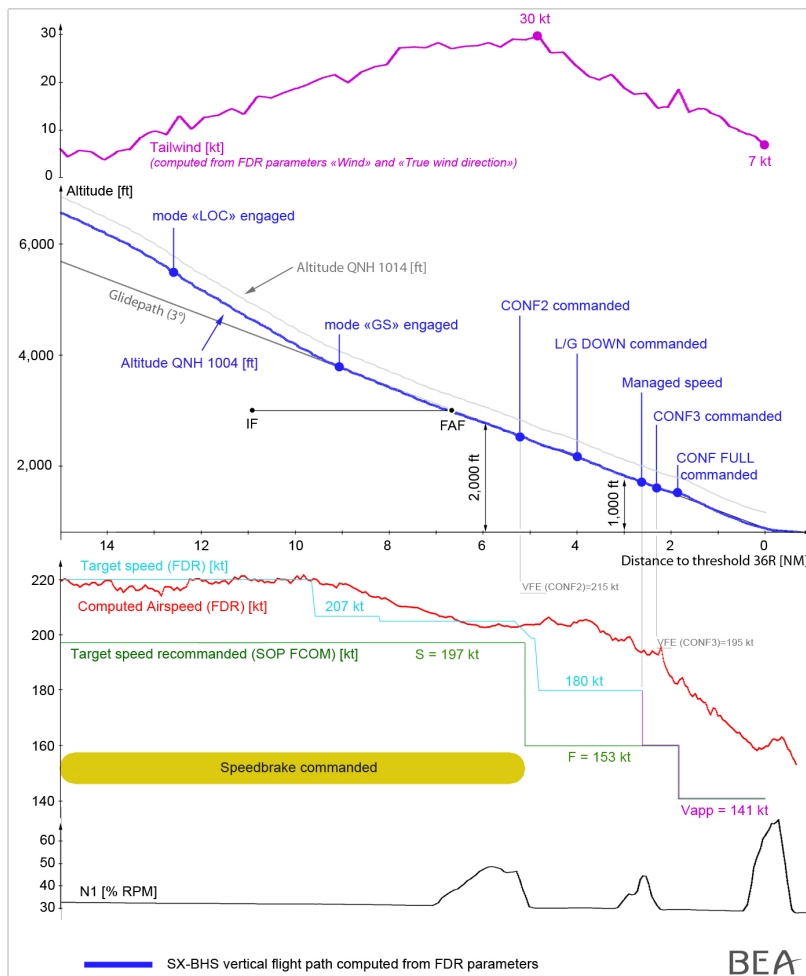
Aeroplan descent profile based on FDR data

The altitude recorded by the FDR is the pressure altitude in a standard atmosphere (QNH 1013). It was corrected to take into account the applicable barometric setting at the time of the approach (QNH 1004). The altitude with the wrong QNH (1014) was also plotted in order to show the altitude indicated to the crew.

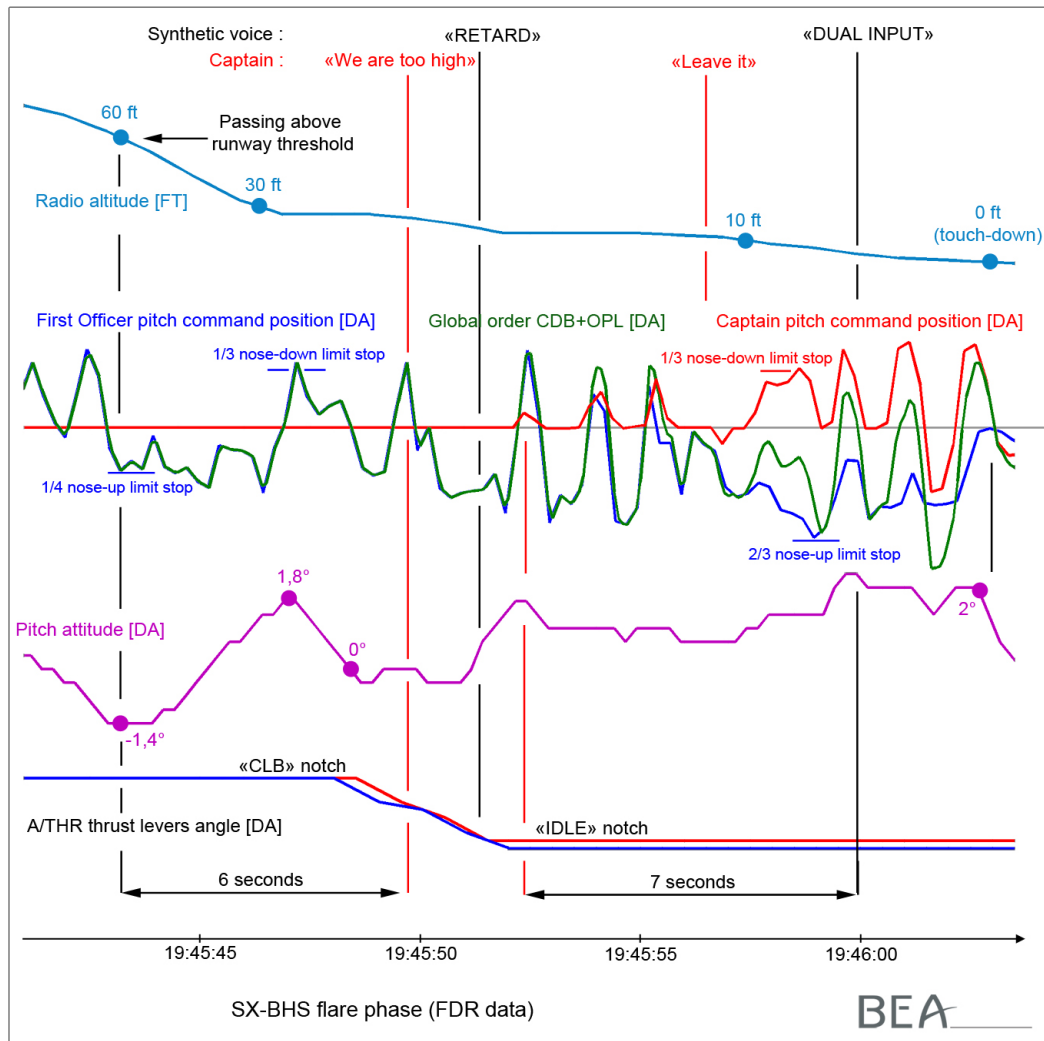
The Captain made a succession of three nose-down inputs (deflections on the sidestick at $1.6^{\circ}/1.9^{\circ}/5.1^{\circ}$), while the copilot alternated nose-up and nose-down inputs (deflections between -10° and $+8^{\circ}$). The Captain called out: "Leave it". The "DUAL INPUT" callout was not generated during these simultaneous inputs, since the callout activation conditions were not met.

The Captain repeated "Leave it". The pilots continued to make opposite inputs. The resulting prevailing input was nose-up until the wheels touched down approximately 18 seconds after crossing the threshold.

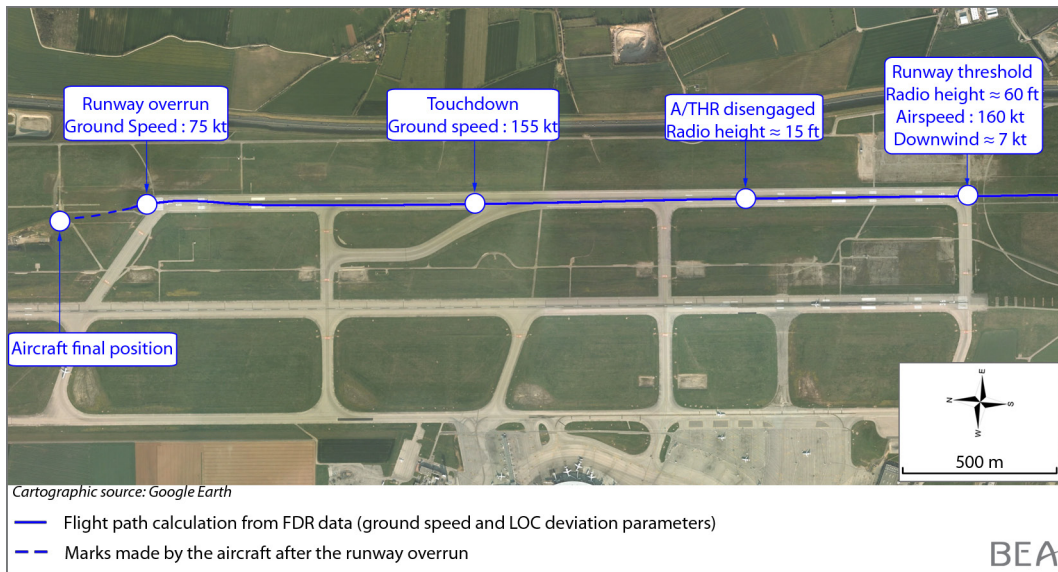
Flight path calculation starting from when the aircraft crossed the runway threshold

- ❑ **touchdown occurred approximately 1,600 metres from the runway threshold;**
- ❑ **the aeroplane overran the end of the runway at approximately 75 kt.**

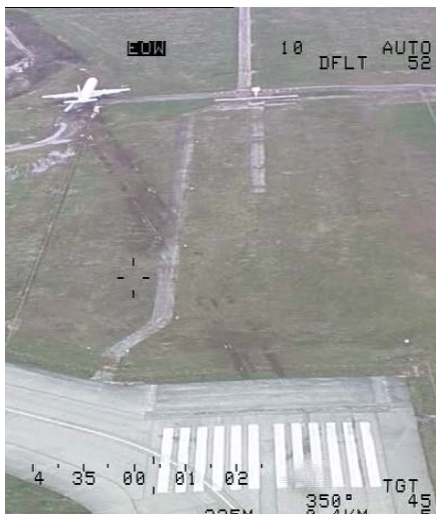
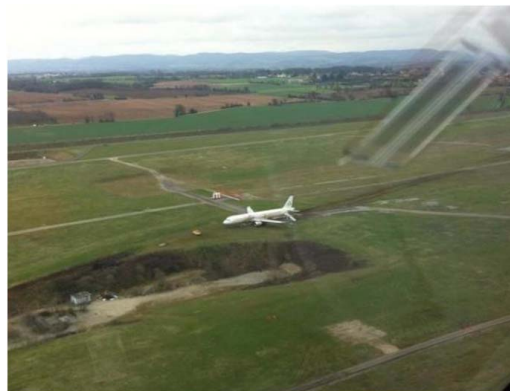
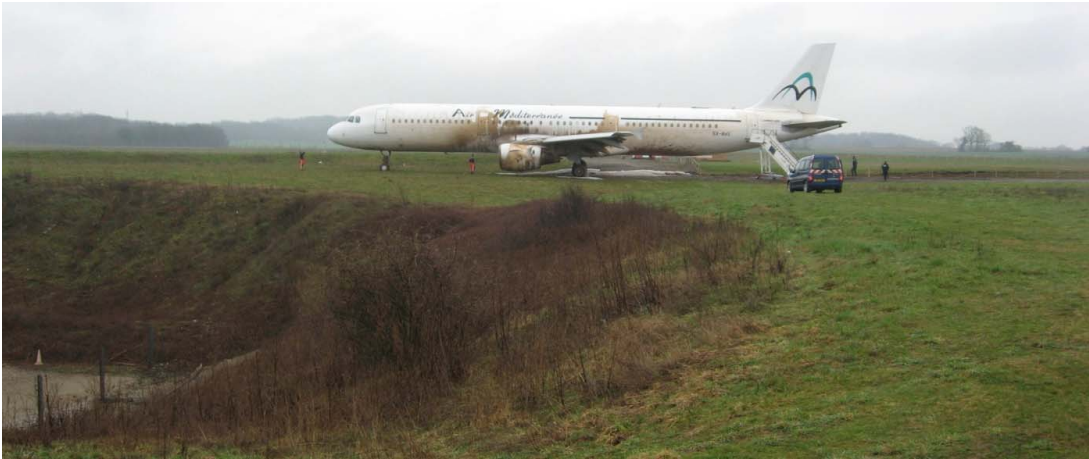
Photographs taken after the accident

The tyres showed no signs of damage, indicating that the wheels had locked up, which is typical of the effect of hydroplaning.

The main damage observed on the engines was located on the first low-pressure compressor stages, and was subsequent to the ingestion of debris and soil while rolling on the loose surface, and with the thrust reversers deployed.

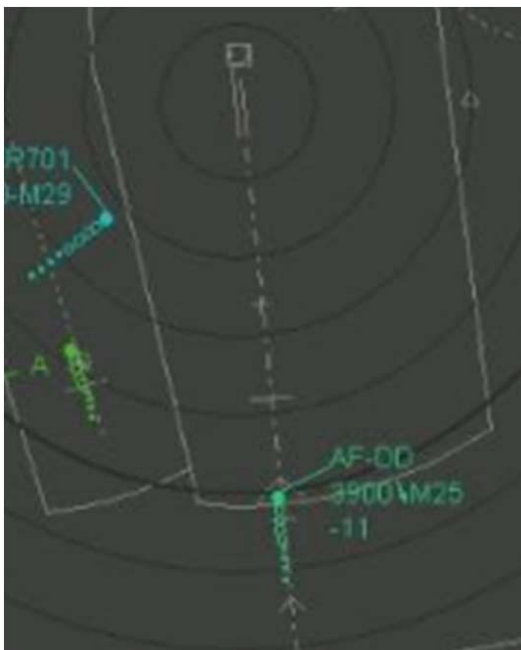
AF-DD - crossing 10 NM
Radar: ground speed of 250 kts
(CAS[FDR] = 220 kts, GS[FDR] = 249 kts)

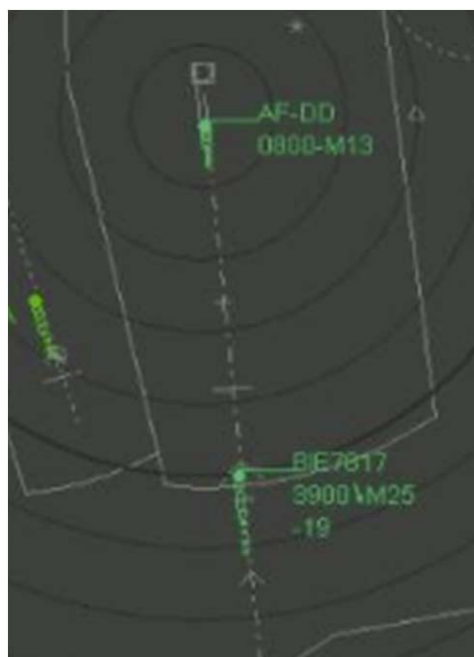
BIE7817- crossing 10 NM
Radar: ground speed of 250 kts
(CAS[FDR] = 222 kts, GS[FDR] = 251 kts)

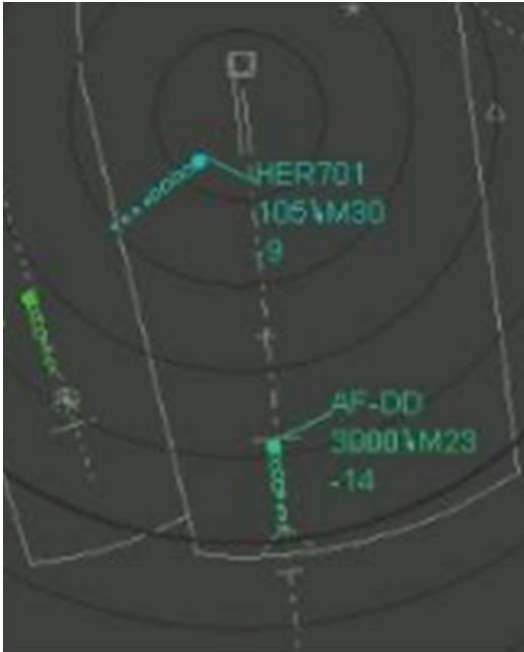
AF-DD - crossing FAF (6.9 NM) – Radar:
ground speed of 220/230 kts (CAS[FDR] = 182
kt, GS[FDR] = 209 kt)

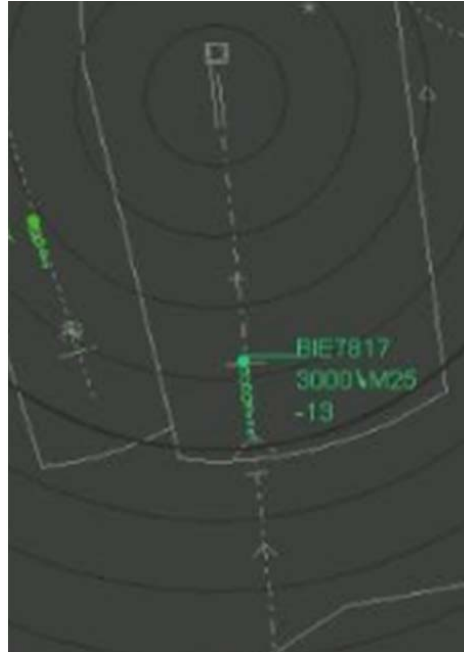
BIE7817 – crossing FAF (6.9 NM) – Radar:
ground speed of 250 kts (CAS[FDR] = 206 kt,
GS[FDR] = 241 kt)

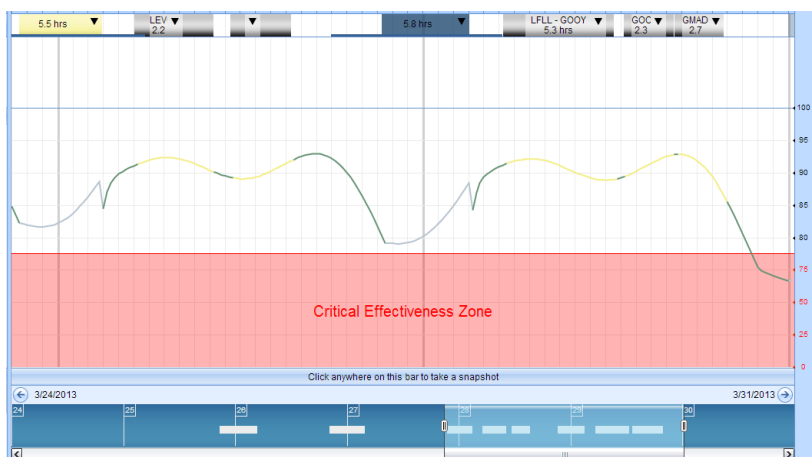
Figure 4. Modélisation de la fatigue (inverse de l'effectiveness) de l'OPL au cours du 28 et du 29/03/2013 (En jaune les périodes de vol et en bleu de sommeil).

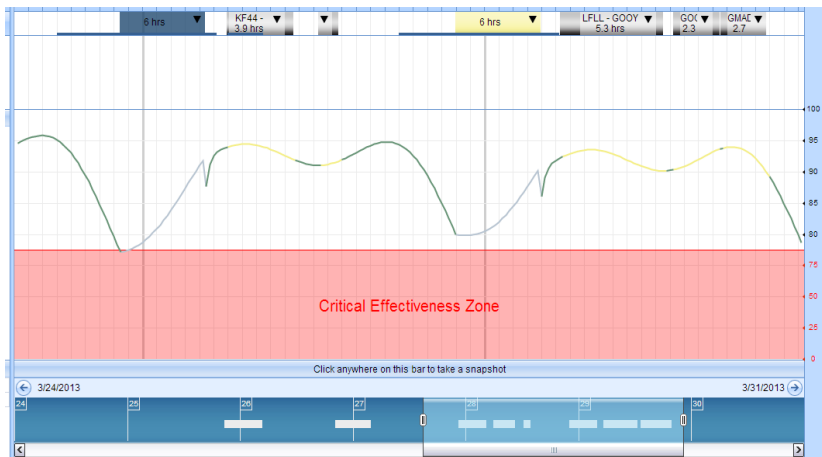
Figure 5. Modélisation de la fatigue (inverse de l'effectiveness) du Cdb au cours du 28 et du 29/03/2013 (En jaune les périodes de vol et en bleu de sommeil).
