Runway overrun during taxiing after landing

Aircraft	Airbus A320 registered TS-IMC
Date and time	12 March 2013 at 10 h 15 UTC ⁽¹⁾
Operator	Tunisair
Place	Paris Orly Airport (94)
Type of flight	Public transport
Persons on board	Captain (PNF), co-pilot (PF), 4 cabin crew members, 140 passengers
Consequences and damage	Nose gear slightly damaged

This is a courtesy translation by the BEA of the Final Report on the Safety Investigation. As accurate as the translation may be, the original text in French is the work of reference.

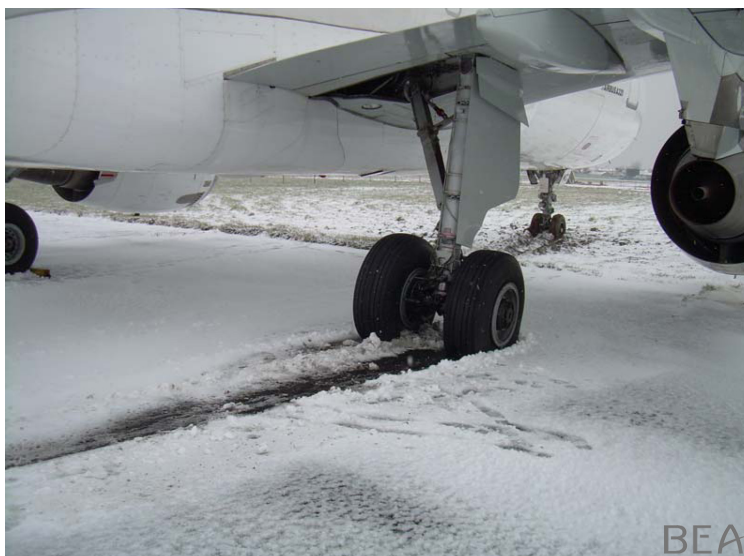
At 10 h 15 min 12, the aeroplane overran the runway at a ground speed of 17 kt (see photo below). It came to a stop four seconds later. The Captain notified ATC and indicated that braking was poor. Emergency teams took swift action.

The Captain and copilot reported having regularly taken into account the weather information during the approach. Landing took place normally on a slightly contaminated portion of the runway. As they were about to exit the runway via W4, the controller asked them to roll on to W31. They then found that the last third of the runway was not clean and that snow was present on the surface, unlike the touchdown zone. The Captain said he was surprised and helpless when braking. The copilot said that the last third of the runway seemed to be icy. The aeroplane overran the runway while the Captain was using the parking brake as a last resort.

The inability to measure runway adherence in real time did not allow the uneven runway contamination to be detected. This led to the crew’s and controllers’ degraded perception of braking conditions at the end of the runway, resulting in the overrun.
