**Accident on 4 March 2013
just after takeoff from Annemasse (France)
to the Beechcraft Premier 1A
registered VP-CAZ**

BEA

Stall after takeoff in icing conditions, collision with the ground, fire

Aircraft:	Beechcraft Premier 1A Model 390 registered VP-CAZ
Date and time:	4 March 2013 at 7h39 ⁽¹⁾
Operator:	Private
Site:	Near Annemasse aerodrome, in the commune of Cranves-Sales (74)
Type of flight:	General aviation
Persons on board:	One pilot and two passengers
Consequences and damage:	Pilot and one passenger killed, one passenger injured, aeroplane destroyed

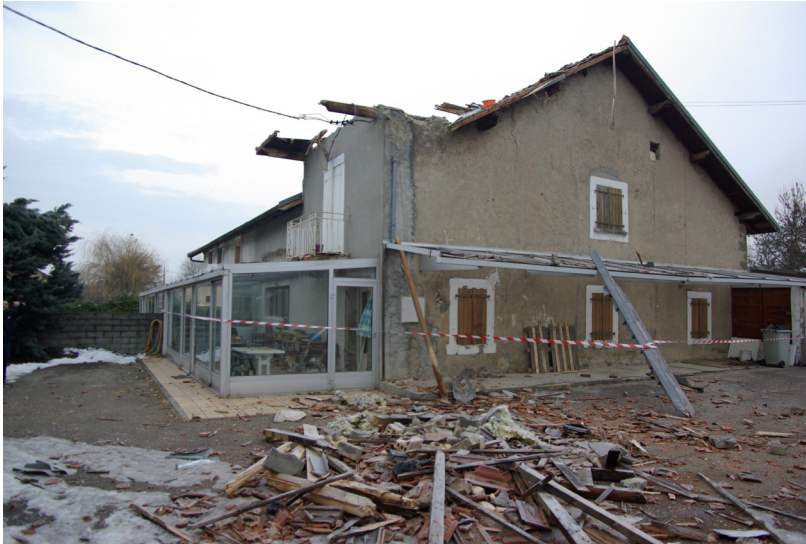
Figure 2 - Damage to the house

The aeroplane struck the roof of a house about 500 m from the threshold of Annemasse runway 30, and then struck trees located 10 to 20 m further. The damaged section of the roof was located about 5 m up. The person inside the house at the time of the accident was not injured.

The aeroplane also destroyed a low garden wall and a shed on a second property.

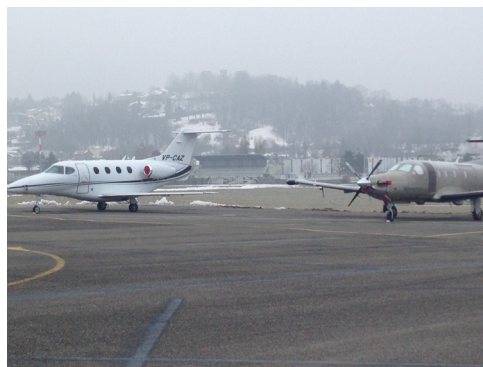
Figure 4 – Photo taken on the morning of the accident at the aerodrome

A photo of the aerodrome taken about 50 minutes before the accident shows the presence of low stratus, as well as snow on the ground.

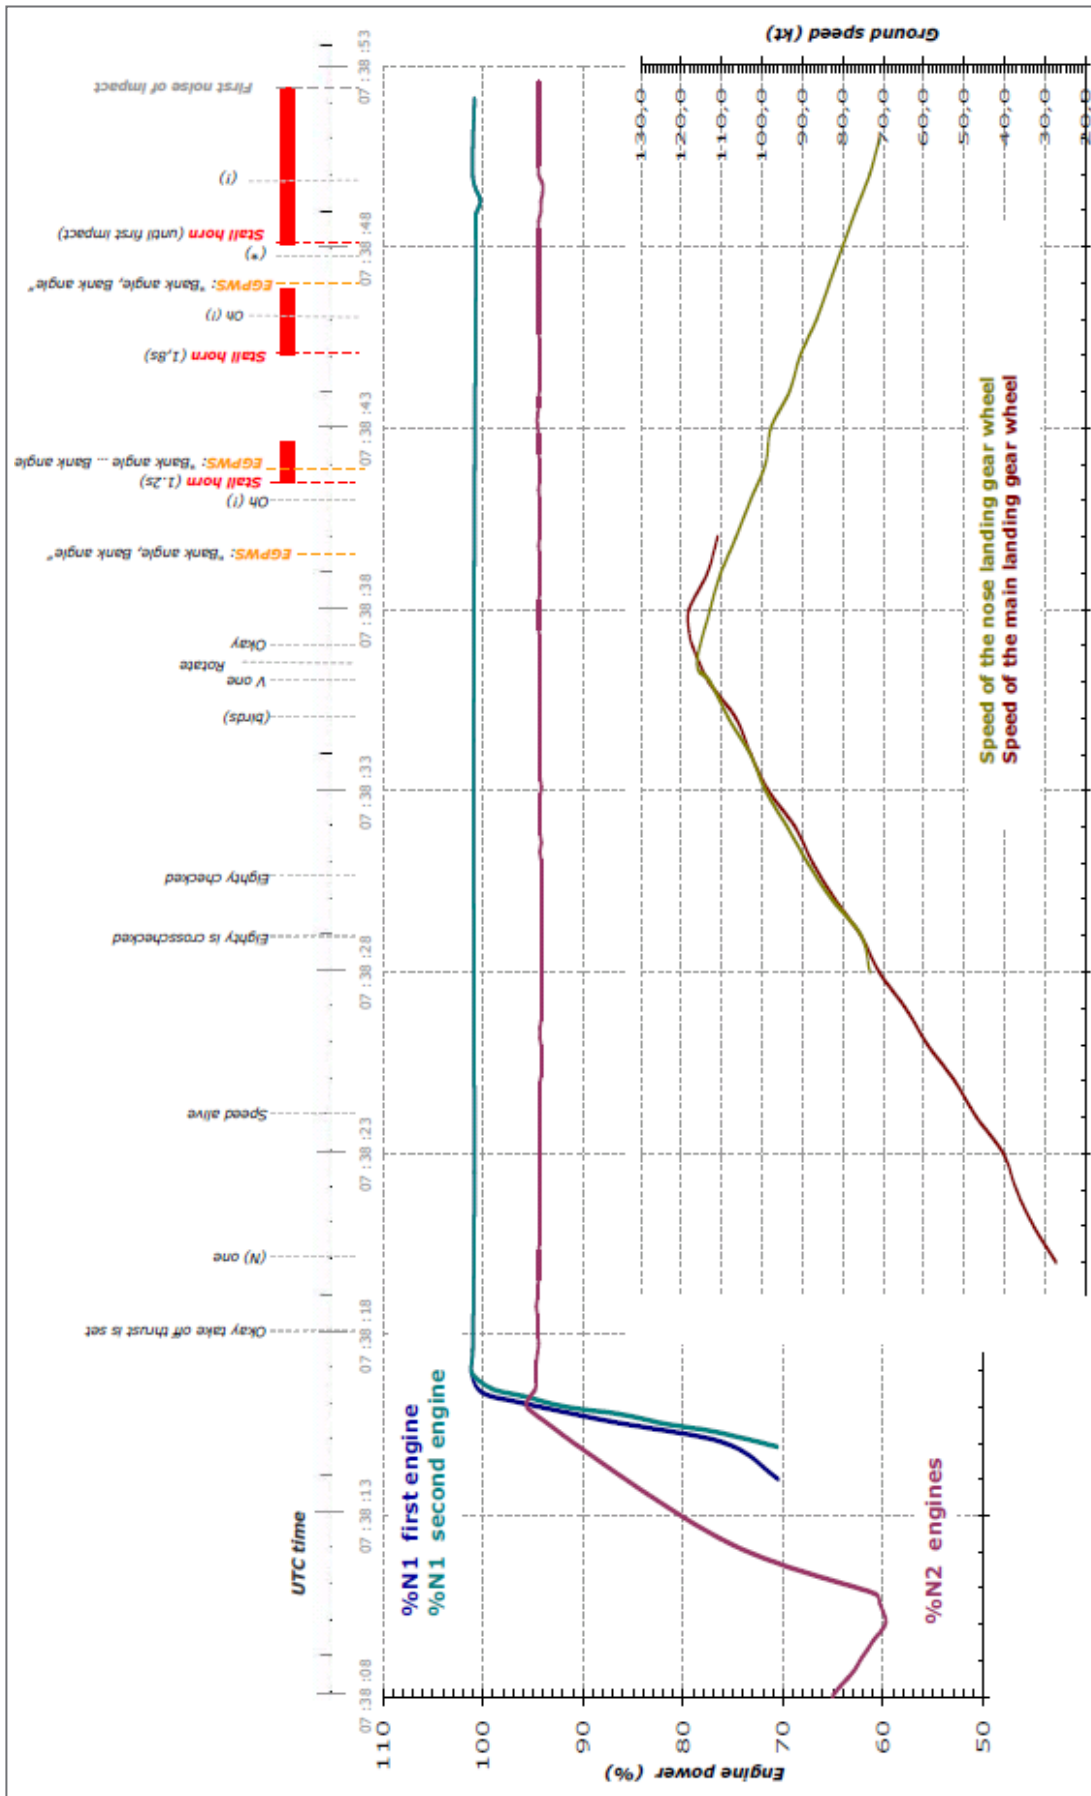
Figure 5 – Summary of data from the CVR

Spectral analysis of the recording made it possible to determine the rotation speeds of the rotating parts of both engines, of the nose landing gear wheel and the main landing gear wheels. It was possible to deduce from this the various speeds of each engine (N1 and N2), as well as the wheel rotation speeds, and therefore a ground speed during taxiing.

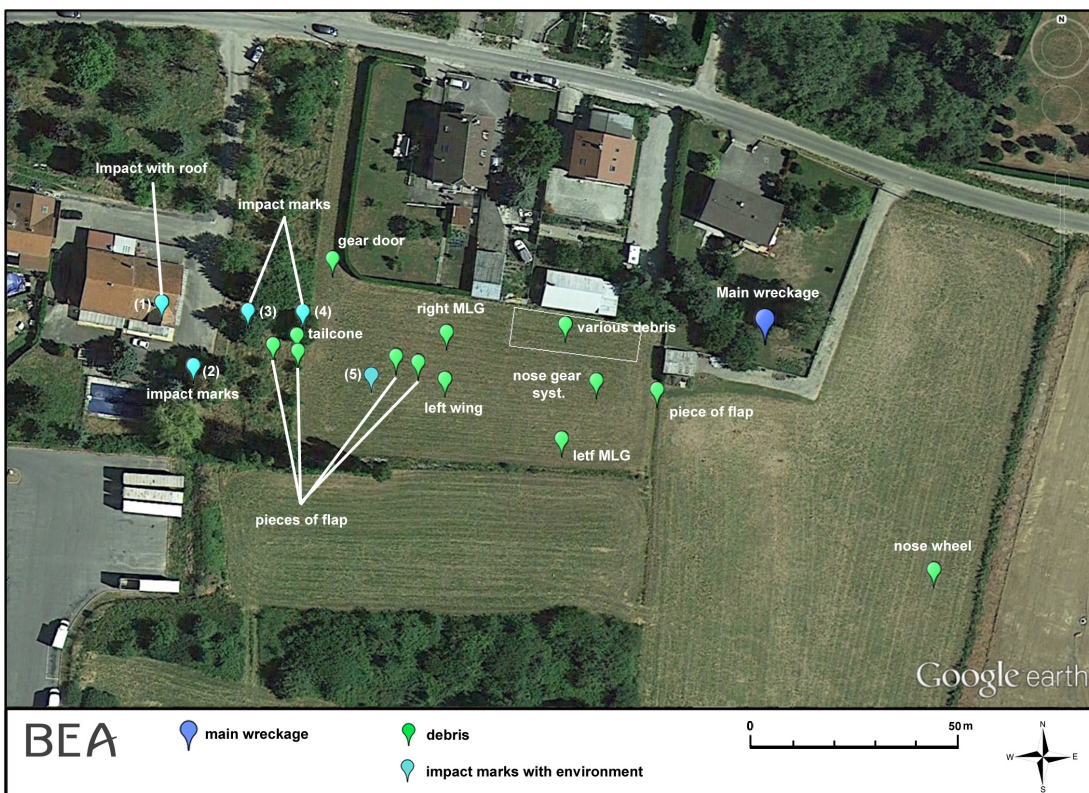
Figure 6 - Distribution of main debris

The wreckage was located about 600 metres south-east of Annemasse aerodrome runway 30 threshold, in the town of Cranves-Sales (France). It was located in an individual's garden. The main part included the fuselage the tail section, the two turbojets, the right wing and the left wing root. The right wing, the central spar and a segment of the left wing were separated from the airframe and were found several metres behind the rest of the wreckage. There was a large quantity of fuel in the right wing.

Initial impact of the aeroplane with the roof of another individual's house was observed about 150 m to the west of the main wreckage.

- ❑ the left wing, which showed marks of the same colour as that of the roof tiles of the first damaged house. Marks of fire (soot) were observed on this wing, at fracture level;
- ❑ the left main landing gear, on which pieces of wooden structure and deposits the colour of tiles were found.

The first major mark of impact with the ground was observed in the field, 20 m from its western edge, over about 15 m. It showed a slight curve to the left (in the direction of the flight path). The right main landing gear was found at the end of this mark.

A second mark, less spread out but deeper, was observed to the left of the previous mark.

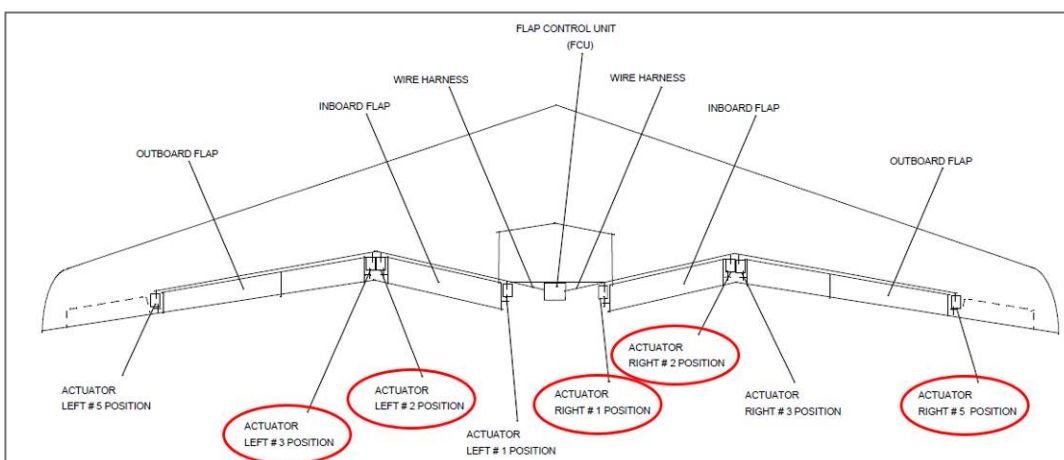
Figure 7 - Position of the flap actuators found at the site

Among the eight flap actuators, six were recovered and examined. The positioning of five of them was identified (circled on the figure below).
