Comparative audio analysis

Title: Result of cigarette and propagation tests

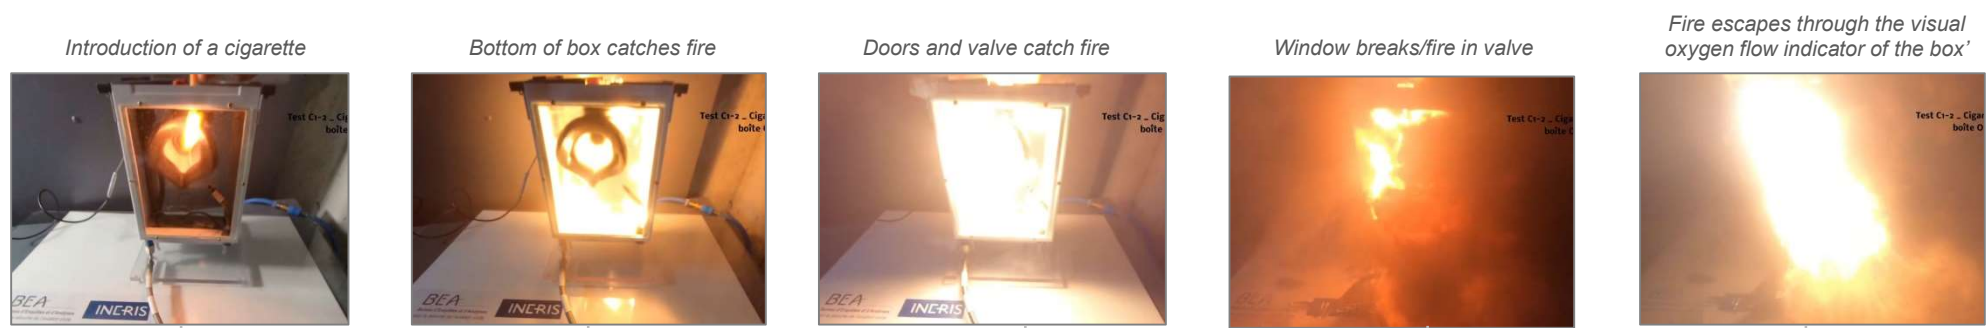
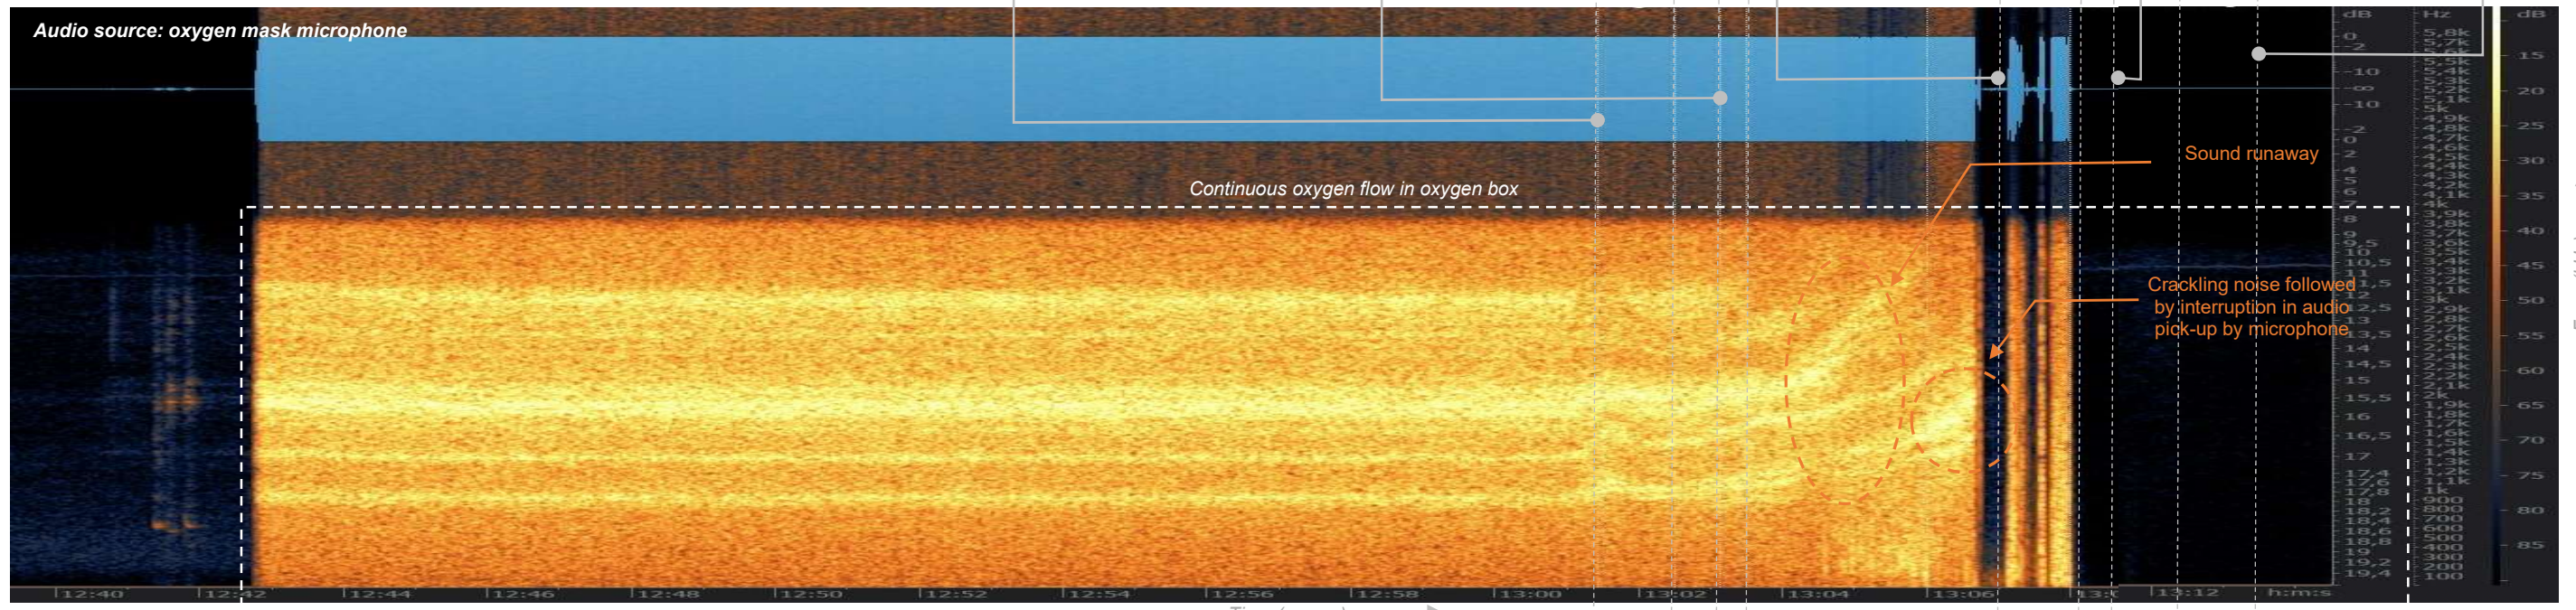
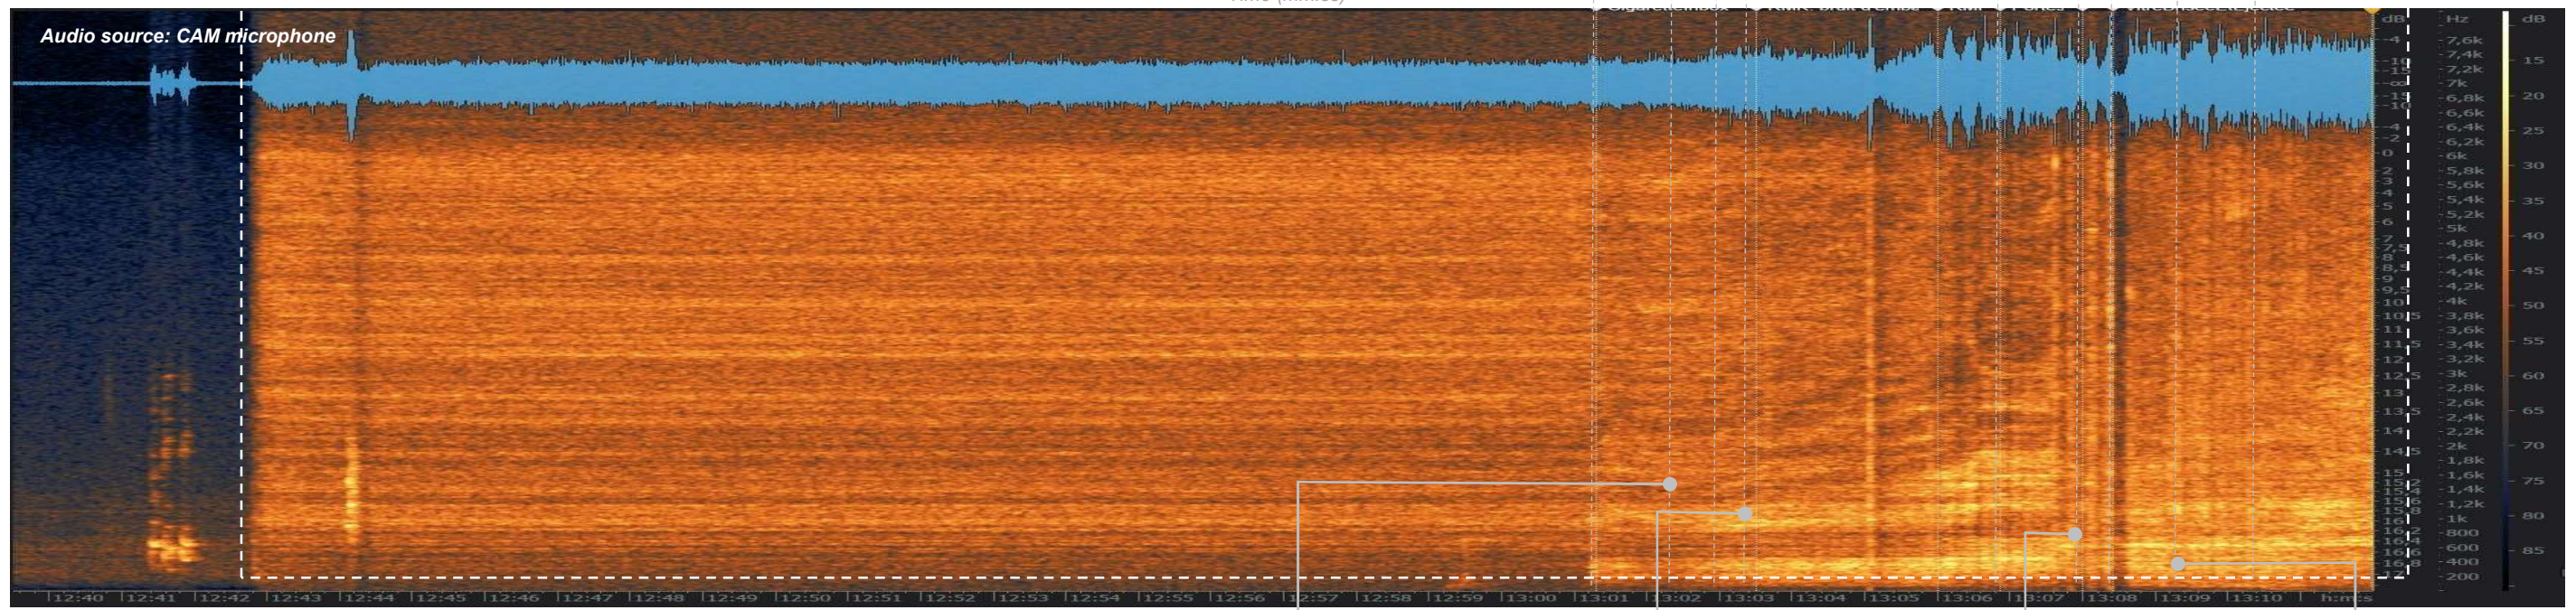
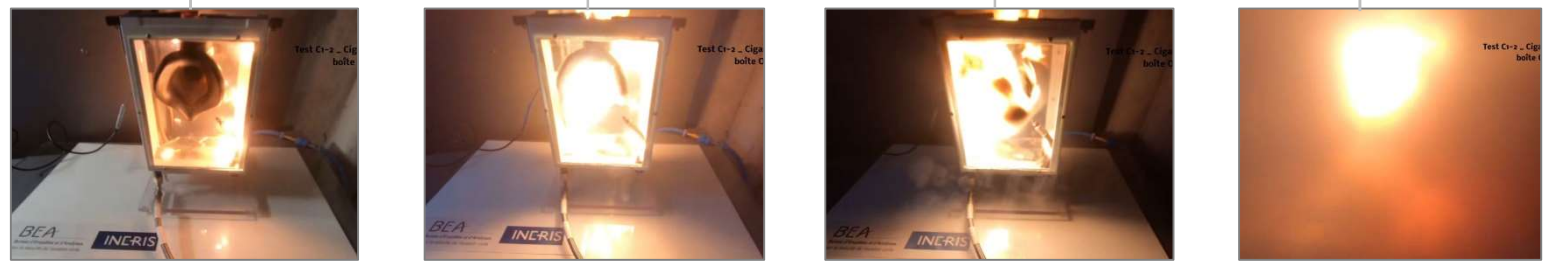
1 ___ Spectrum and waveform of audio recording of "Cigarette_00" test

- Page #1 shows the waveform of the audio recording (oxygen mask microphone signal and CAM signal) during the "Cigarette_00" test and the associated sequence of images. In the presence of an established oxygen leak, the cigarette introduced into the box immediately ignited, and very quickly set fire to the entire box and its contents (oxygen mask). There was a sound runaway 2.5 s after the cigarette was introduced and the microphone on the oxygen mask stopped working 3.5 s after the mask ignited.

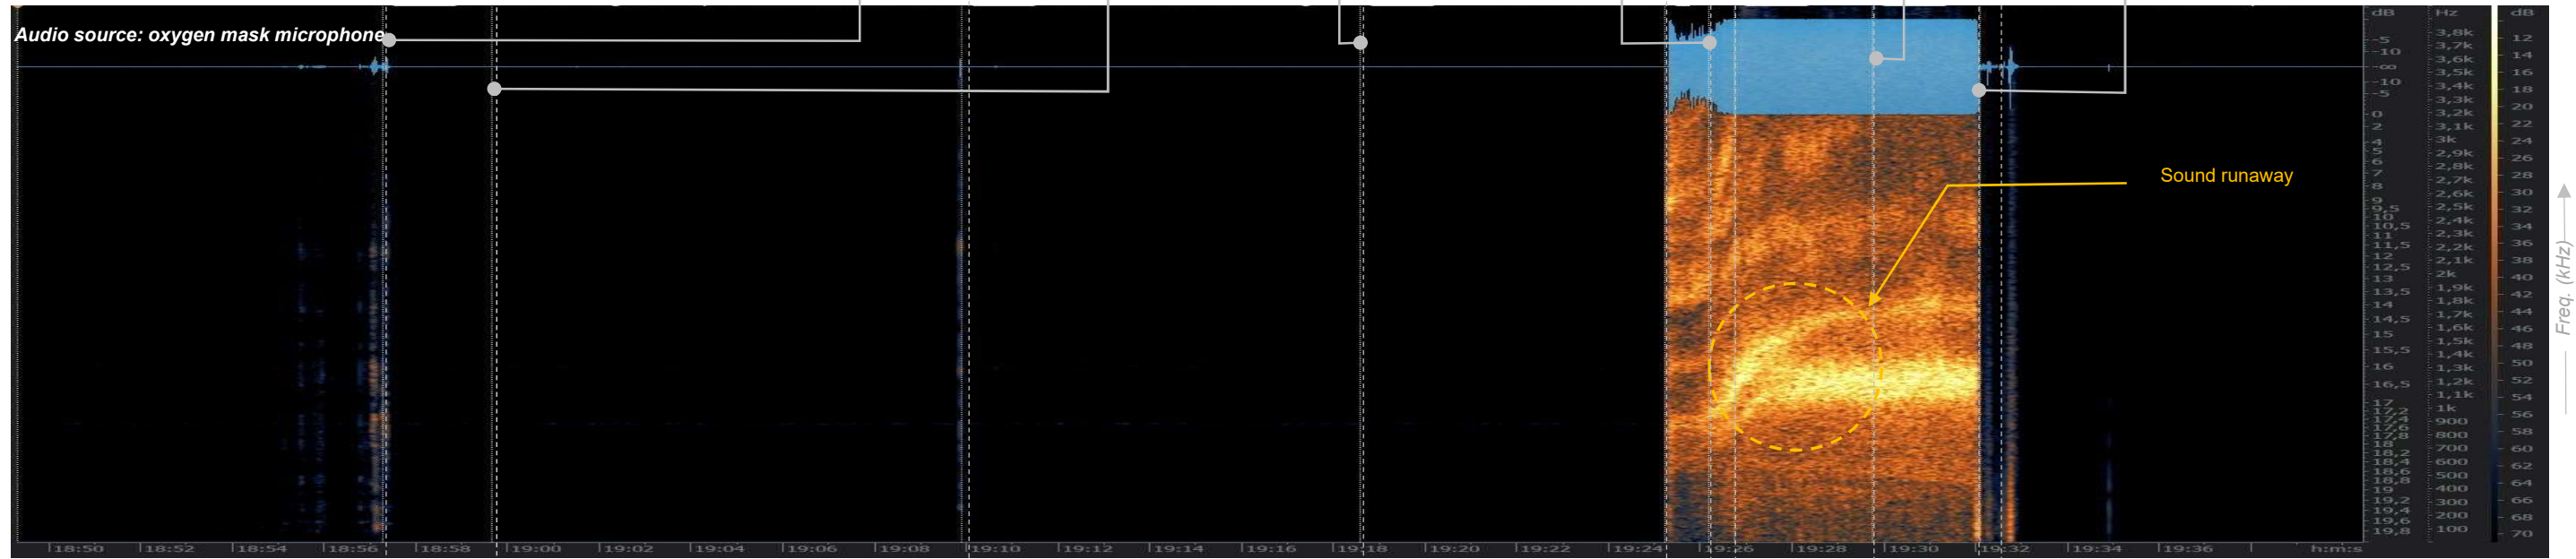
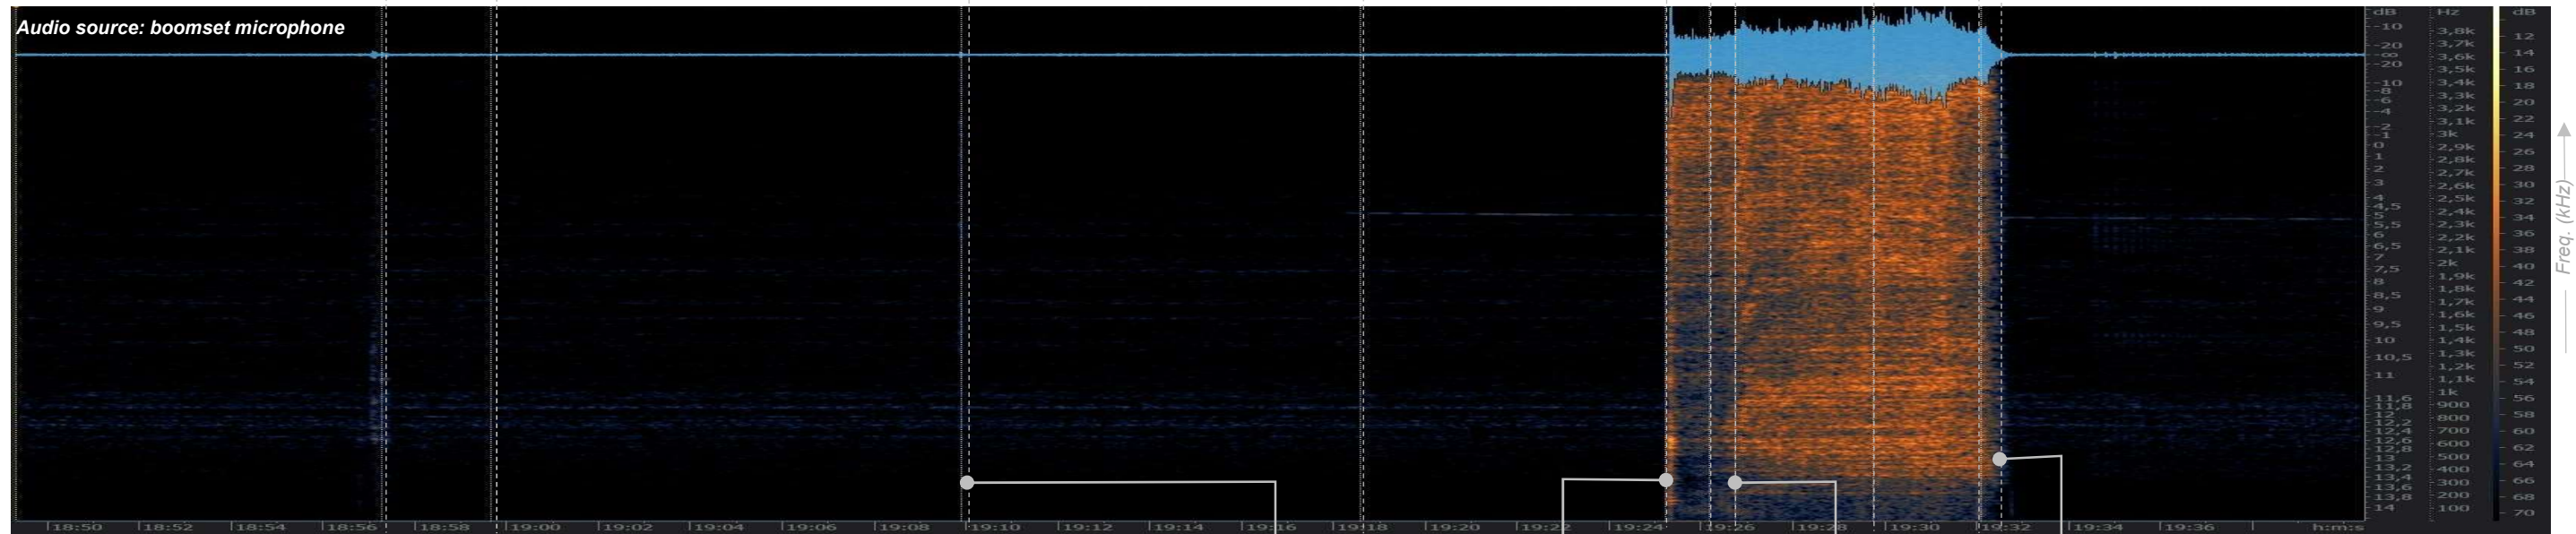
2 ___ Spectrum and waveform of audio recording of "Cigarette_01" test

- Page #2 shows the waveform of the audio recording (oxygen mask microphone signal and boomset microphone signal) during the "Cigarette_03" test and the associated sequence of images. The cigarette introduced into the oxygen-enriched box progressively damaged the oxygen mask hose (28 s of crackling noises are present during which the combustion of the braided protection is visible) until the core of the hose was pierced. When the hose was pierced, there was a broadband noise followed 1s later by a sound runaway. The fire that immediately followed the piercing of the hose very quickly engulfed the entire box and its contents (oxygen mask). The oxygen mask microphone stopped working 6 s after the mask caught fire.

Cigarette falls to bottom of oxygen box

Cigarette seems to extinguish/hose envelope glowing red

Mask catches fire

Fire escapes from oxygen box

Slight crackling noises/combustion of envelope of mask oxygen hose

End of audio pick-up by oxygen mask microphone

Cigarette burning at bottom of oxygen box

Oxygen mask hose pierced

Oxygen box assembly catches fire

Oxygen supply to oxygen box cut off

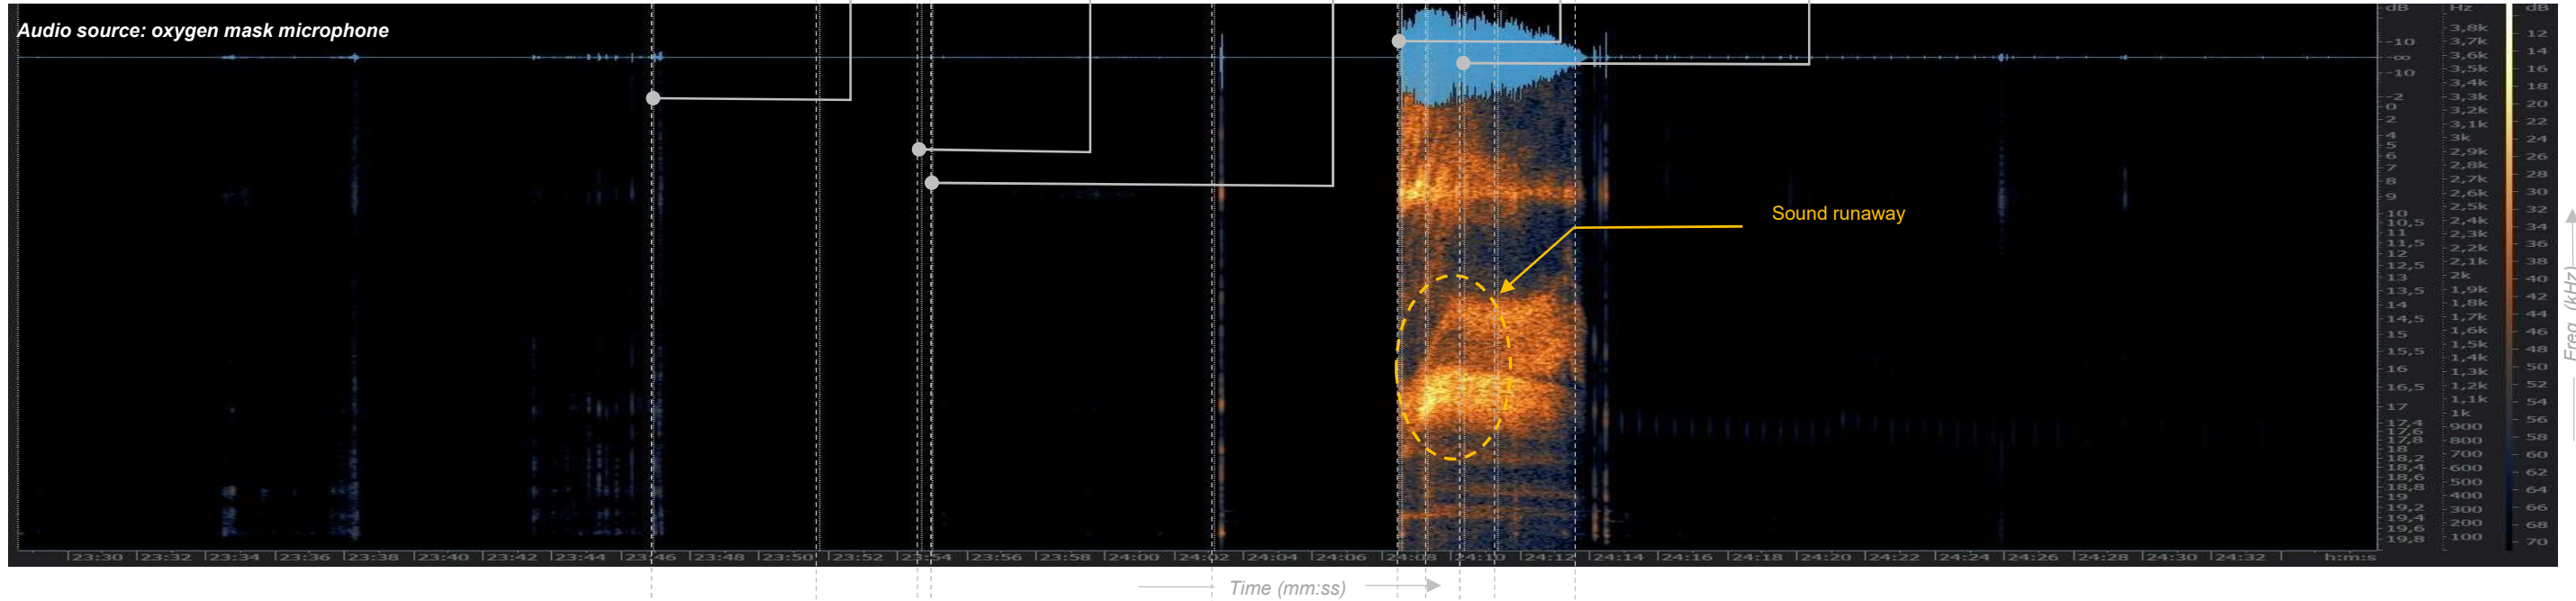
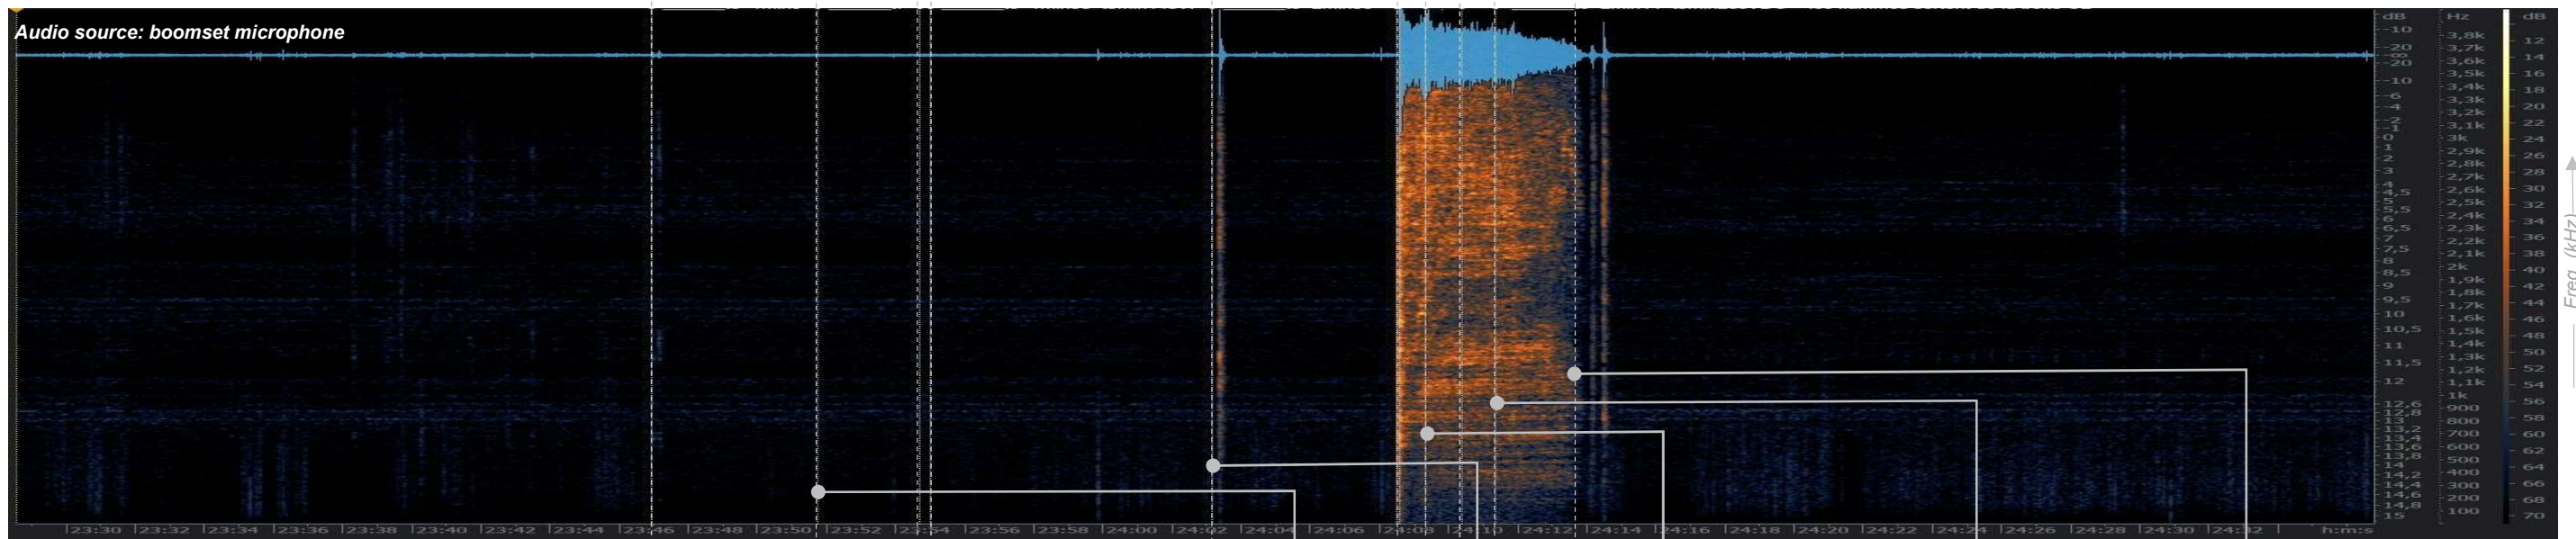
3 ___ Spectrum and waveform of audio recording of "Cigarette_02" test

- Page #3 shows the waveform of the audio recording (oxygen mask microphone signal and boomset microphone signal) during the "Cigarette_04" test and the associated sequence of images. The cigarette introduced into the oxygen-enriched box progressively damaged the oxygen mask hose (22 s of crackling noises are present during which the combustion of the braided protection is visible) until the core of the hose was pierced. When the hose was pierced, there was a broadband noise followed 0.5 s later by a sound runaway. The fire that followed the piercing of the hose very quickly engulfed the entire box and its contents (oxygen mask). The oxygen supply was cut off 5 s after the mask ignited and before the oxygen mask microphone was damaged.

Cigarette falls to bottom of oxygen box

Fire spreads to harness and Nomex protection of hose

Oxygen mask hose pierced

Oxygen box assembly catches fire

Slight crackling noises/combustion of envelope of mask oxygen hose

Cigarette burning at bottom of oxygen box

Window cracks

Mask catches fire

Fire escapes from oxygen box

Oxygen supply to oxygen box cut off

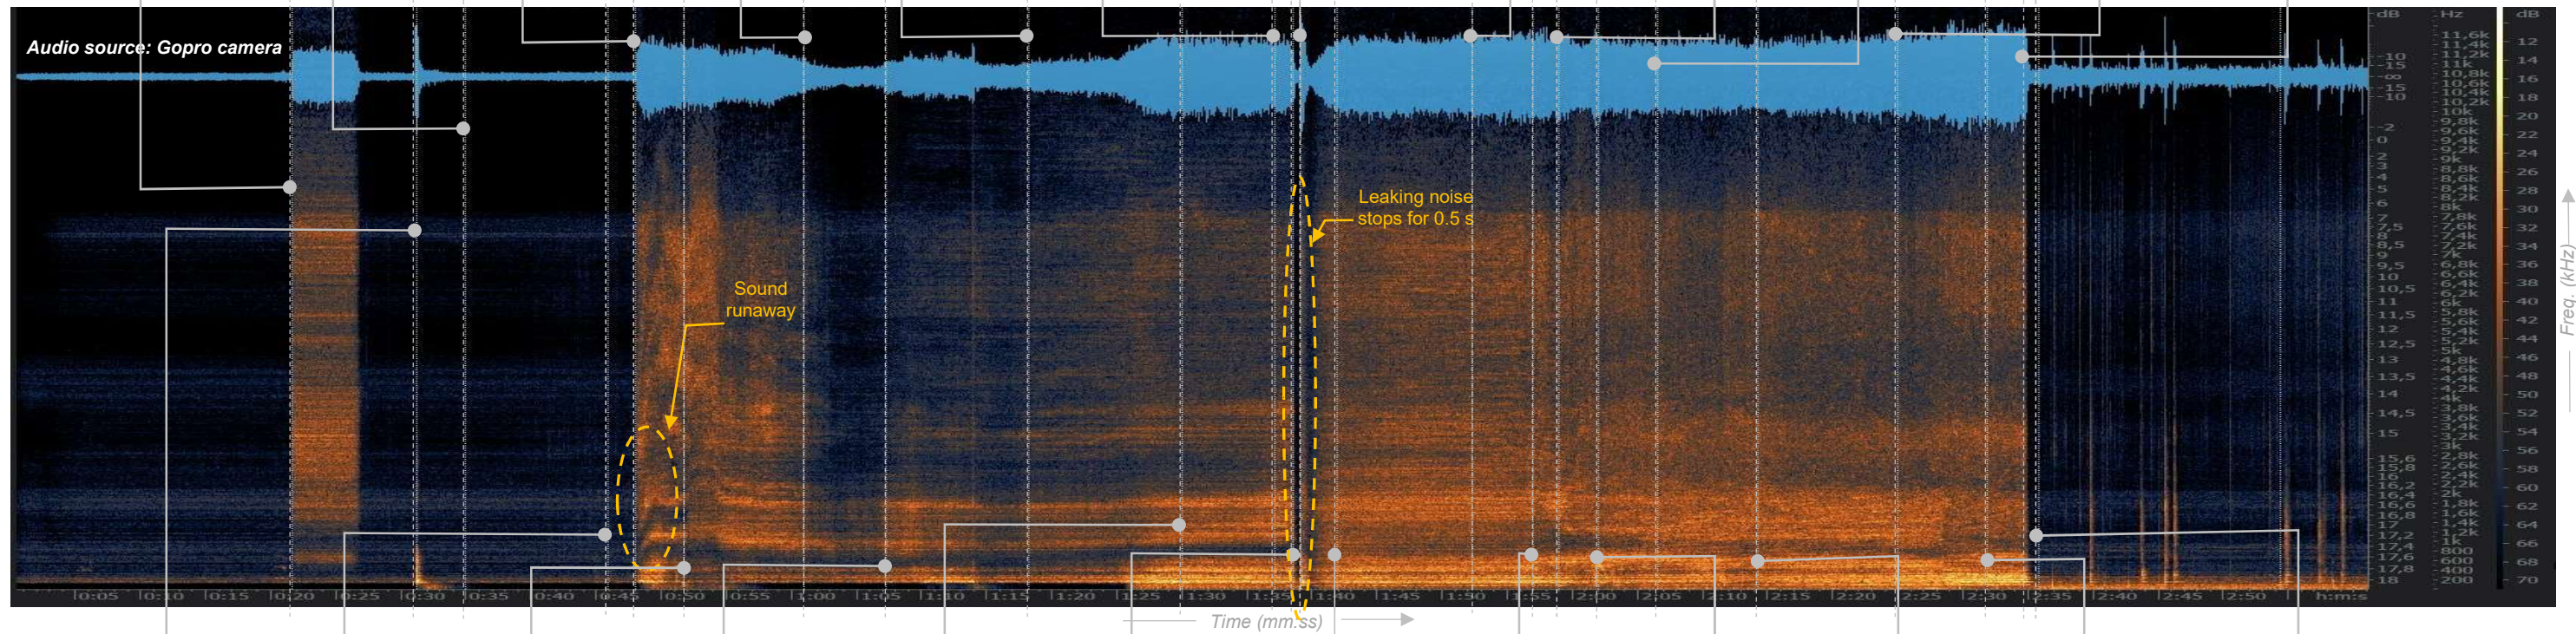
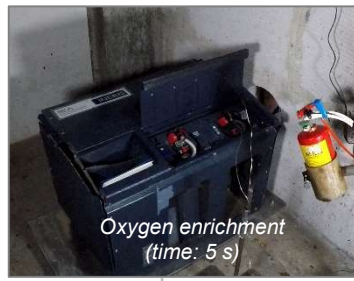
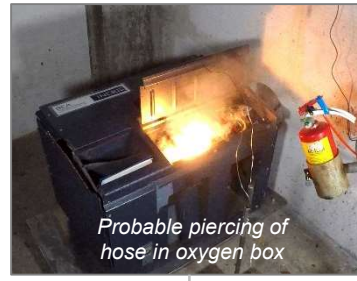
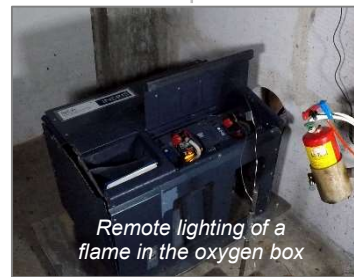
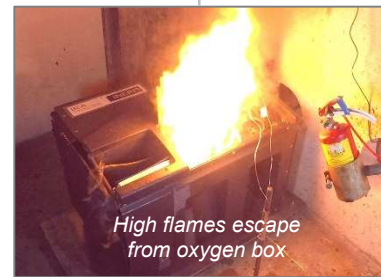
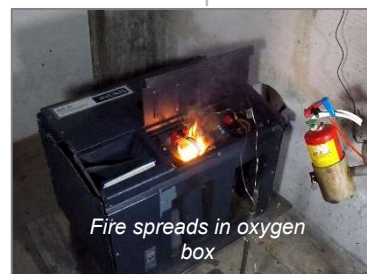
4 ___ Spectrum and waveform of audio recording of "Propagation_01" test

- Page #4 shows the waveform of the audio recording (GOPRO camera sound band) during the "Propagation_01" test and the associated sequence of images. Smoke and flames could be seen coming out of the oxygen box 5 s after the remote lighting of a cotton pad placed in the bottom of the oxygen box. The mask hose was probably pierced 18 s after the start of the fire. This was shown by a broadband noise followed 1s later by a sound runaway. The fire that followed the piercing of the hose spread rapidly to the surrounding elements. The leaking noise suddenly stopped for 0.5 s - without any action by the test operators - 50 s after the mask hose was probably pierced. This short interruption in the leak preceded a detonation, the resumption of the leak and the enrichment of the fire.

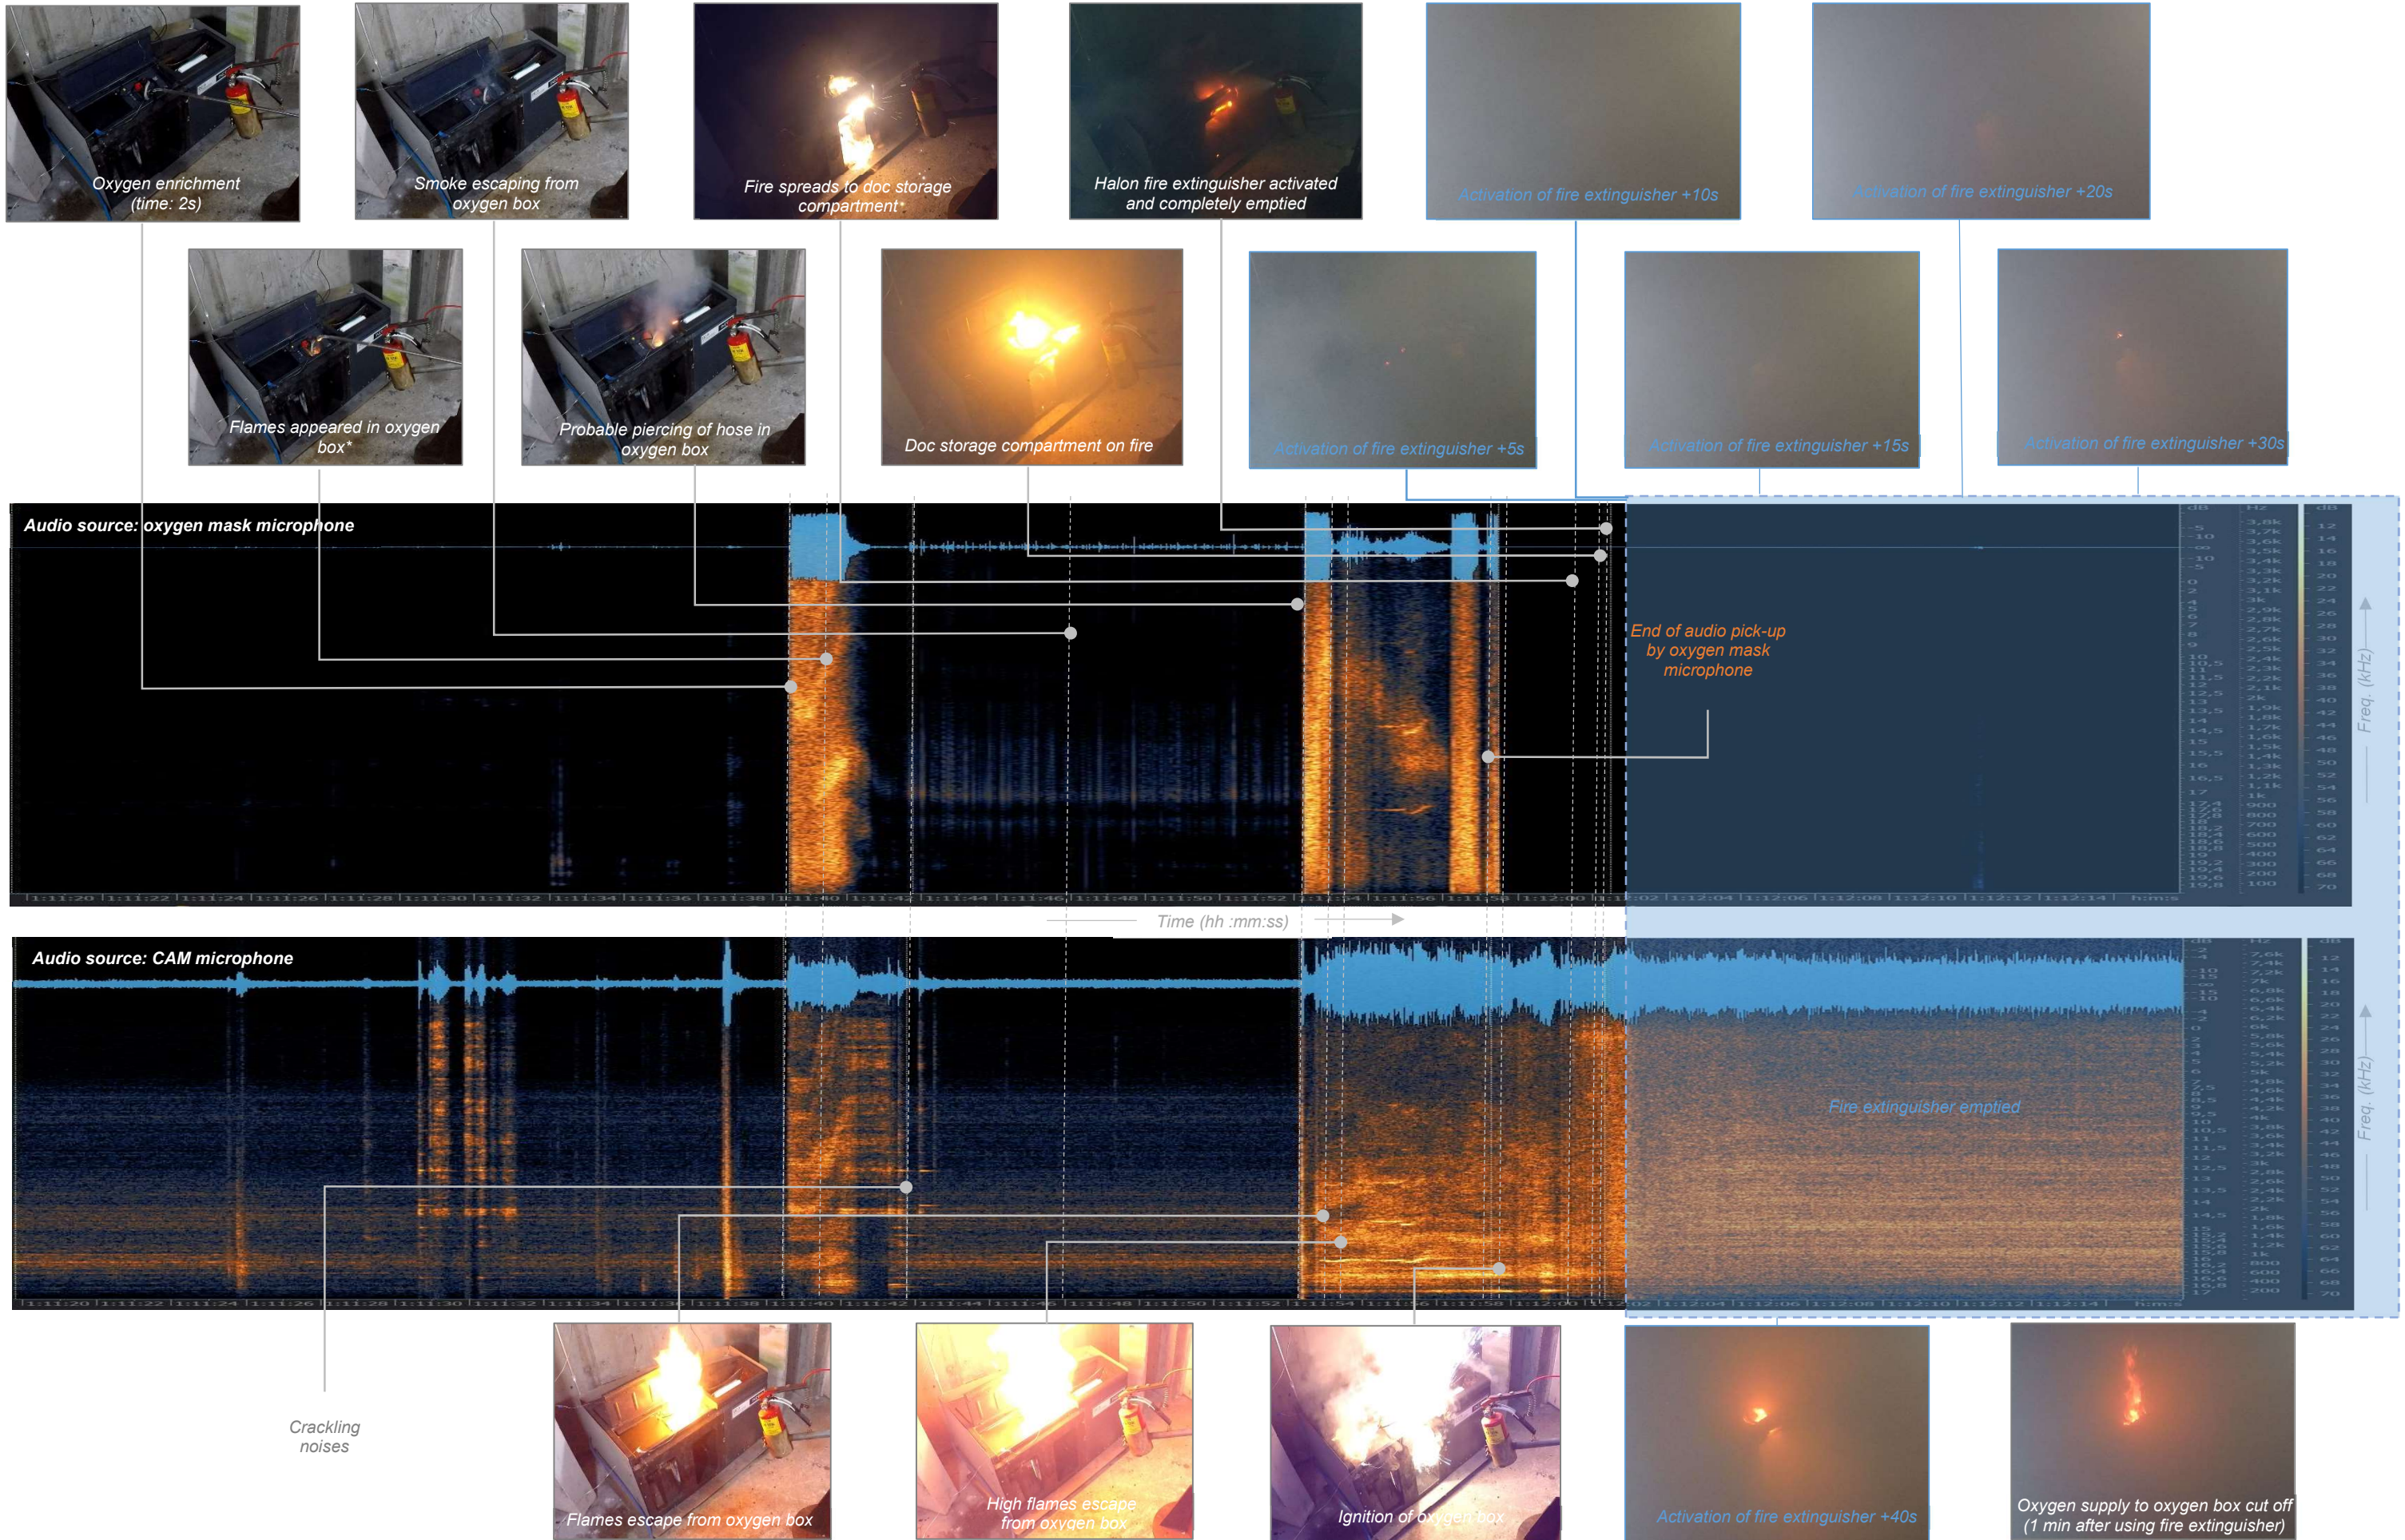
5 ___ Spectrum and waveform of audio recording of "Propagation_02" test

- Page #5 shows the waveform of the audio recording (oxygen mask microphone signal and CAM signal) during the "Propagation_02" test and the associated sequence of images. Smoke and flames could be seen coming out of the oxygen box 6 s after the remote reactivation of the cotton pad fire in the bottom of the oxygen box⁴. The mask hose was probably pierced 13 s after the reactivation of the fire. It was preceded over the same period by cracking noises picked up by the oxygen mask microphone. The probable piercing of the hose produced a broadband noise. The sound runaway described for the previous tests was not perceived. The fire that followed the piercing of the hose spread rapidly to the surrounding elements. The leaking noise was continuous until the oxygen supply of the test set-up was cut off.

The oxygen mask microphone stopped working 5 s after the probable piercing of the oxygen mask hose.

* residual embers from a previous aborted remote lighting of a fire flame up

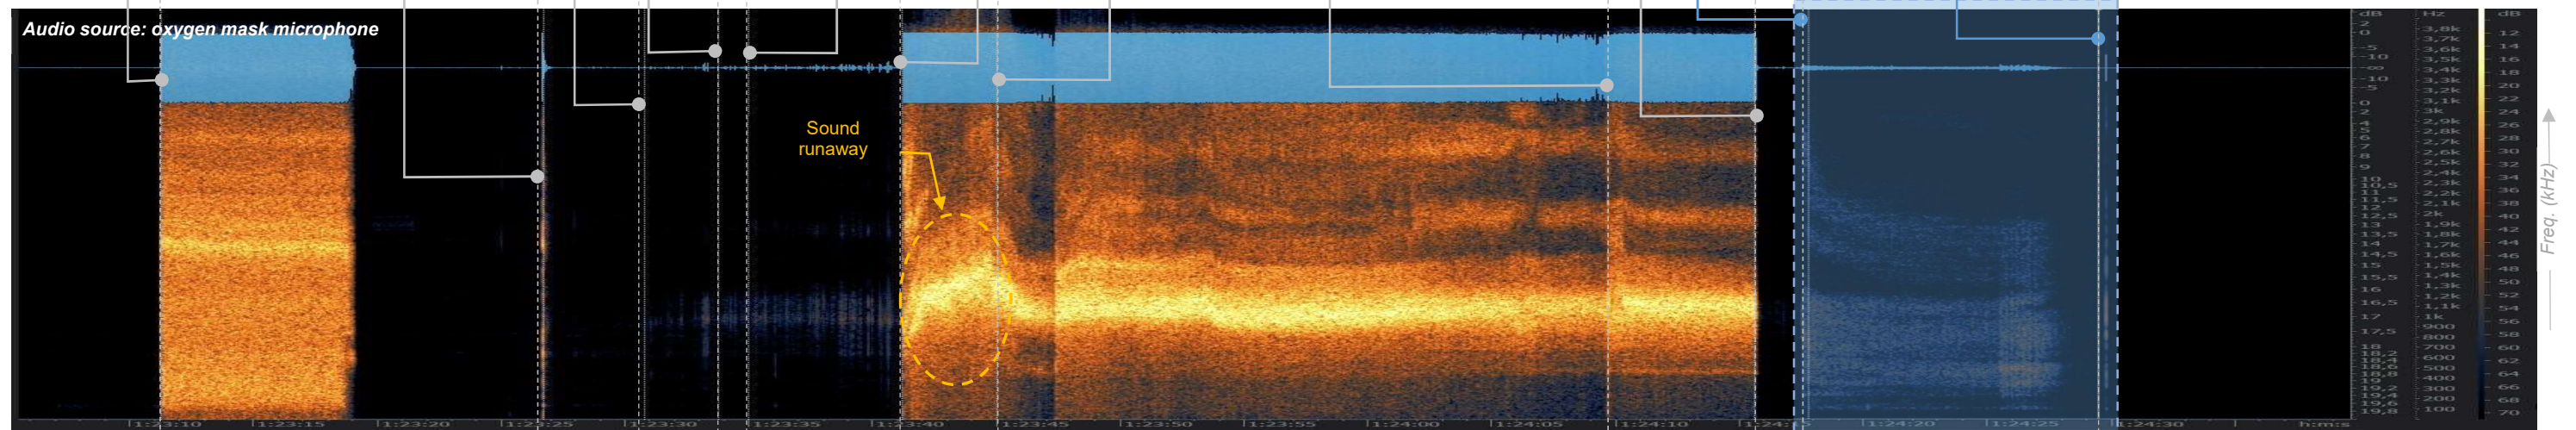
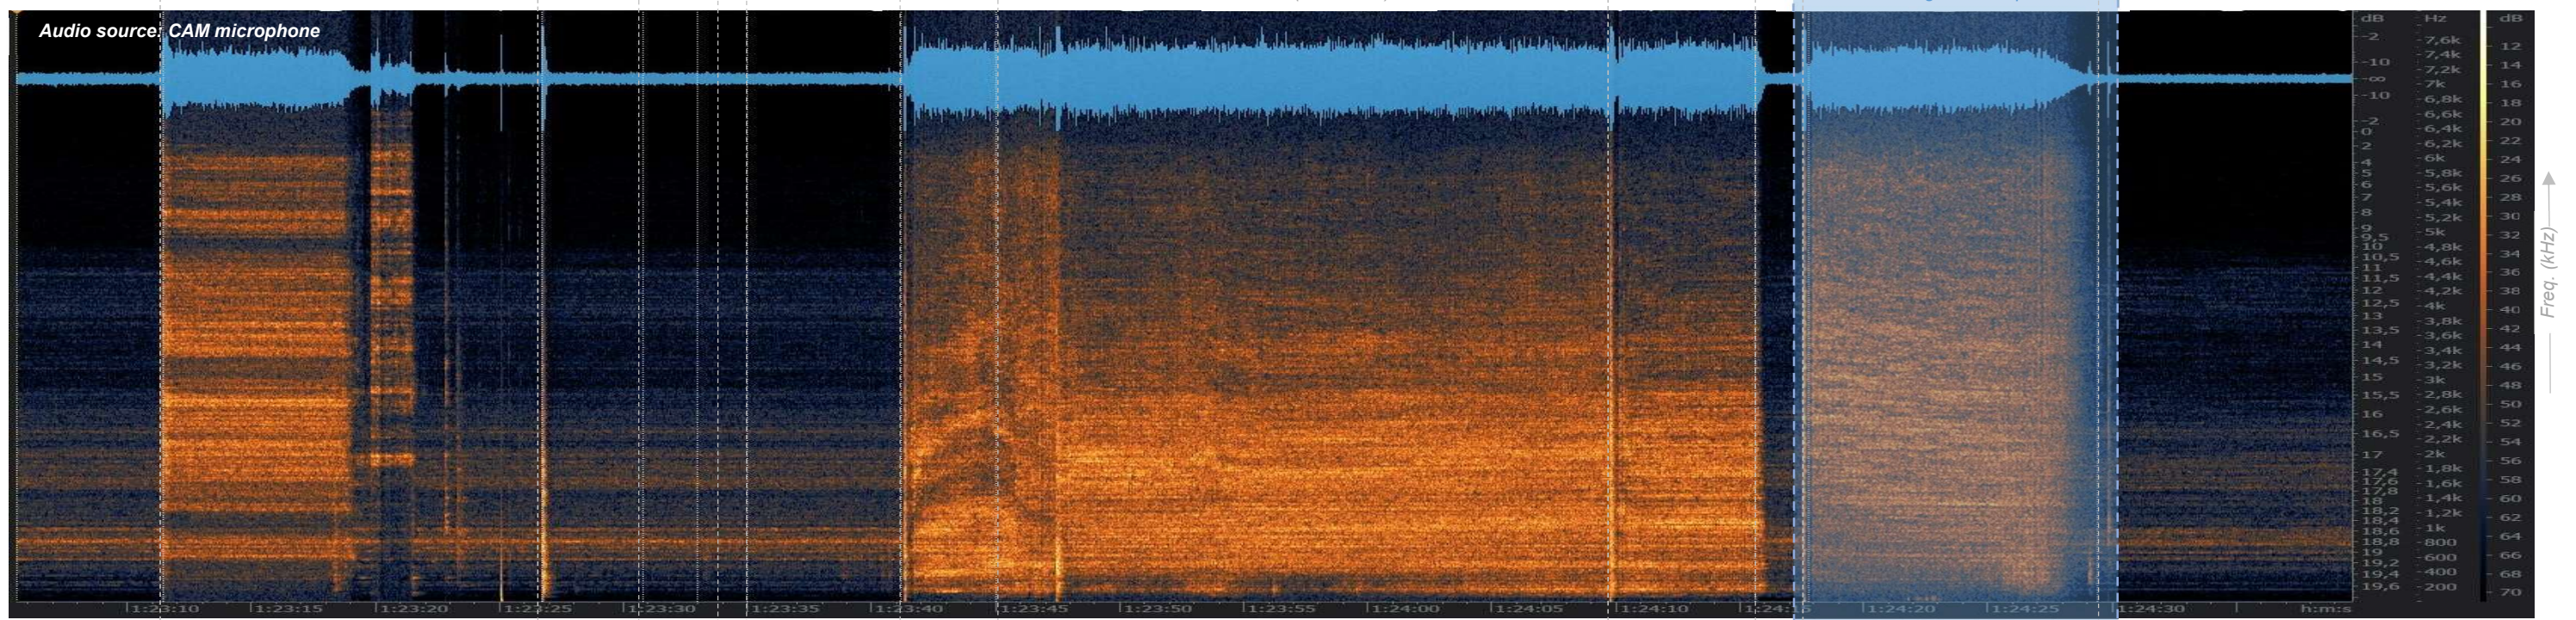
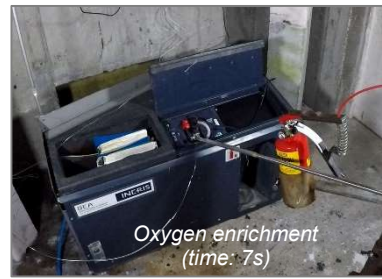
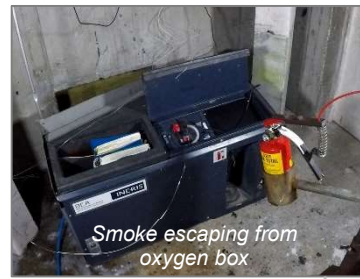
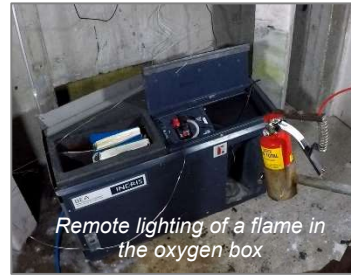
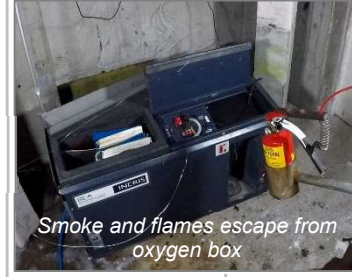
6 ___ Spectrum and waveform of audio recording of "Propagation_03" test

- Page #6 shows the waveform of the audio recording (oxygen mask microphone signal and CAM signal) during the "Propagation_03" test and the associated sequence of images. Smoke and flames could be seen coming out of the oxygen box 7 s after the remote lighting of a cotton pad placed in the bottom of the oxygen box. The mask hose was probably pierced 14 s after the start of the fire. It was preceded over the same period by cracking noises picked up by the oxygen mask microphone. The probable piercing of the hose produced a broadband noise followed 0.5 s later, by a sound runaway. The fire that followed the piercing of the hose spread rapidly to the surrounding elements. Cutting off the oxygen supply - which preceded the use of the fire extinguisher - stopped the leaking noise.
