Comparative audio analysis

Title: Result of cigarette and propagation tests

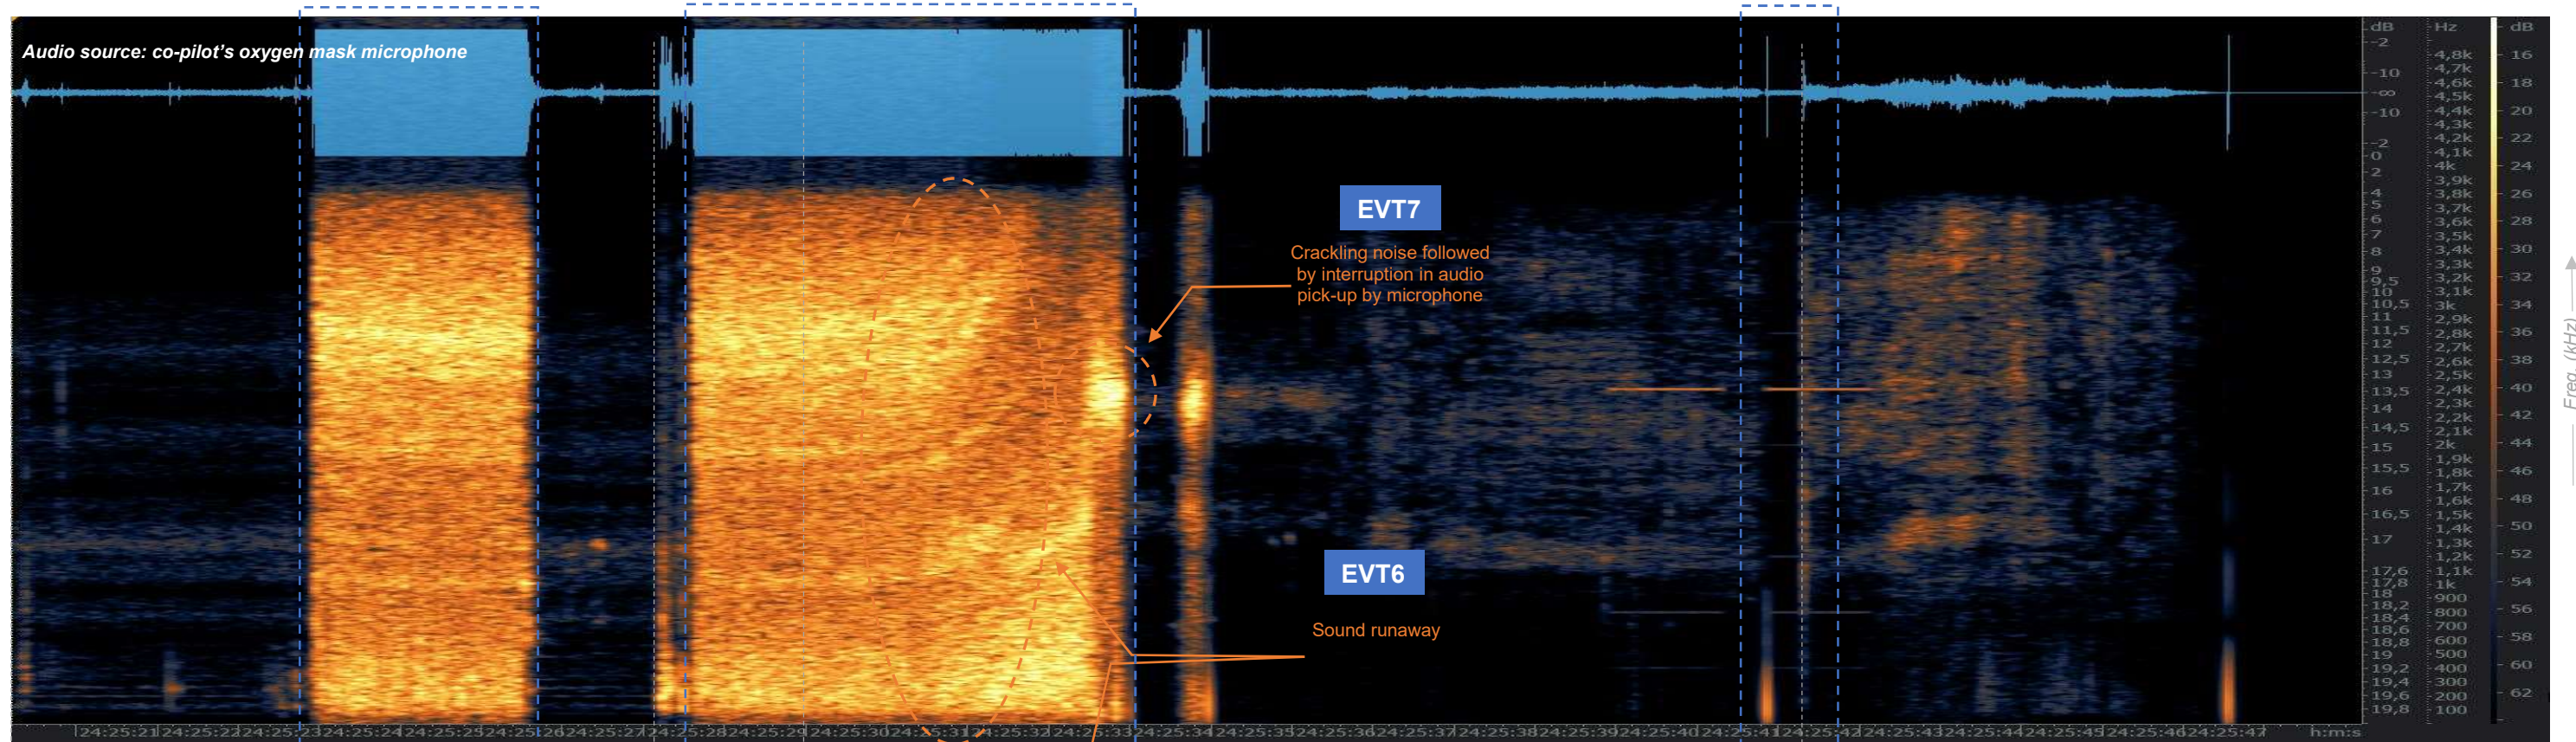
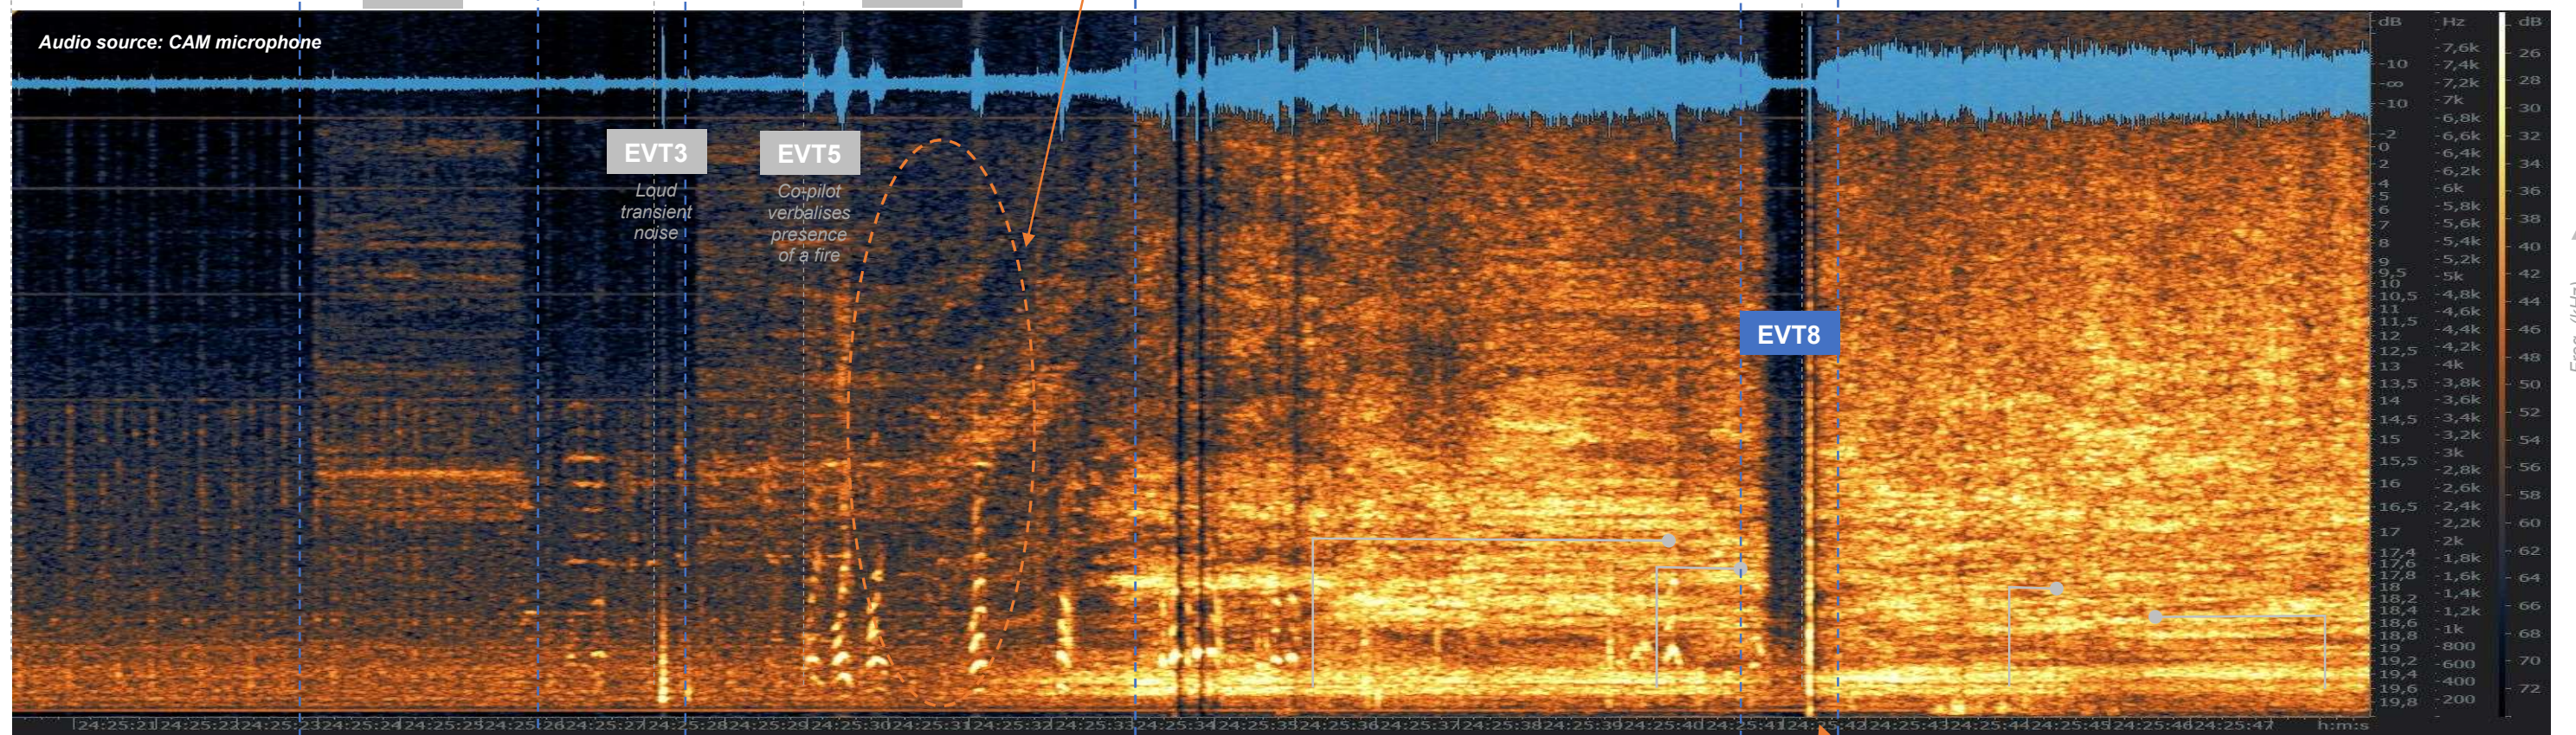
7 ___ Spectrum and waveform of occurrence recorded on CVR of MS804

- Appendix 7 shows for comparison purposes, the waveform of the CVR audio recording of MS804 (co-pilot's oxygen mask microphone signal and CAM signal).

- No crackling noise can be perceived in the recording from the co-pilot's oxygen mask microphone.
- A sound runaway was present on the co-pilot's oxygen mask microphone and CAM channels at 00:25:31 (EVT6). This noise can probably be attributed to the co-pilot's oxygen mask catching fire.
- The screeching noise that preceded the loss of the microphone signal from the co-pilot's oxygen mask at 00:25:33 (EVT7) was probably produced by the destruction of the mask microphone by the flames.
- The momentary interruption (510 ms) of the oxygen leak at 00:25:42 (EVT8) was probably produced by damage to the oxygen assembly⁵ located in and/or under the lateral storage compartment.

Noise of oxygen flow in co-pilot's mask
Probable cause: mask EMERGENCY knob being pressed

Noise of continuous oxygen flow in co-pilot's mask
Undetermined cause/start of leaking noise has a very similar spectrum to EVT2

Leaking noise momentarily stops
Duration: 0.5 s
Loud transient noise (detonation)
