## Sequences/scenarios of actions on oxygen mask and mask storage box

## SU-GCC – CVR event sequence (first oxygen activity noise / co-pilot's mask)

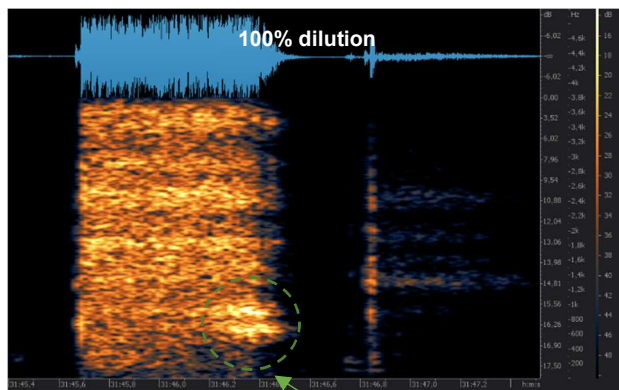
Short presence of two noise bumps (average 600 and 900 Hz) which appeared during the transient noise release, producing a hollow hiss. This signature was observed in all the tests carried out with the dilution set to 100%.

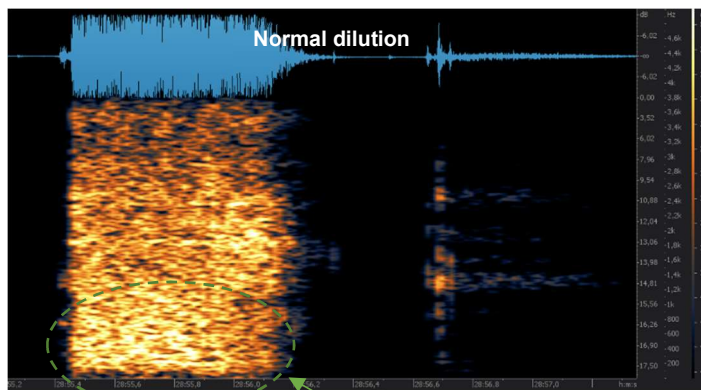
Low-frequency contribution to the spectrum. This contribution was observed in all the tests carried out with the dilution set to Normal.

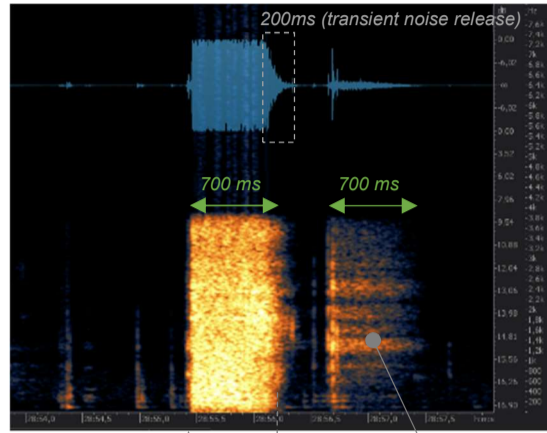
**Box Press To Test PB pressed and held / Mask set to Normal**

Door Press To Test PB pressed and held, Pressurization, System bleed (reverberation), Door Press To Test PB released

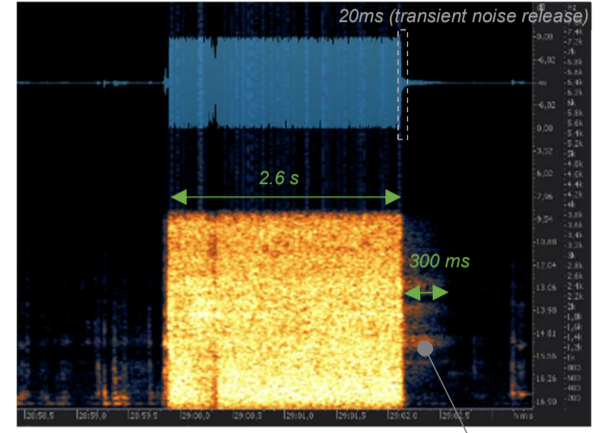
**Simultaneous pressing of box Press To Test PB and mask knob (EMERGENCY)**

Door Press To Test PB and mask knob pressed and held, System bleed (reverberation), Door Press To Test PB and mask knob released

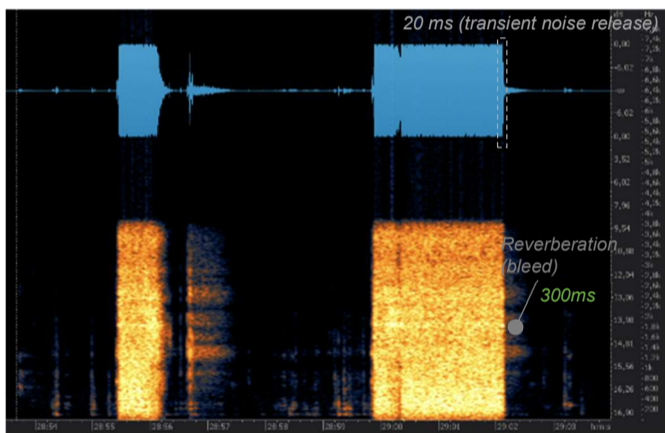
**Seq.0/** SOPs / Door Press To Test PB and mask knob pressed / released simultaneously

Door Press To Test PB pressed and released, Door Press To Test PB and mask knob simultaneously pressed (2.5 s), Door test PB and mask knob released

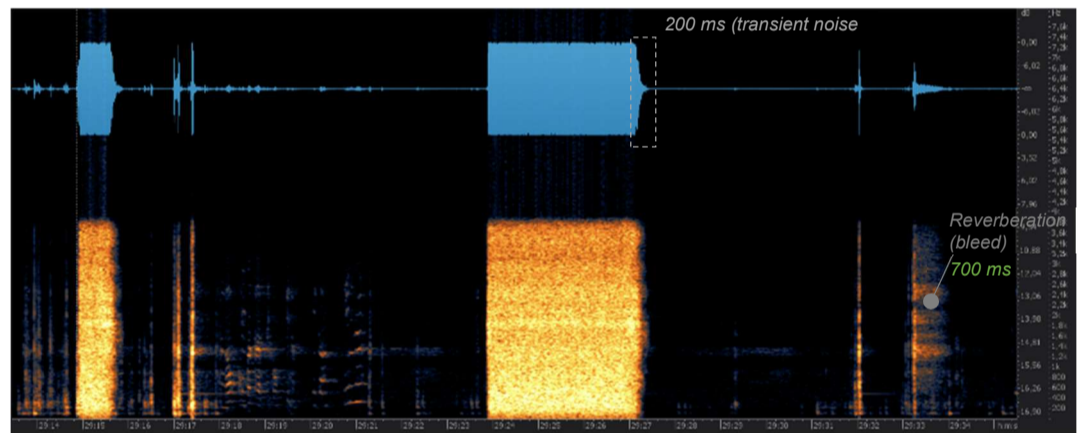
**Seq.1/** Door opened and then closed / Mask knob pressed (3s) then oxygen box reset

Door opened, Door closed (No reset), Mask knob pressed (3 s), Mask knob released, Door Press To Test PB pressed (Reset)

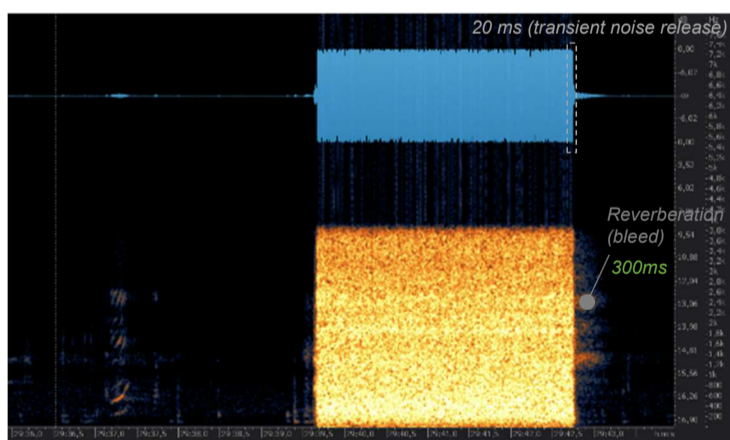
**Seq.2/** Door Press To Test PB and mask knob simultaneously pressed for 2.6 s

Door Press To Test PB and mask knob simultaneously pressed (2.6 s), Door test PB and mask knob released

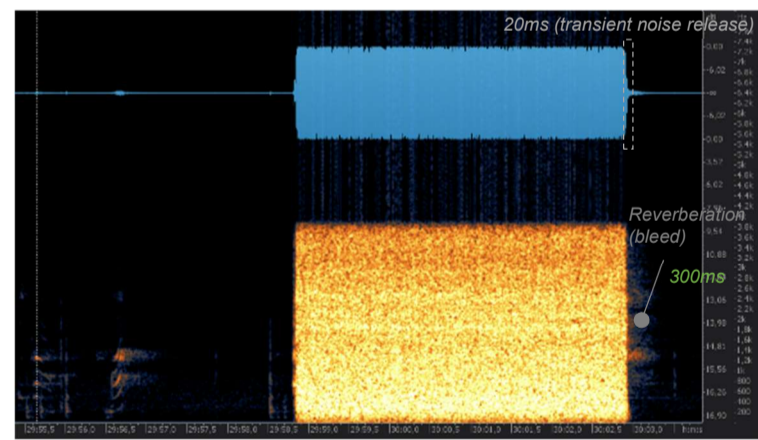
**Seq.3/** Door Press To Test PB pressed for 2.6 s with mask in EMER

Door Press To Test PB pressed (2.6 s), Door Press To Test PB released

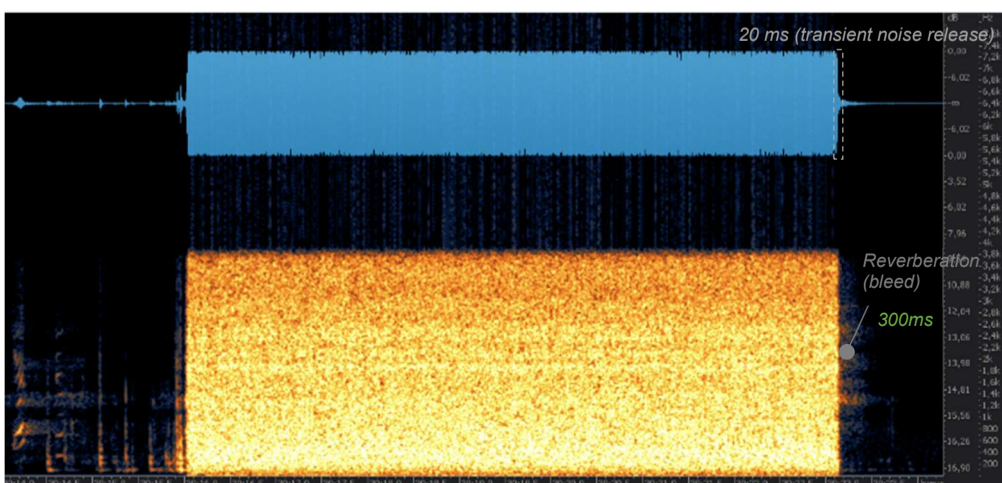
**Seq.4/** Door of mask storage box opened with mask in EMERGENCY position

Oxygen box opened, Box reset (Press To Test PB) after closing door

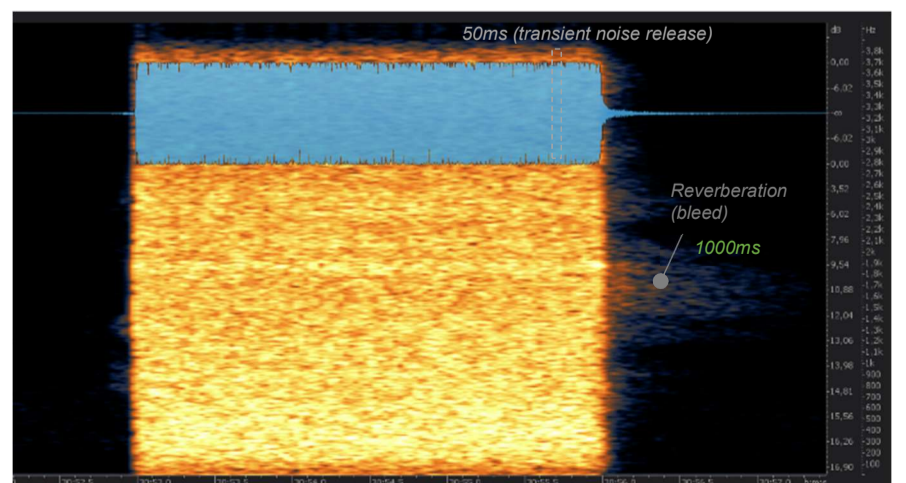
**Seq.5/** Temporary oxygen supply (2.6 s via solenoid control\*) with door of mask storage box open and mask in EMERGENCY position

Solenoid valve ON (2.6 s), Solenoid valve OFF

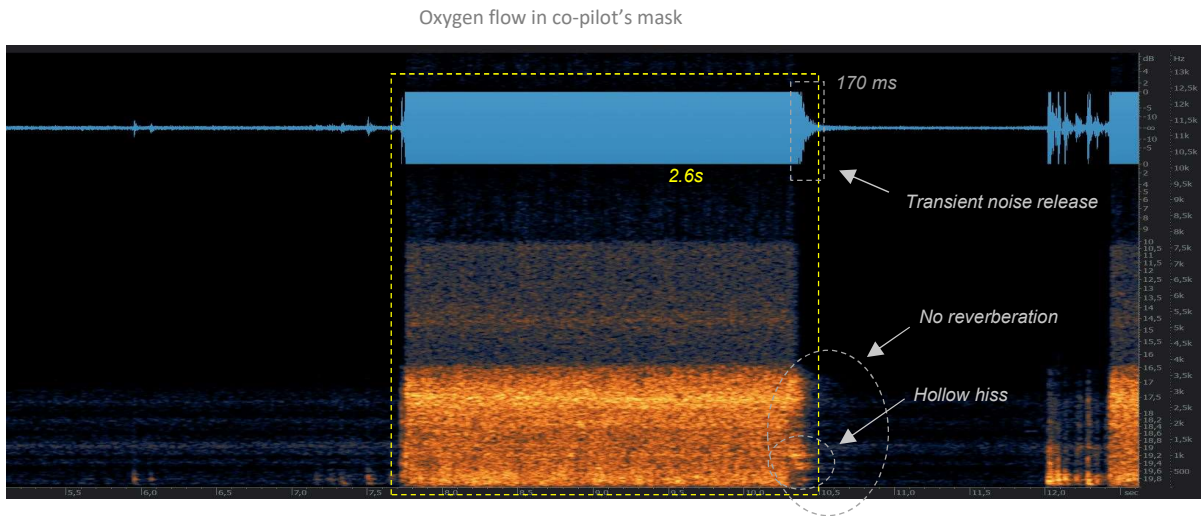
Note 1: audio pick-up by oxygen mask microphone

Note 2: the co-pilot's fixed oxygen equipment on flight MS804 was composed of an MF20 oxygen mask and an MXP801 mask storage box.

The flow time of 2.6 s indicates that oxygen was being expelled from the mask (via the regulator).

The duration of the transient noise release (200 ms) corresponds to the end of pressurisation to 5 bar of all the hoses upstream of the regulator:

The reverberation (bleed) corresponds to the evacuation of excess pressure.

The hollow hiss indicated that the co-pilot's mask was in the 100% oxygen position.
