# Oxygen fire in cockpit study - Accident to the A320 registered SU\_GCC on 19 May 2016

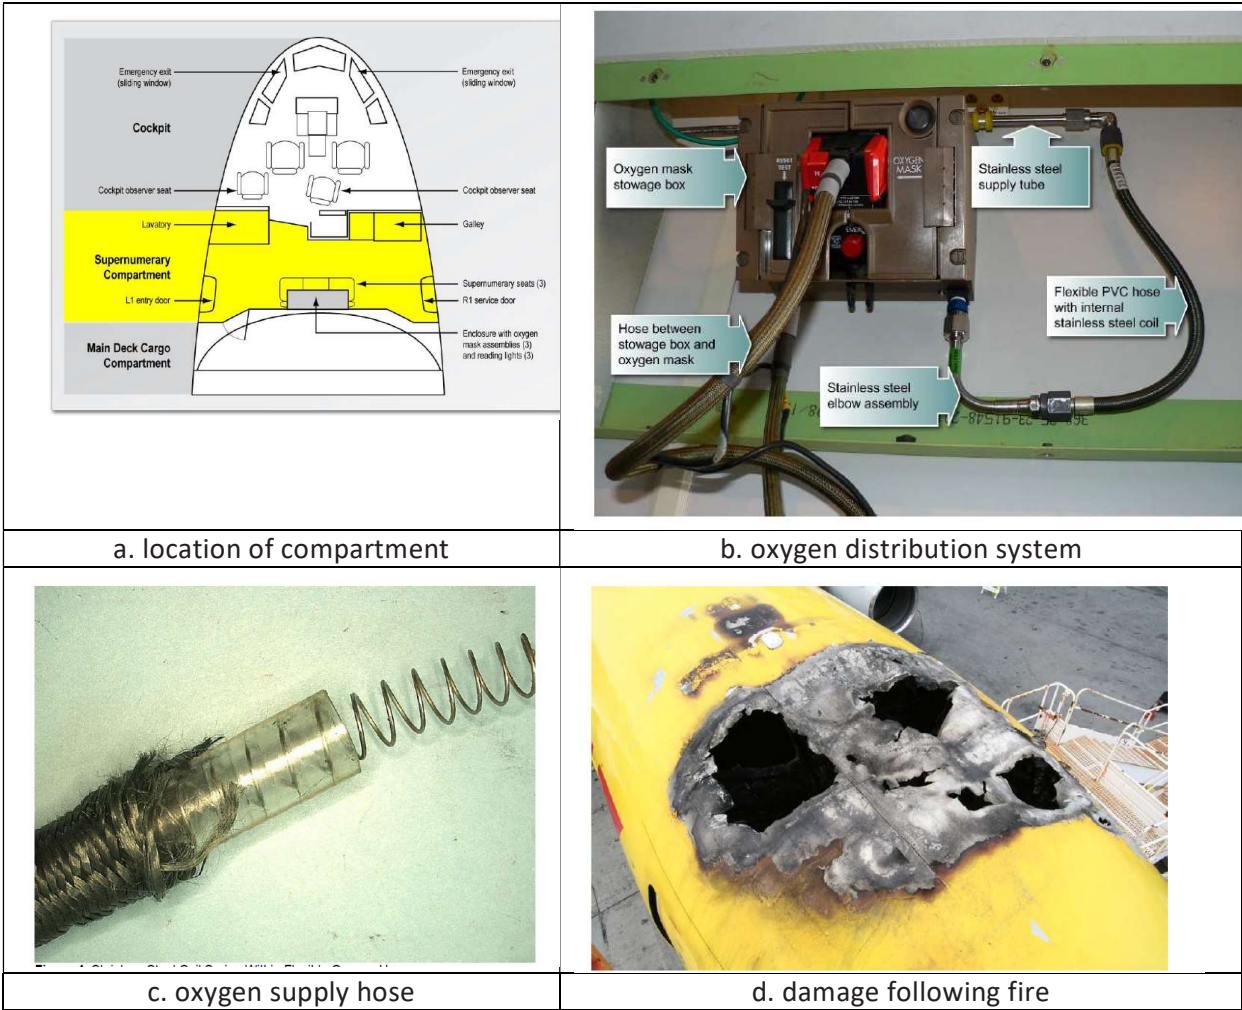
Figure 7: images from investigation report (source: NTSB)

The oxygen hose ignited when exposed to the fire, and the fire burned through the aeroplane's fuselage.

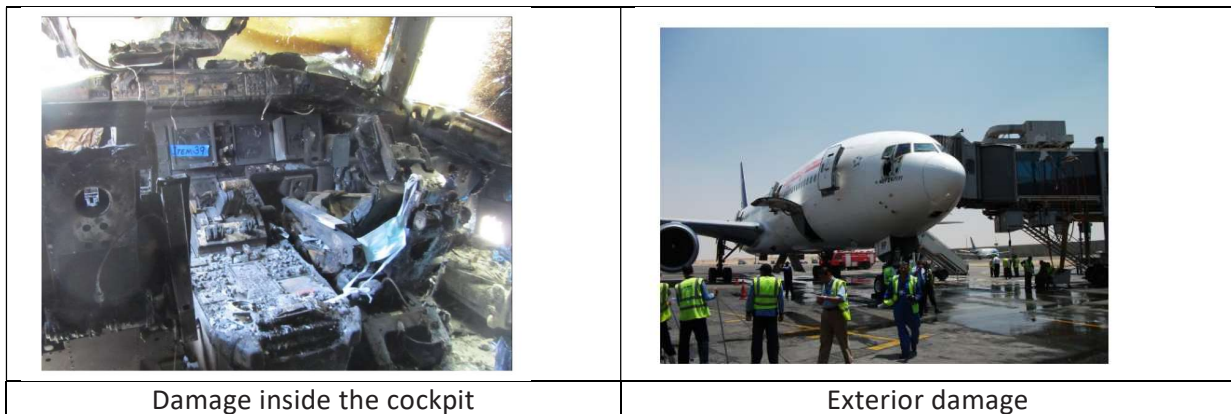
The captain asked the co-pilot to exit the cockpit and to warn the crew of the fire. The captain used the cockpit fire extinguisher, situated behind his seat, to fight the fire. This attempt was unsuccessful, and the fire continued to spread in the cockpit.

**Figure 8: photos from investigation report (source: EAAID)**

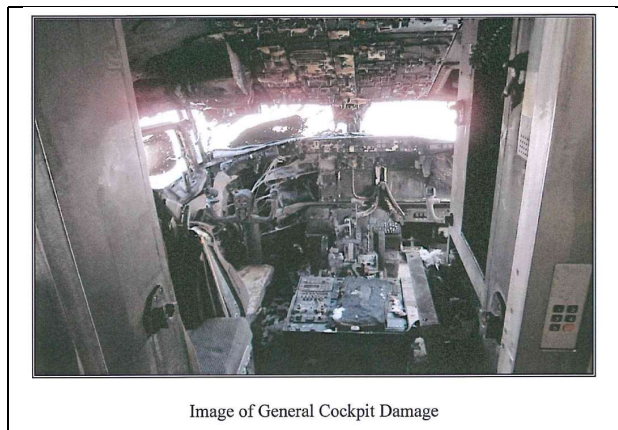
An oxygen leak and fire broke out in the cockpit on the captain's side. It is said that two seconds after the start of the leak, the co-pilot reported the problem and called out "cologne". The captain asked the pilots to leave the cockpit and asked for a fire extinguisher. A fire extinguisher was activated one minute later. The passengers were evacuated and the aircraft rescue and firefighting service intervened to bring the fire under control. The fire caused substantial damage in the cockpit as well as in the electronic and avionics bays along with heat damage to the outer skin.

**Figure 9: photo from draft investigation report (source: safety investigation authority)**

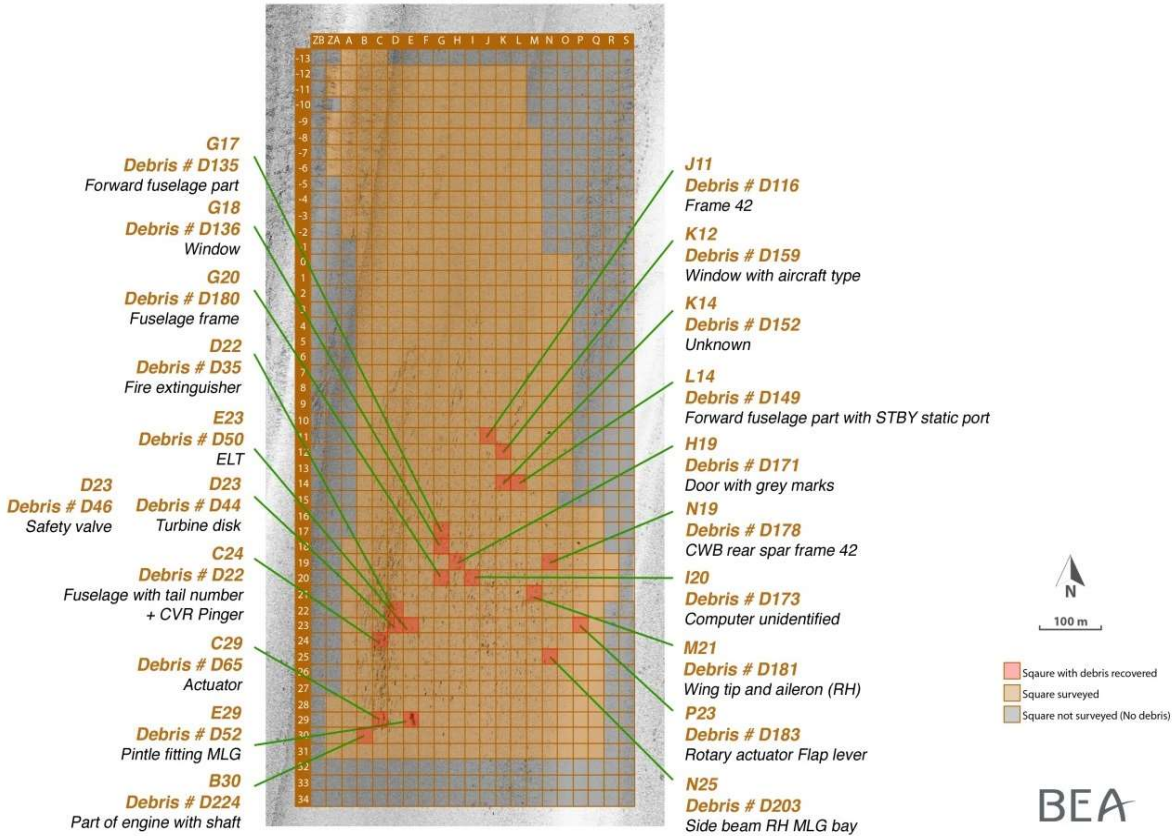
A sonar search located the wreckage and defined the limits of the field of debris. The debris was scattered in a rectangle measuring 1.2 km by 525 m. The debris was then identified, mapped and some pieces recovered. All the extremities of the aeroplane were within the identified rectangle: the cockpit, the wings and the tail. These observations, together with the small size of the debris, made it possible to conclude that the aeroplane had collided with the surface of the water under high energy and ruled out the scenario of the aeroplane having broken up in flight.

**Figure 15: field of debris (source: BEA/EAAID)**

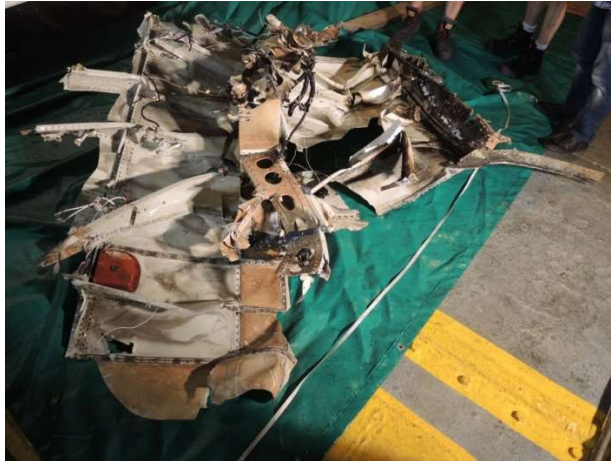
**Figure 16: cockpit debris showing black deposits (source: BEA/EAAID)**

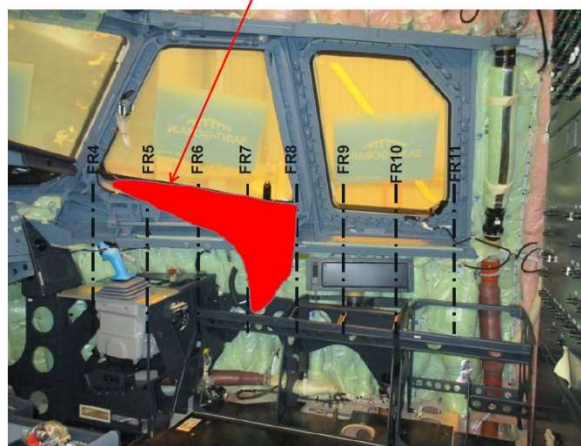
Approximate burnt & soot area

**Figure 17: corresponding area on an A320 (source: BEA/EAAID)**

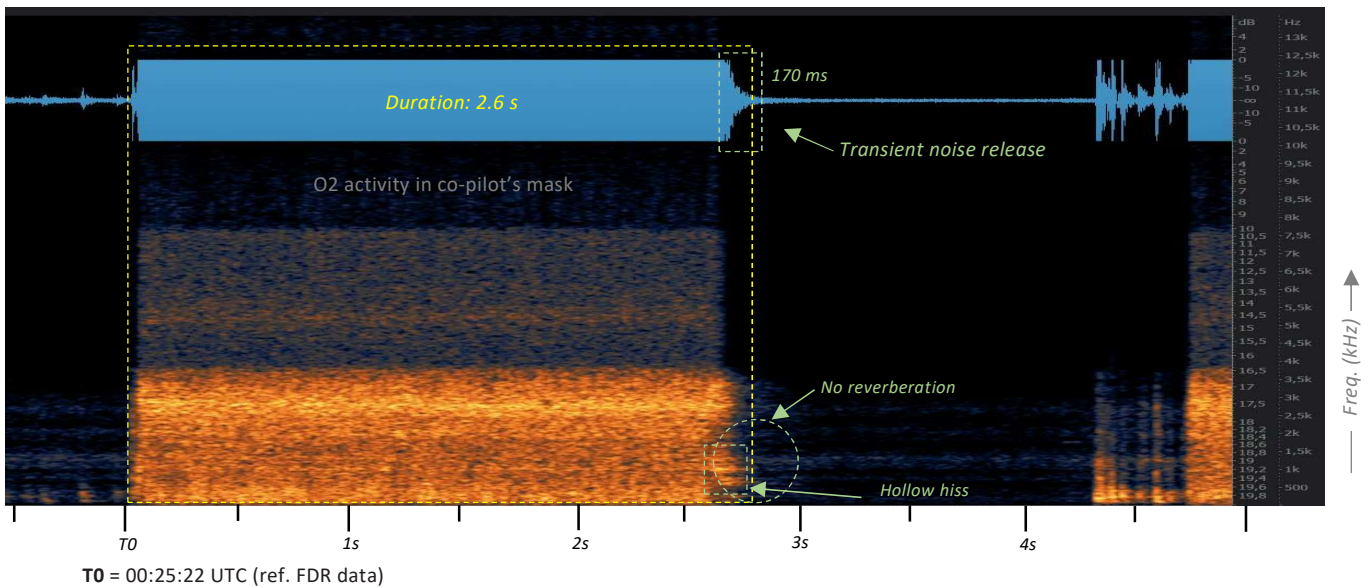
**Figure 21: first oxygen flow activity in co-pilot's mask (spectral view – source: BEA)**

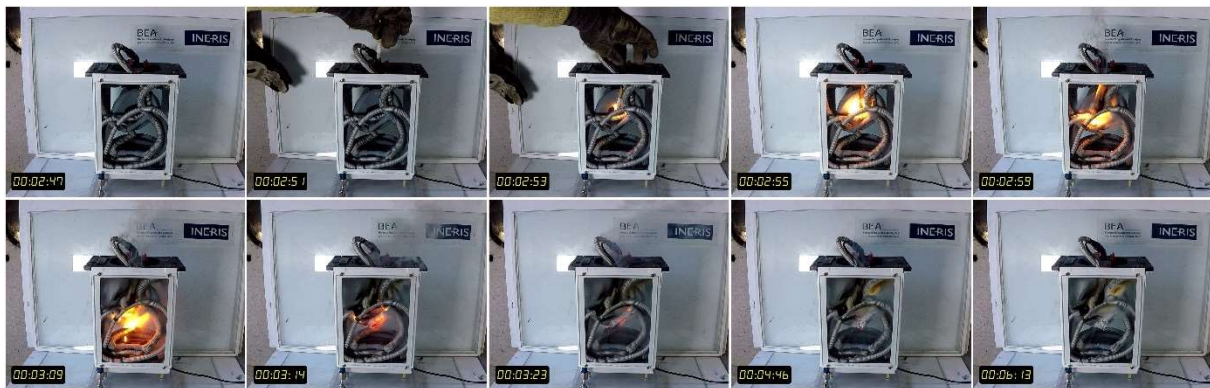
During the first test (Cigarette\_01), the cigarette landed on the mask's harness and perforated it. The fire did not spread to other parts of the mask and extinguished.

Figure 31: cigarette\_01 test - video sequence (source: BEA)

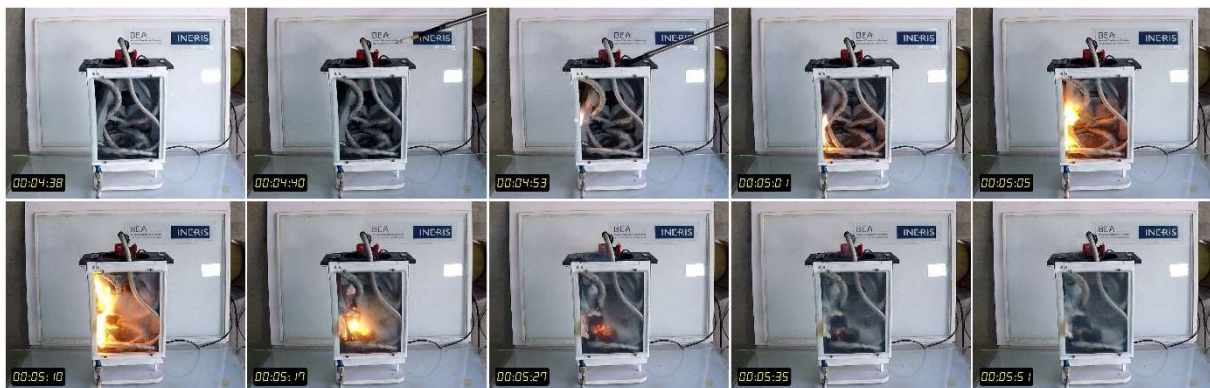
During the second test (cigarette\_02), the cigarette landed on the silicone envelope of the oxygen mask nose cup and began to consume this part of the mask. When the oxygen contained in the box was consumed, the intensity of the fire decreased and the fire went out.

Figure 32: cigarette\_02 test - video sequence (source: BEA)

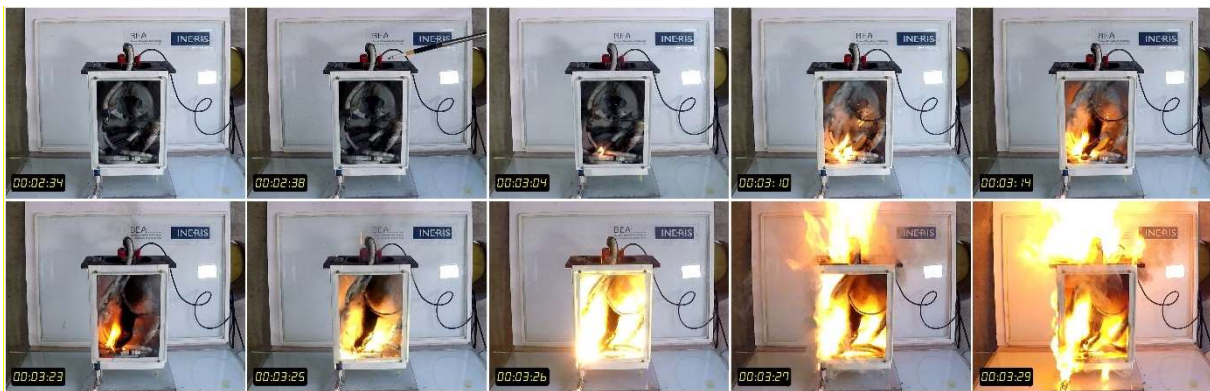
Cigarette\_04 test: crackling noises for 22 s were audible, corresponding to the combustion of the hose casing. The subsequent piercing of the hose produced a broadband noise. The mask ignited 0.5 s later, causing a sound runaway. The oxygen supply was cut off before the mask microphone was damaged.

Figure 34: cigarette\_04 test - video sequence (source: BEA)

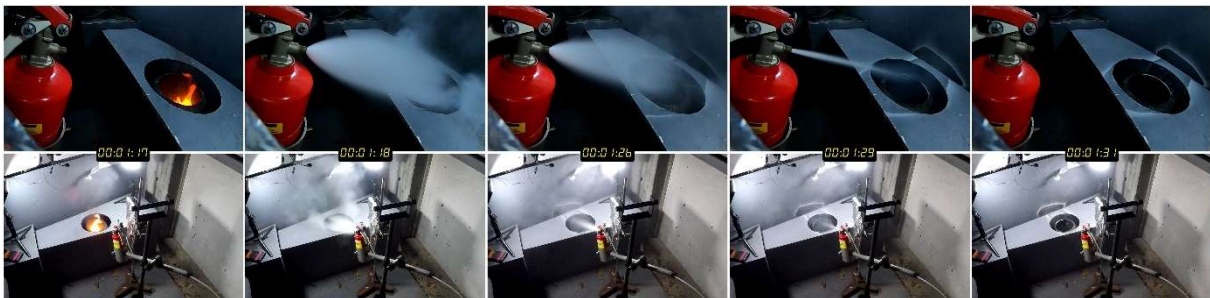
Figure 49: extinguisher\_01 test - video sequence (source: BEA)

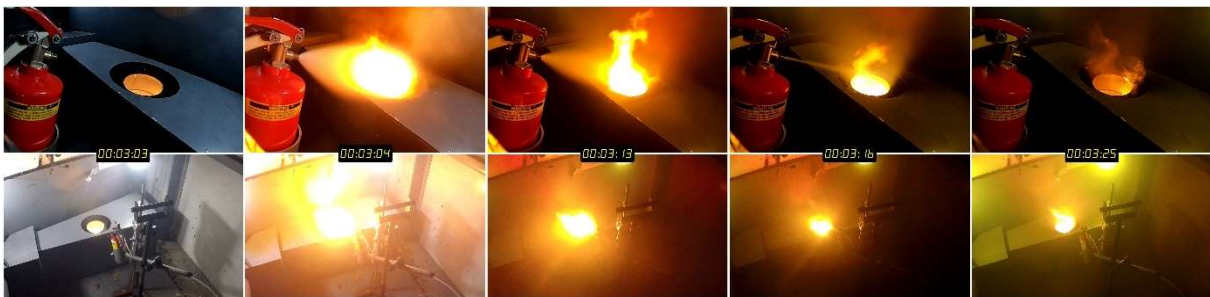
Figure 50: extinguisher\_02 test - video sequence (source: BEA)
