# CONCORDE ACCIDENT

25 JULY 2000

## THE OCCURENCE

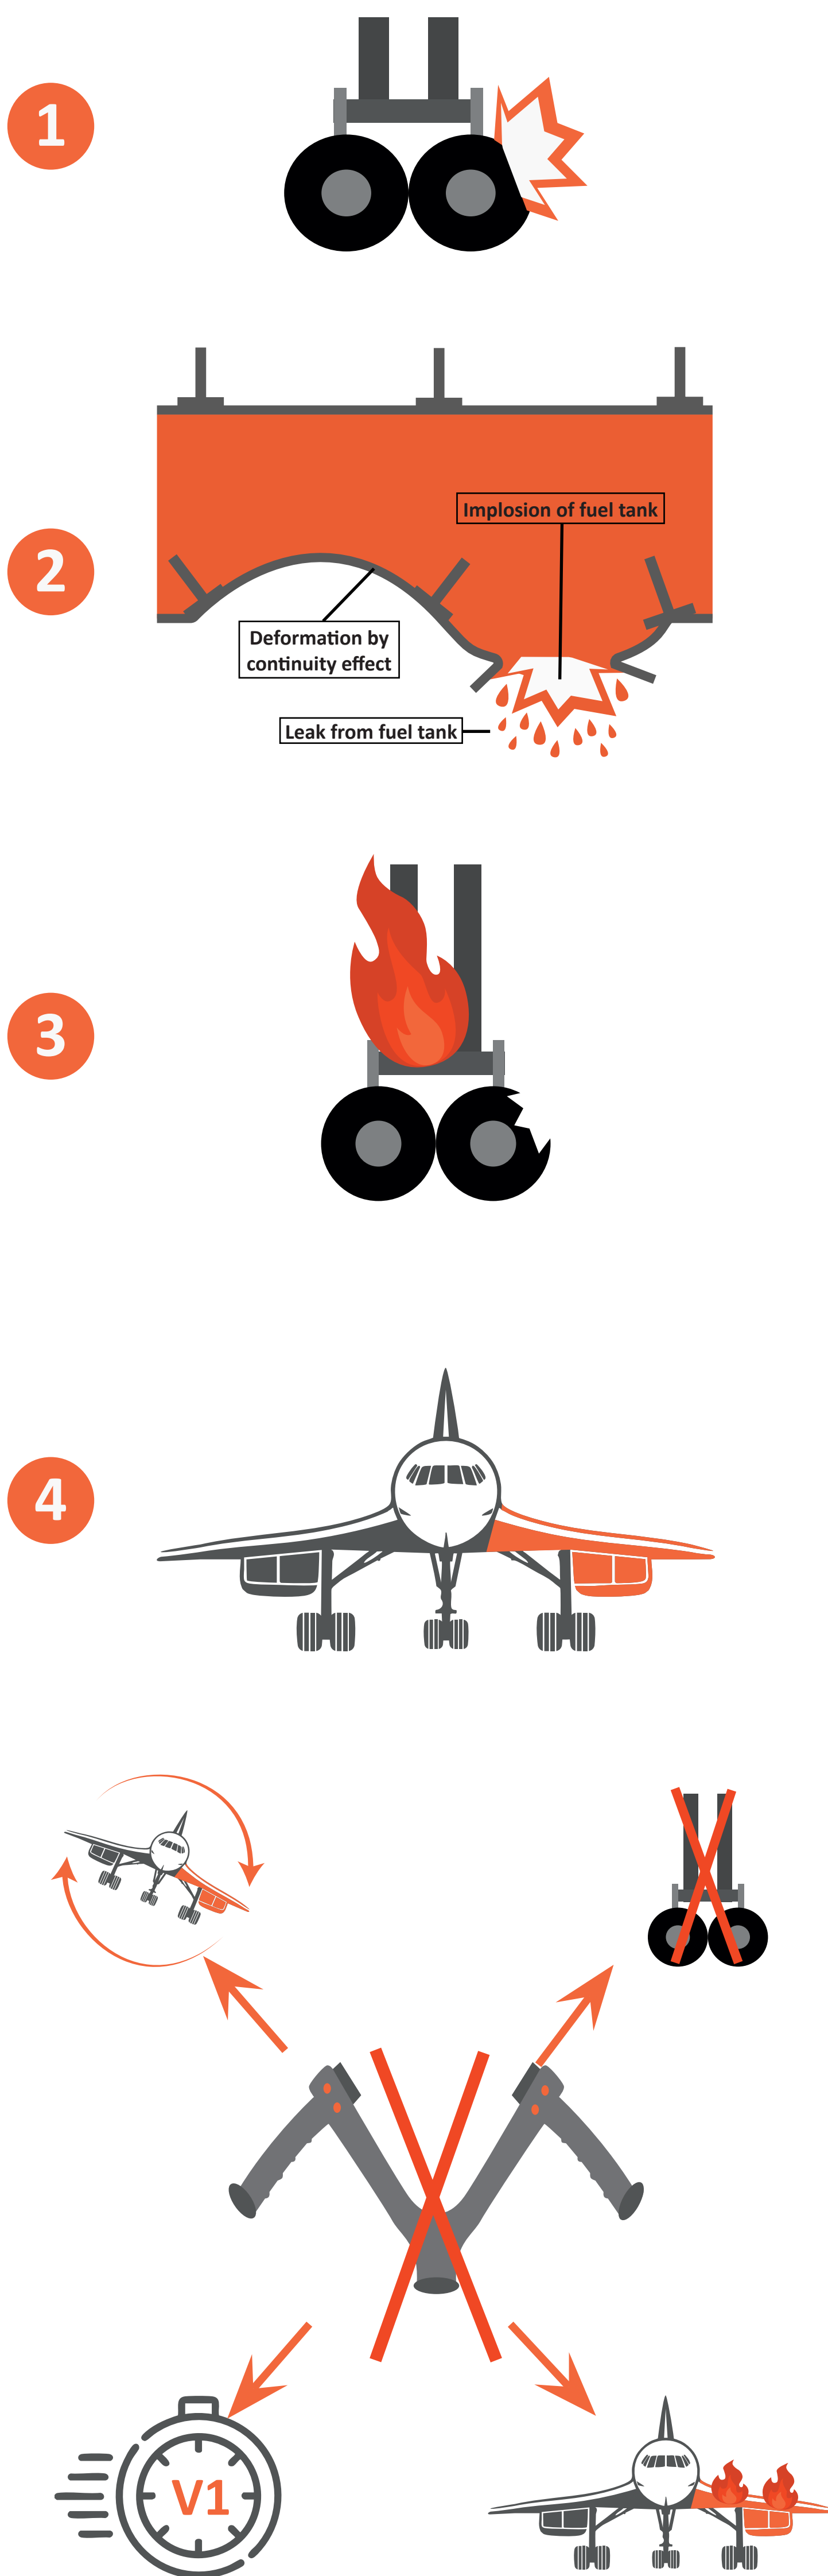
As the aeroplane reached a speed of approximately 300 km/h, the right front tyre of the left main landing gear ran over a titanium strip, a relatively rigid metal. The tyre was lacerated and violently exploded. A piece of tyre weighing over 4 kg was propelled upward and forward at very high speed.

This piece of tyre struck the underside of the left wing, level with fuel tank No 5. The impact was so violent that it deformed the wall, creating a hydrodynamic shock wave inside the full tank. This internal overpressure caused the tank's structure to collapse from the inside, and a breach at the weakest point of the tank's structure.

Approximately 75 litres per second of kerosene escaped through this breach. This pulverized fuel immediately ignited. (The investigation was unable to determine what exactly caused it to catch fire.) A huge sheet of fierce flames clung to the landing gear strut.

Engine No 2 (inside left) suffered severe surges as it ingested hot gases from the fire and unburned fuel. It lost almost all its power. The crew shut it down, in accordance with procedures. Engine No 1 (outside left) also lost almost all its power for the same reasons a few seconds later.

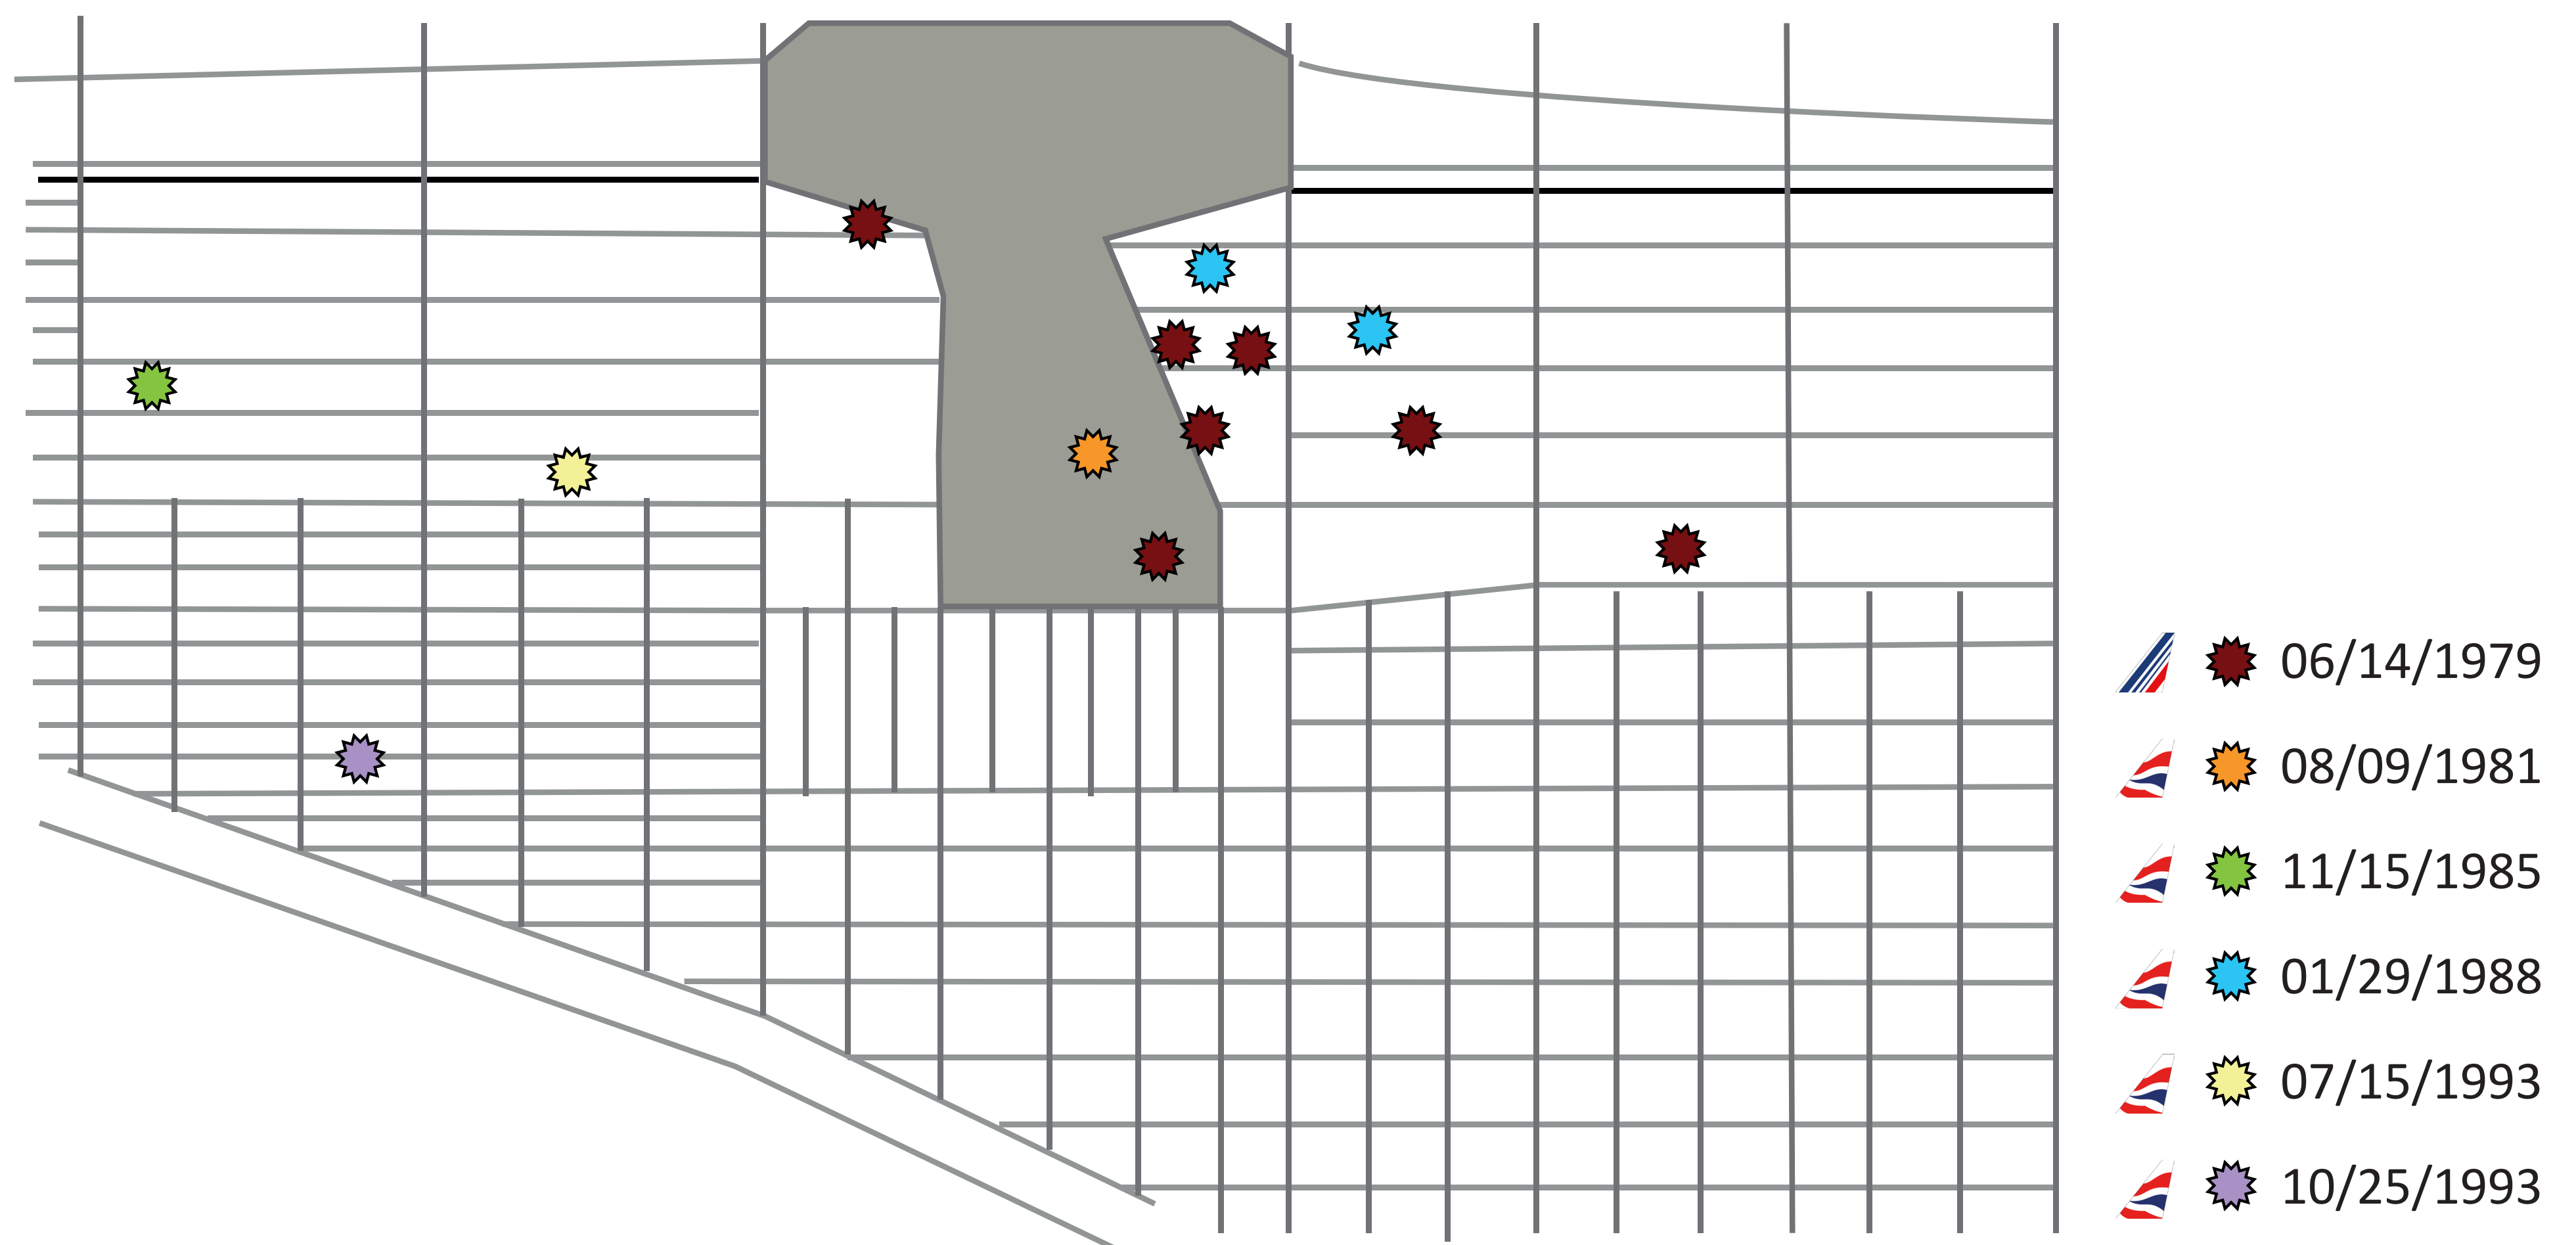
Diagram of impacts with perforation in the six occurrences (right wing and left wing)  
- landing gear door in grey -

In the incident involving the Concorde F-BVFC, several perforations were observed on tanks 2, 5, and 6 (see figure above). One of these perforations was caused by tyre debris, and the others were caused by small aircraft debris from the main landing gear area.

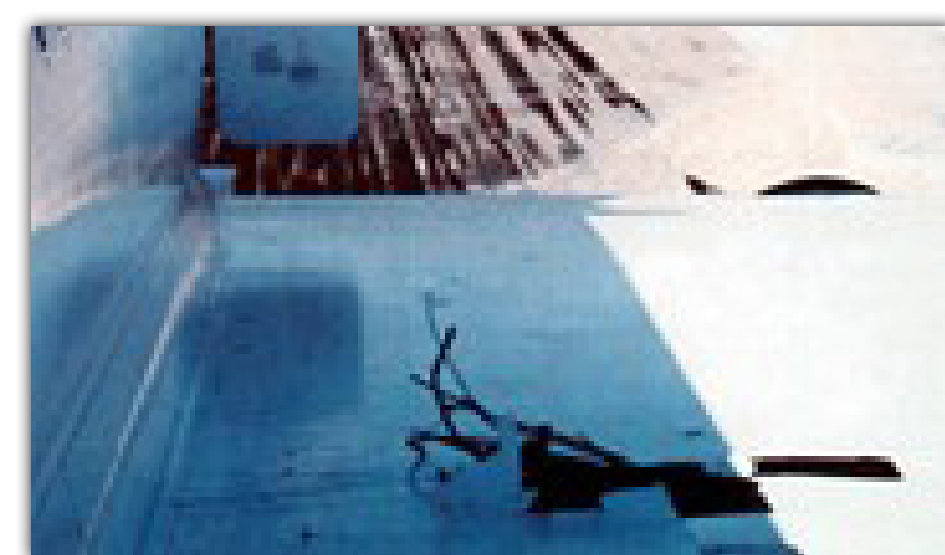
Photo (viewed from above) of damage to the left wing of F-BVFC, following the penetration of wheel No 5 debris

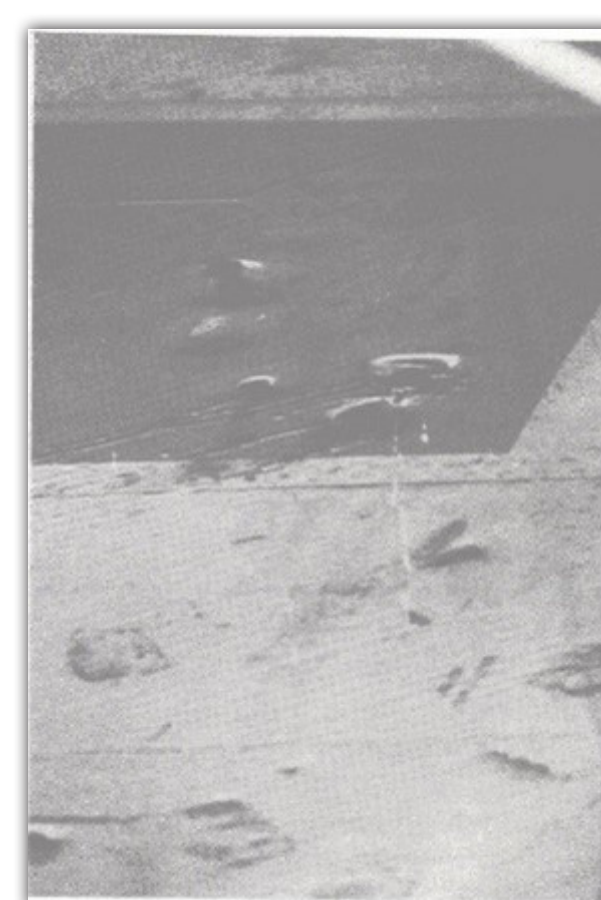
Photo showing the perforation of the fuel tank located in the left wing of F-BVFC and the fuel leak

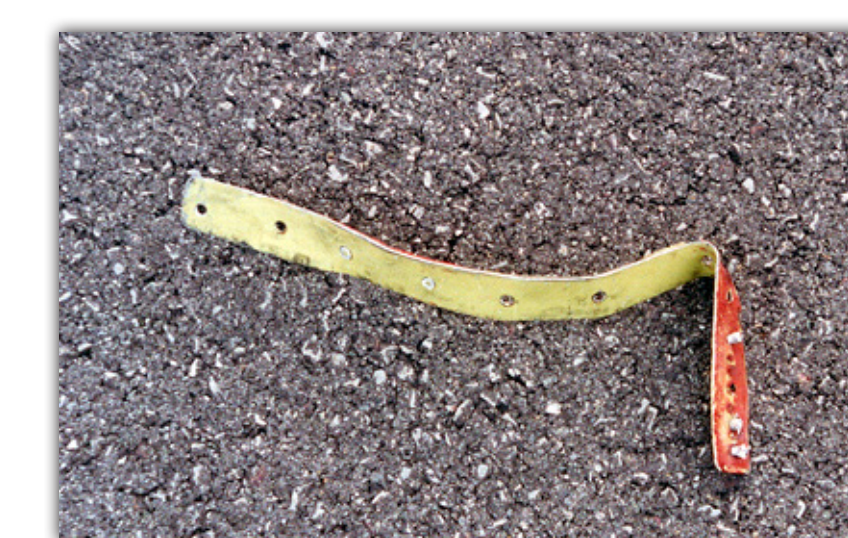
Titanium strip found on the runway
