# ERMENONVILLE ACCIDENT

3 March 1974

BEA

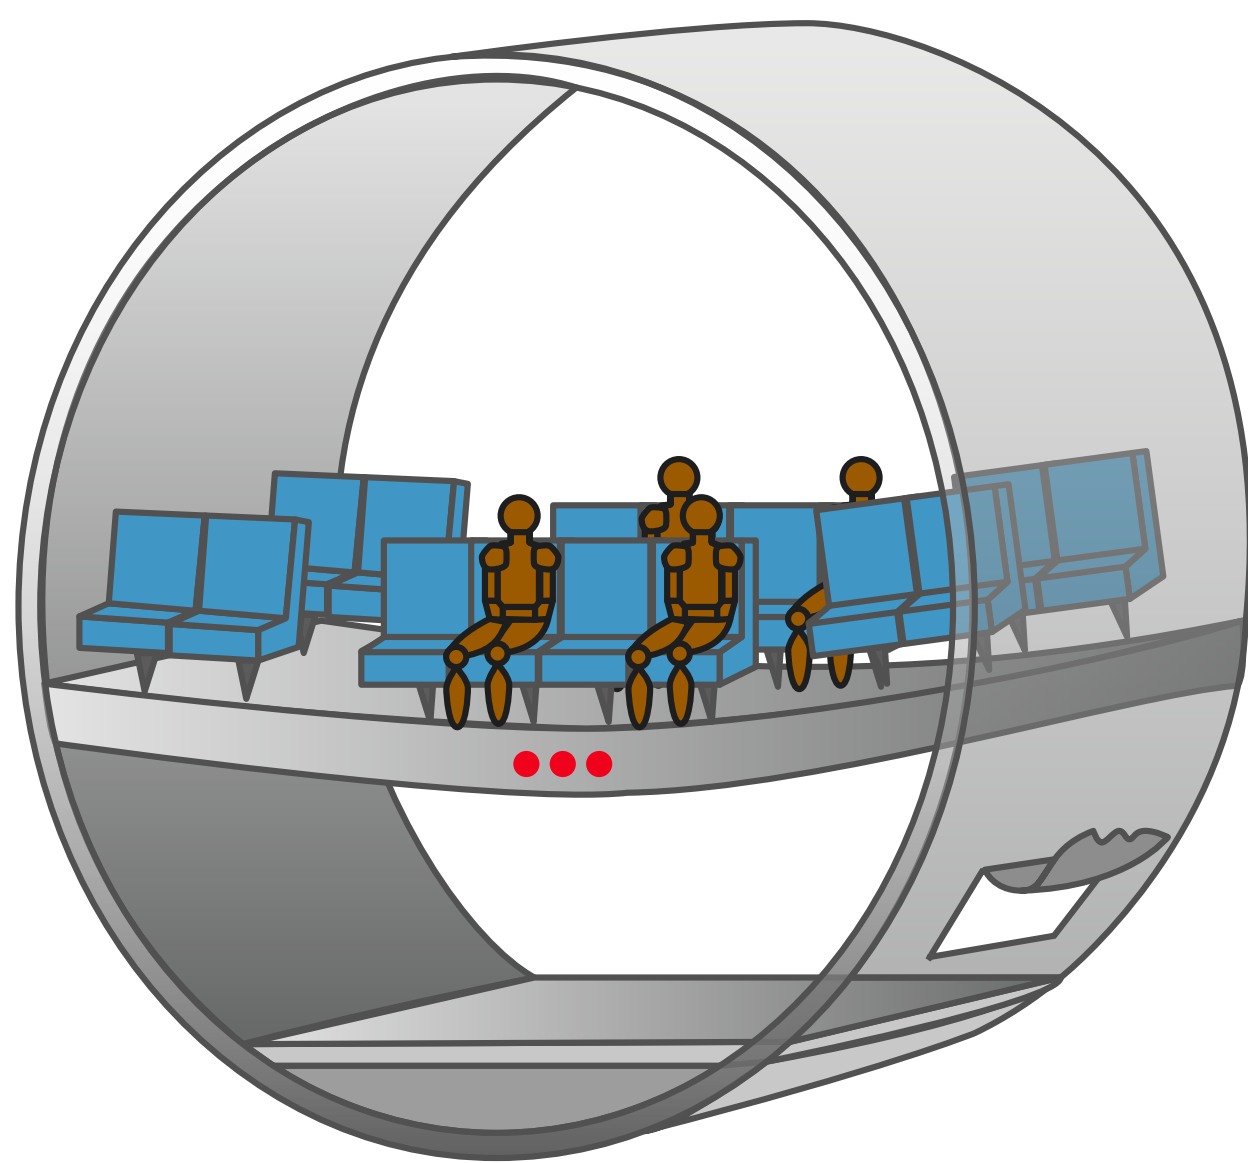
**1972's accident (Windsor)**

*venting issues  
+ floor slightly loaded*

*Non catastrophic outcome*

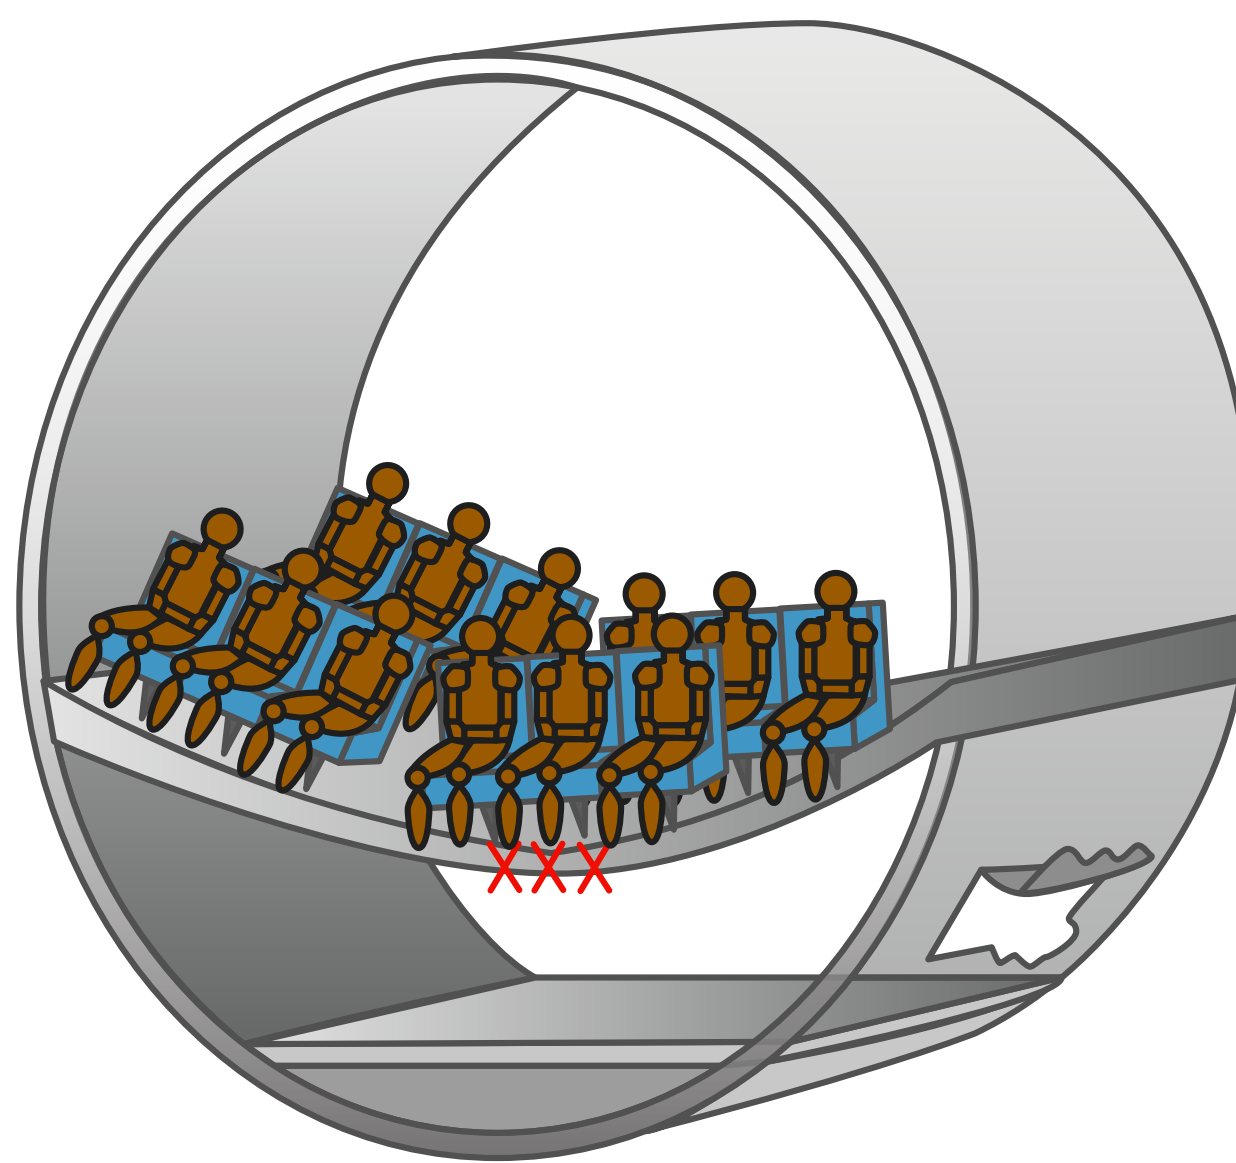
**1974's accident (Ermenonville)**

*venting issues  
+ floor heavily loaded*

*Catastrophic failure*

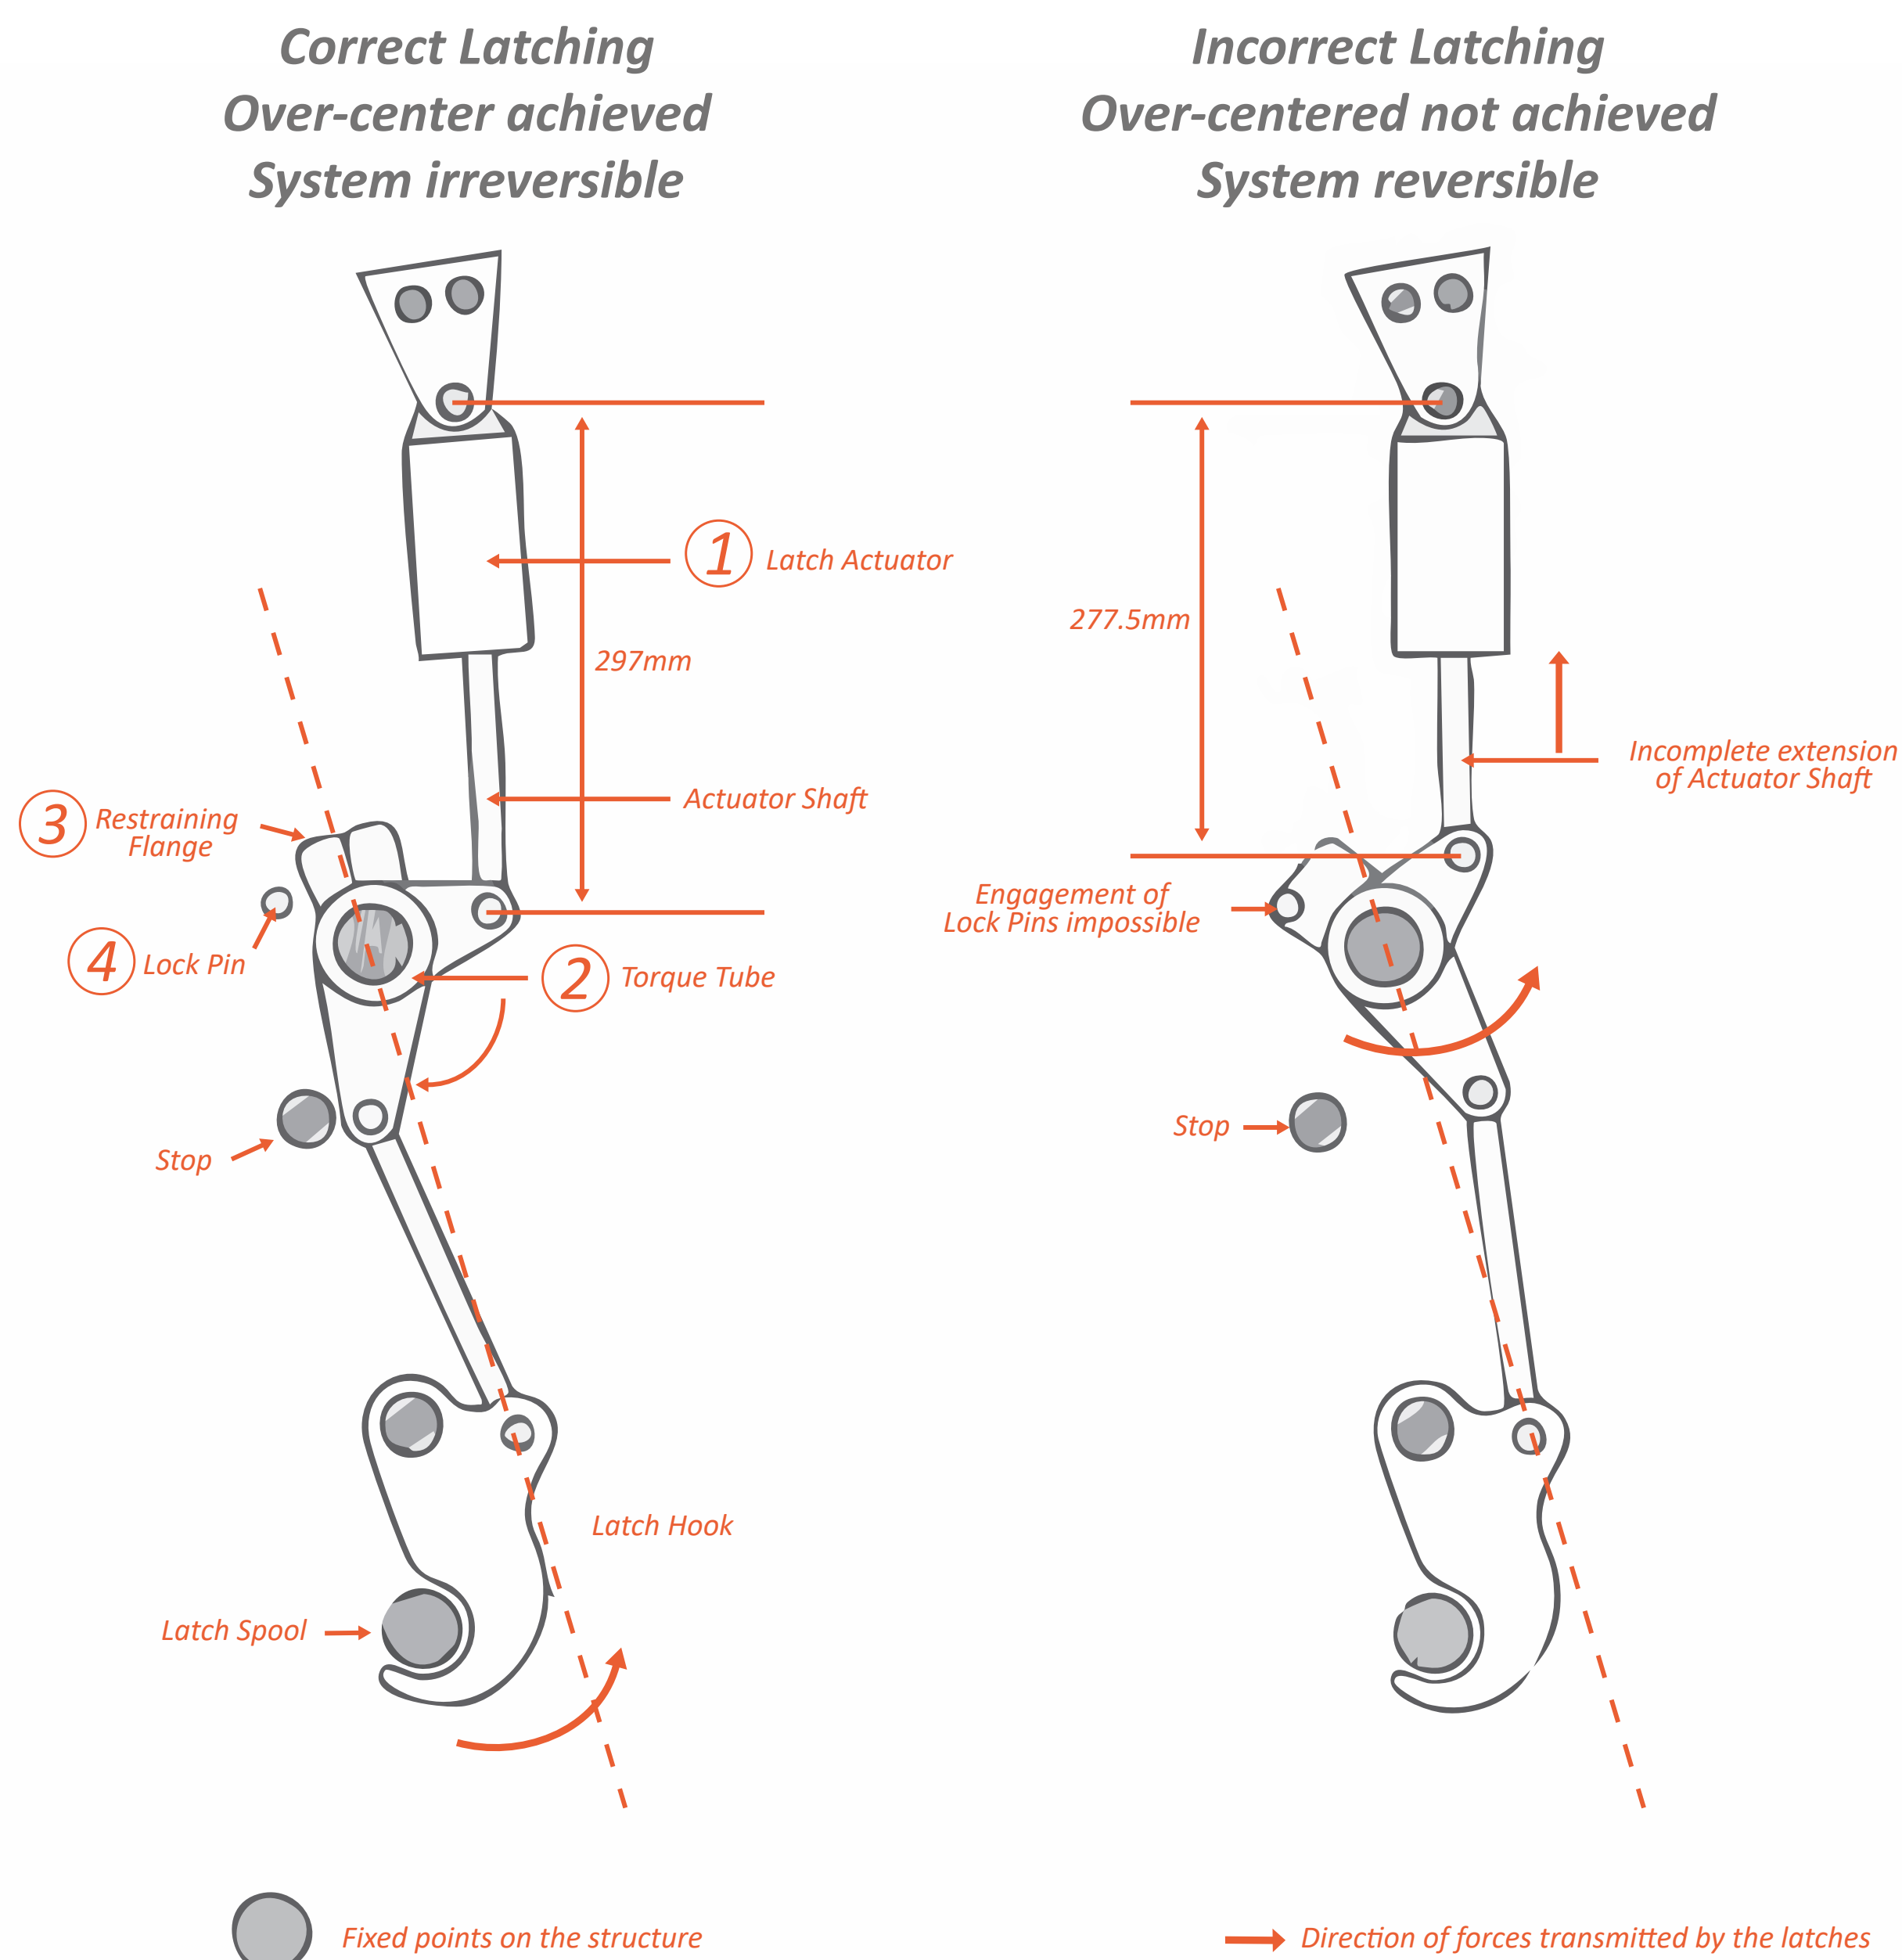
The safety investigation was able to show that before taking off, this door had **not been correctly locked** and that the **warning light**, located in the cockpit, **extinguished prematurely** due to an incorrectly adjusted contactor.

In order to completely lock the door, the latch actuator shaft ① must be sufficiently extended. This leads to the rotation of the torque tube ② and the restraining flange ③ in order to give access for the engagement of the locking pins ④ when the mechanism has reached its locking position (after the over-centre).

In this occurrence, the **locking pins were not in place** although there was a view port to visually check they were correctly engaged.

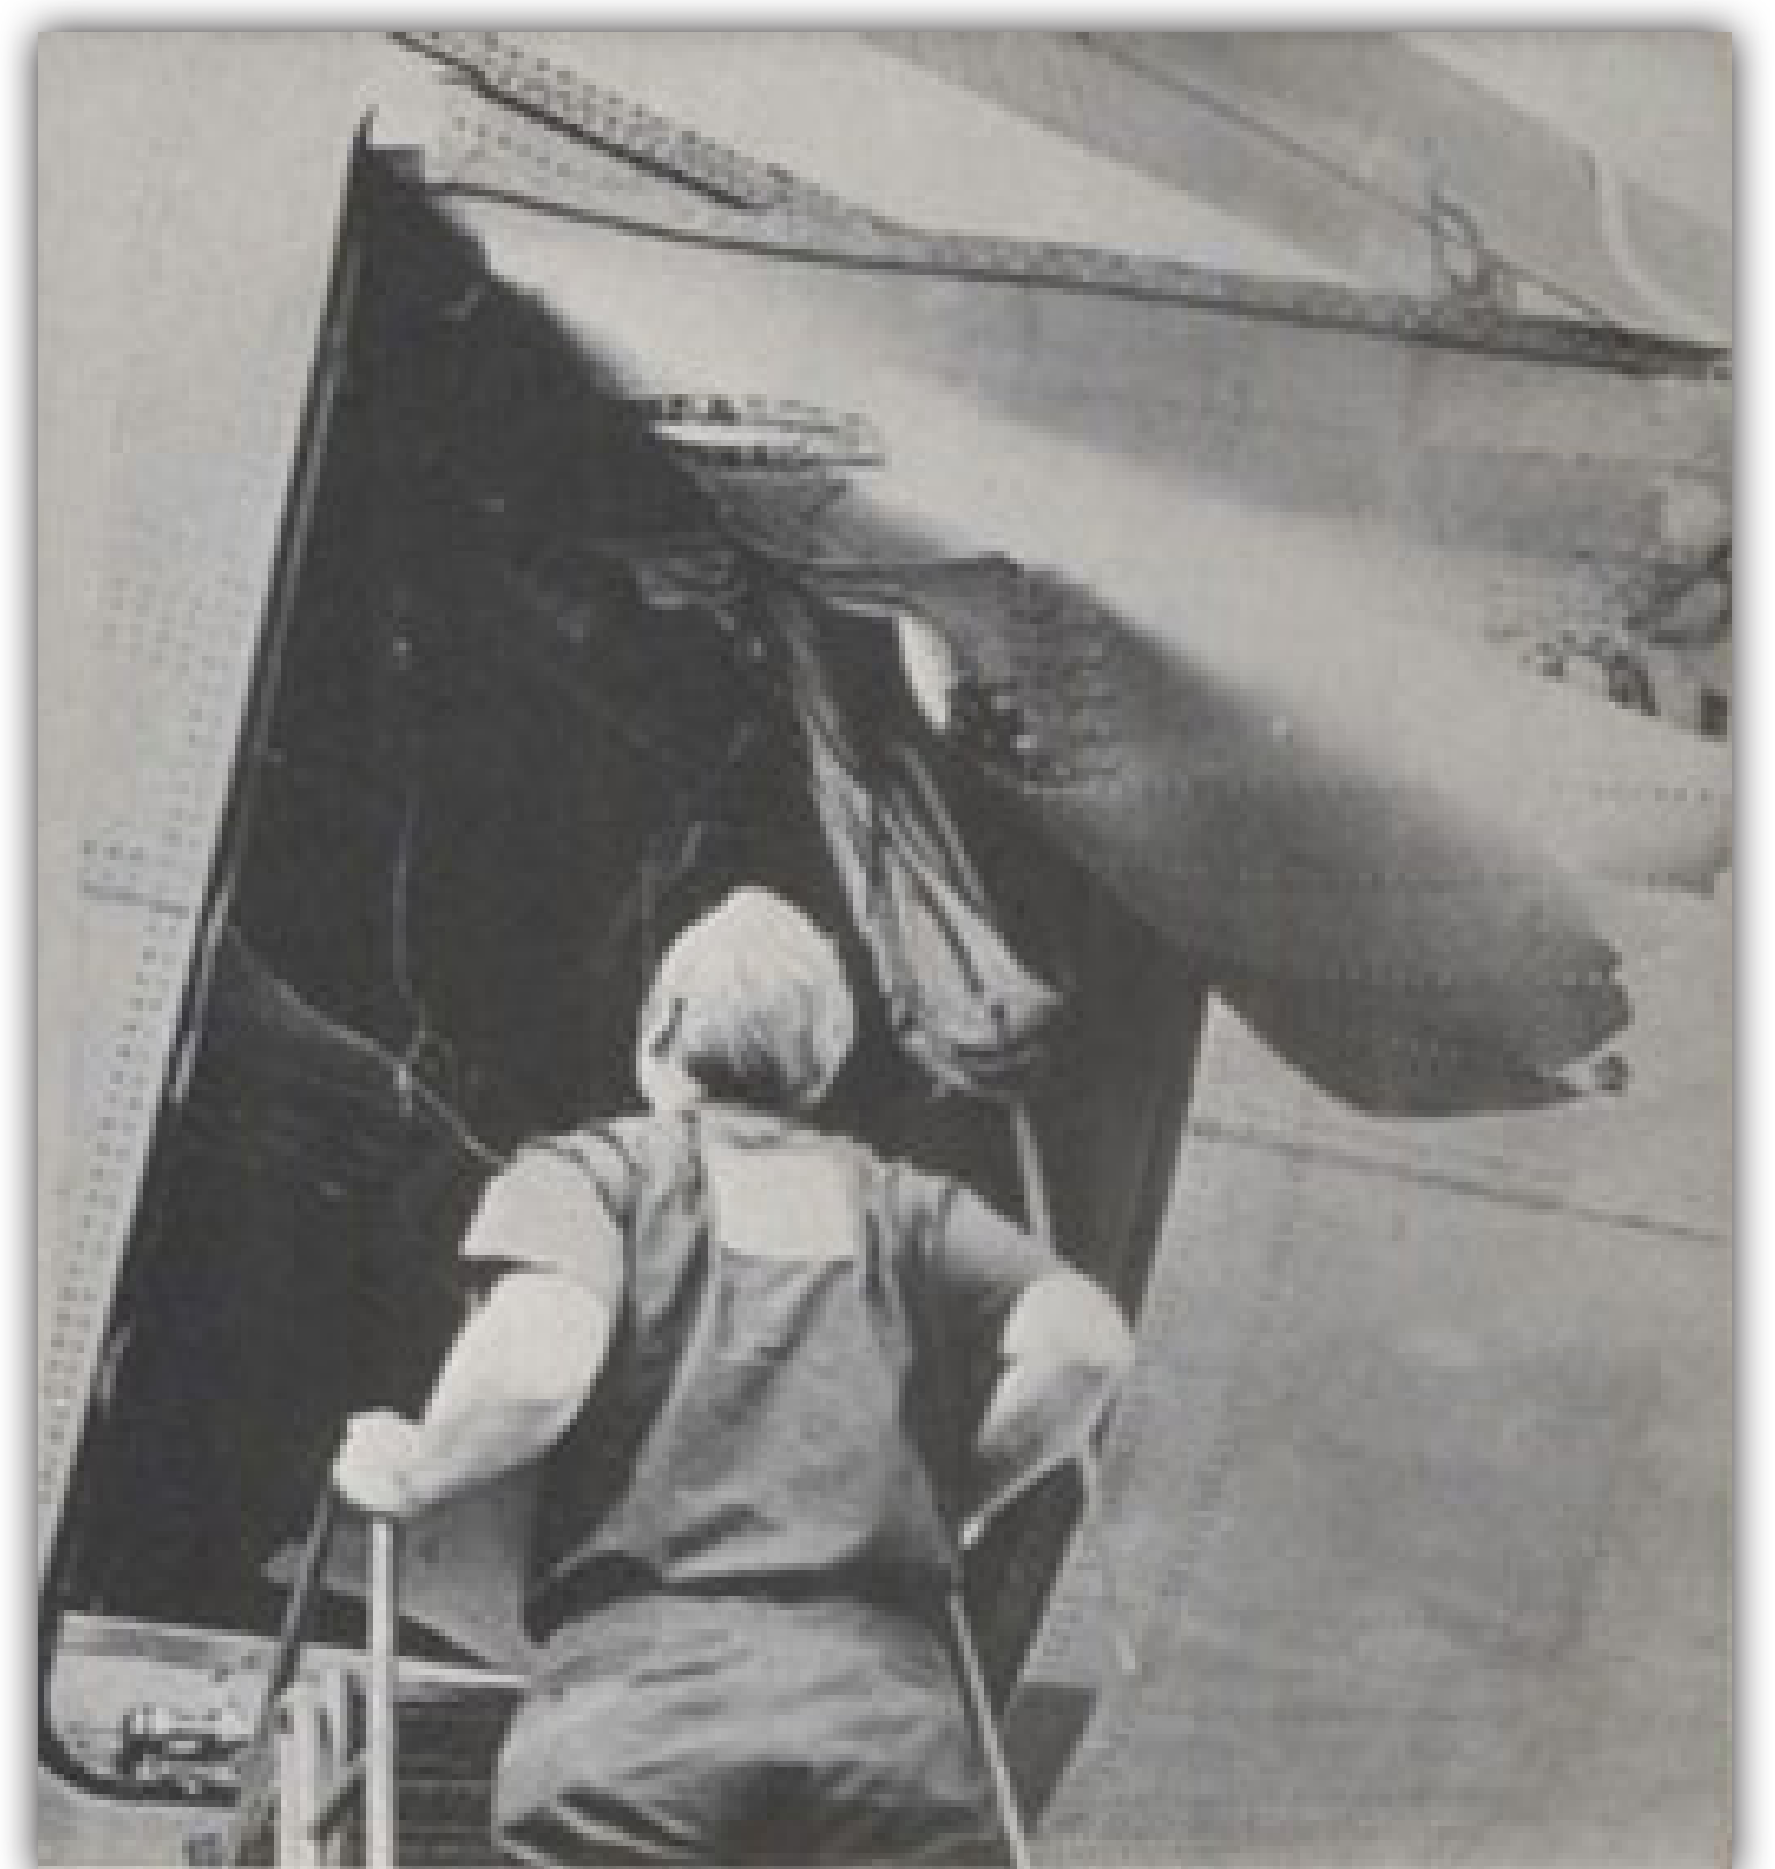
The examination of the cargo door, which was found largely intact close to Windsor, found that the **latches designed to hold the door closed in flight had not operated correctly and the locking pins were not in place**.

*Photo of the American Airlines DC-10 door from the accident in 1972.*

- Recommendation A-72-97 regarding the modification of the cargo door locking system to make it physically impossible to position the external locking handle and vent door to their normal door locked positions unless the locking pins are fully engaged.
- Recommendation A-72-98 regarding the means to minimize the pressure loading on the cabin flooring in the event of sudden depressurization of the cargo compartment.
