TECHNICAL REPORT

**Accident on 23 July 2020
at Bâle-Mulhouse airport (Haut-Rhin)
to the PIPER - PA-28RT-201T
registered HB-PNP**

Examination of wreckage

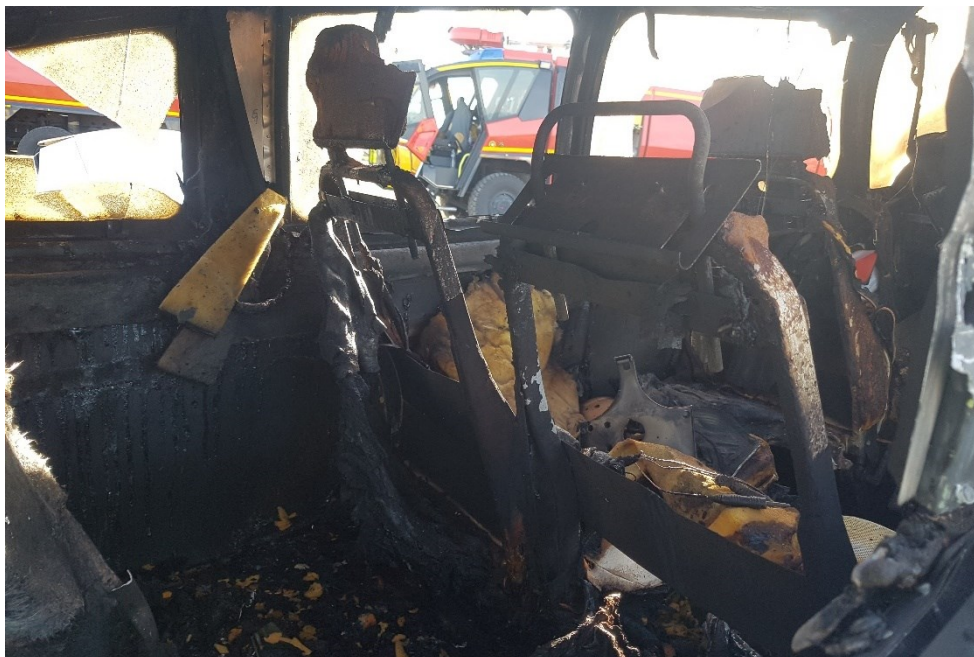
- The outer surface damage was concentrated on the right side of the aeroplane, on the rear section of the luggage hold and around the rear right passenger window (**Figure 1**).
- The interior of the cockpit was covered with soot, extending from the instrument panel to behind the luggage hold. The seats were partially burnt (**Figure 3** and **Figure 4**).

Figure 3: Interior of cockpit, 3/4 view from rear right
Source: BEA - photo taken day of accident

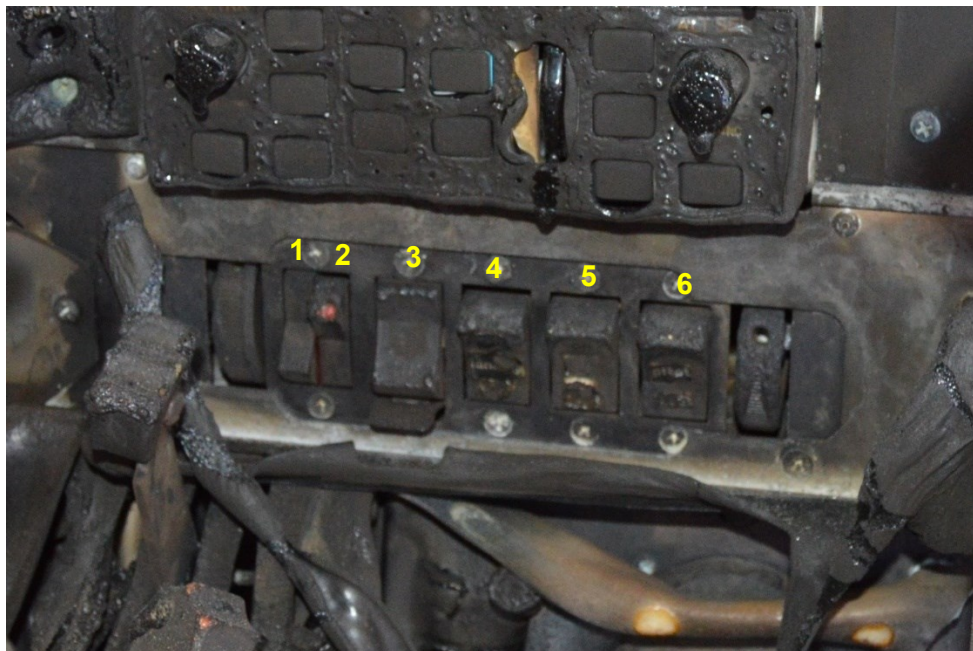
- The left side windows and the right side rear windows were broken or had melted.
- On the instrument panel, the controls were found in the following positions (**Figure 5**):

Figure 5: Instrument panel controls
Source: BEA

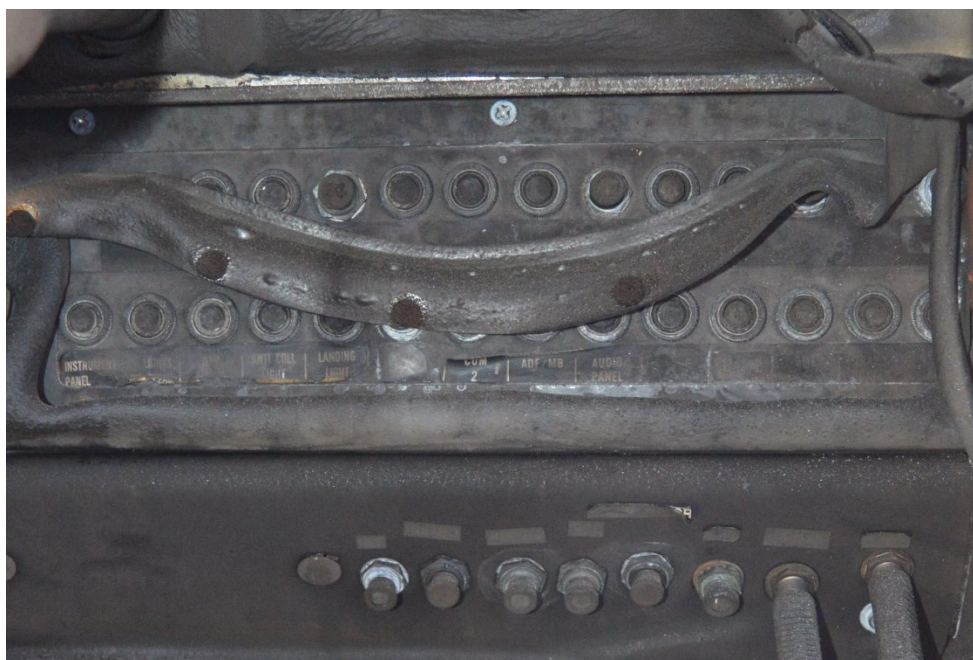
No circuit breaker was found open on the instrument panel (**Figure 6**).

Figure 6: Circuit breakers on instrument panel
Source: BEA

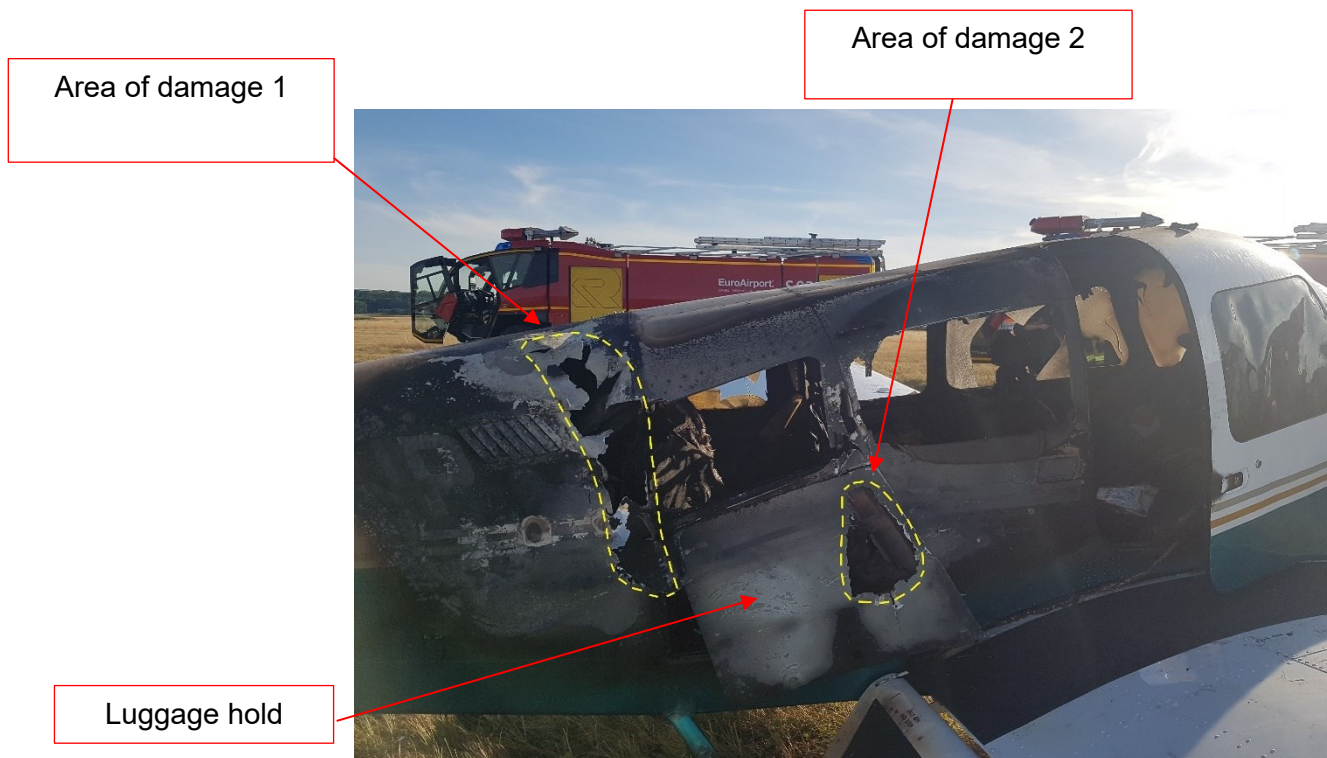
This area was characterised by the destruction of the aluminium alloy sheet making up the aeroplane's fuselage. It had taken a V-shape which is typical of damage which occurs after the release of intense heat. The closed end of the V probably corresponds to the area of maximum heat. At the open end of the V, the fuselage sheet was laid bare, its outer coating (layers of paint) having been destroyed.

This area was characterised by the destruction of the sheet of the aeroplane's fuselage.

Figure 8: Right side of aeroplane
Photo taken day of accident

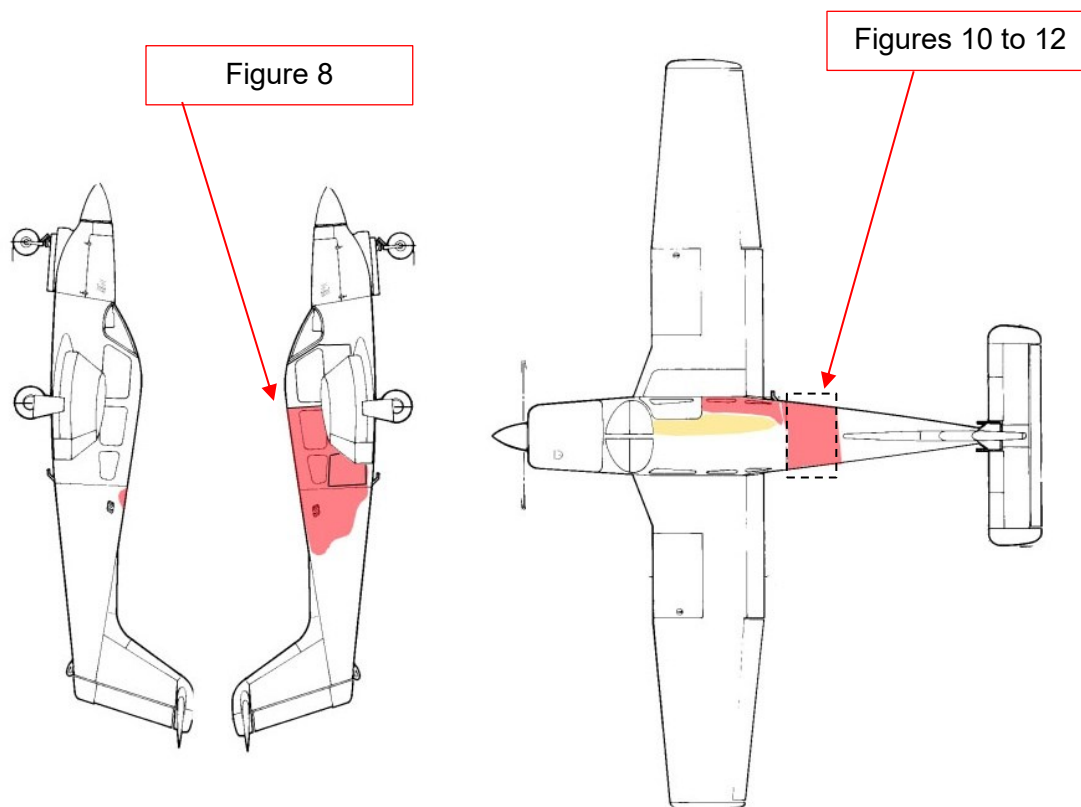
Furthermore, the external paint was damaged on the rear right side and part of the rear upper surface of the fuselage. The degree of damage varied according to the area of the airframe. This variation in damage reflects the spread of the hot smoke in the cockpit. The paint was more damaged at the rear, aft of the luggage hold and on the right side.

Figure 9: Identification of areas where the outer skin was destroyed or damaged
Source of original diagram: Piper Maintenance Manual

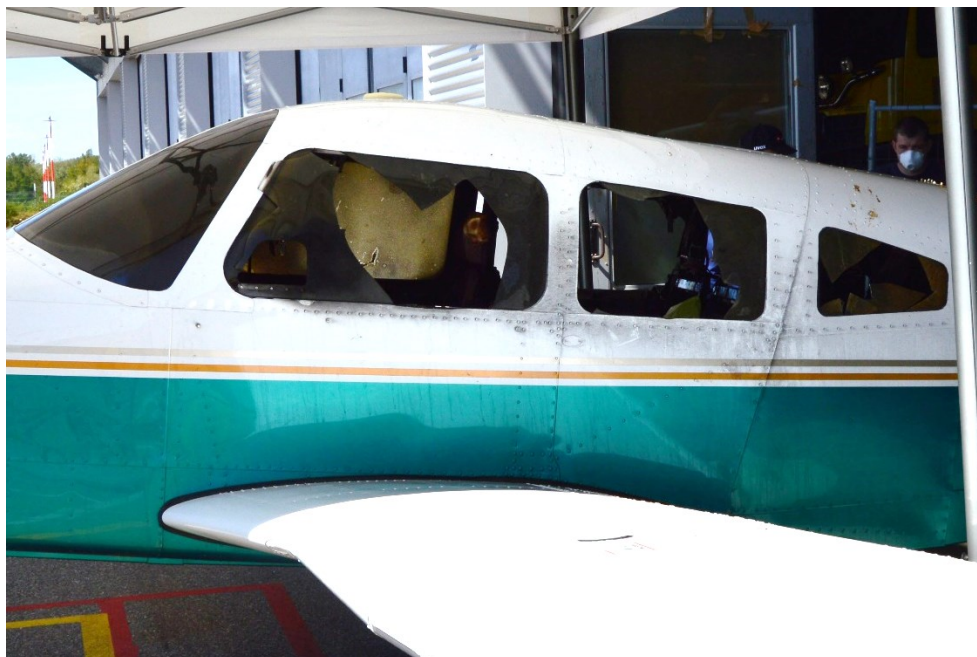
The glass panels on the left side were broken (**Figure 13**). These ruptures had a curved profile. According to the expert consulted, this type of profile suggests that this damage was the consequence of a high temperature and not a mechanical action.

Figure 13: Glass panels on left side
Source: BEA

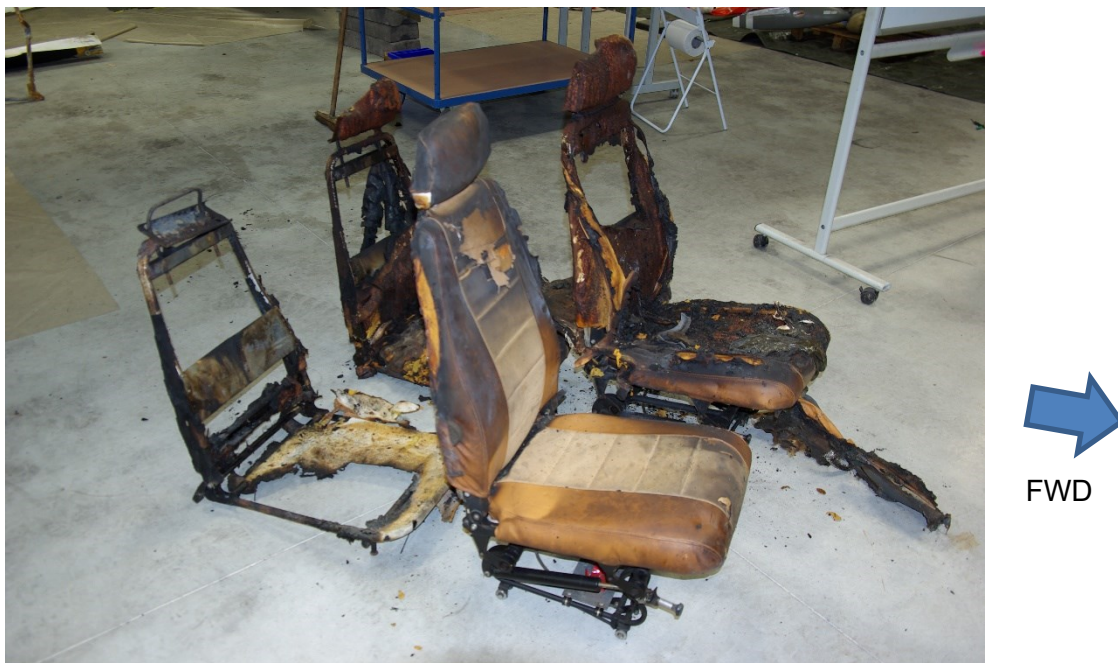
The four seats showed substantial damage (**Figure 16**), in particular the destruction by combustion of most of the non-metal components. Only the front right seat cushion and backrest showed little damage. This can be explained by the seat having been folded forward by the rear passenger when he exited the aircraft. This observation indicates that the damage in the cockpit continued after the persons on board had exited the aircraft. The condition of the aeroplane, as described above, is thus not that on touchdown or landing.

Figure 16: Seats removed from cockpit at the BEA's premises
Source: BEA

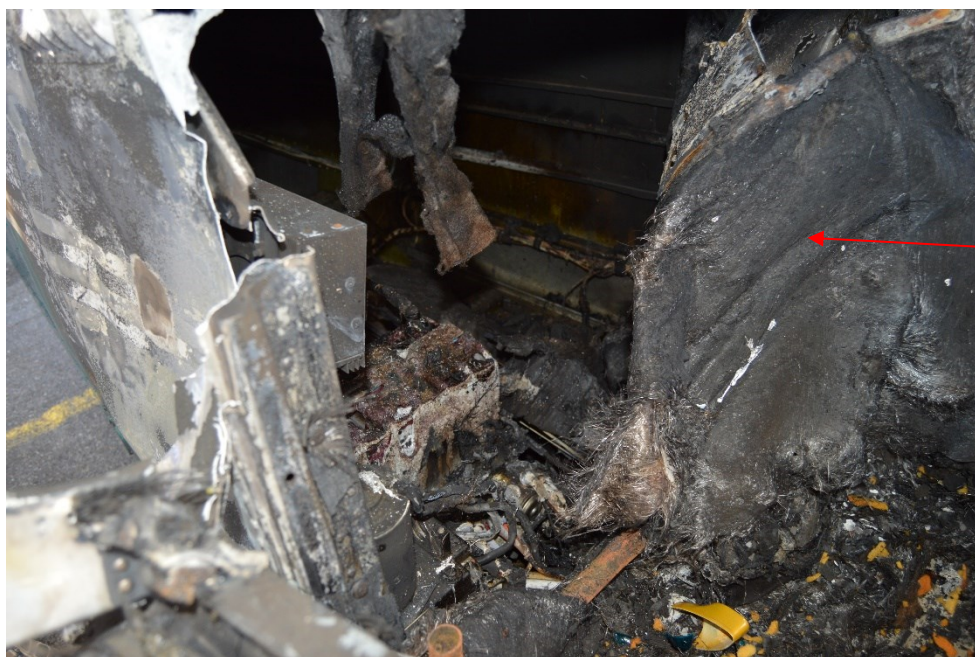
The partition closing off the rear part of the luggage hold was partially destroyed (**Figure 27**).

Partition closing off rear part of luggage hold

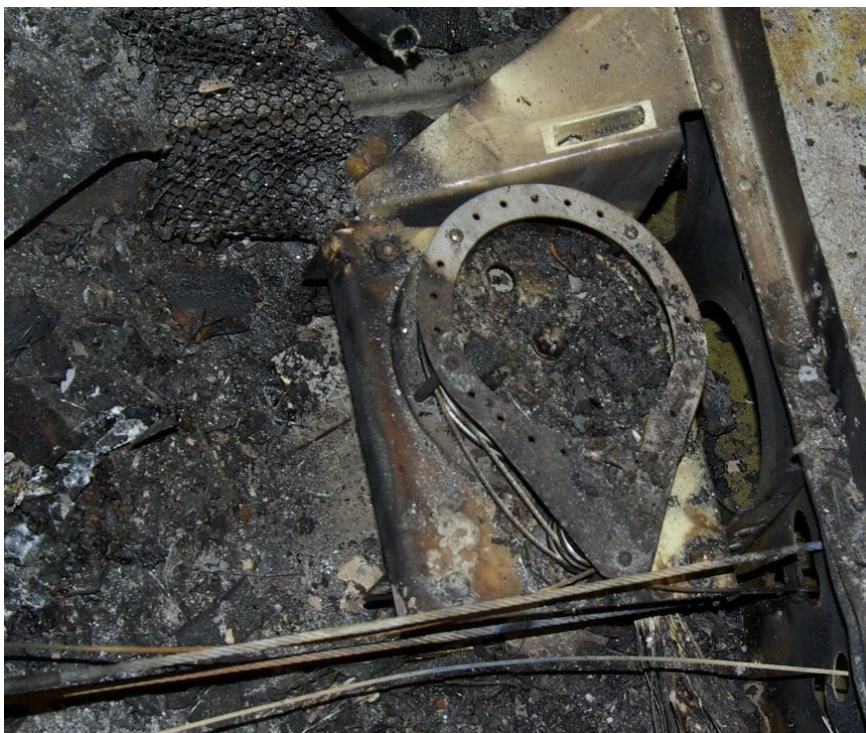
The servocontrol was still in position on the floor (**Figure 28**). It showed no substantial damage. Its electrical connections and the associated conductors were whole, no singularity was observed (**Figure 29**).

Figure 28: Servocontrol in position
Source: BEA

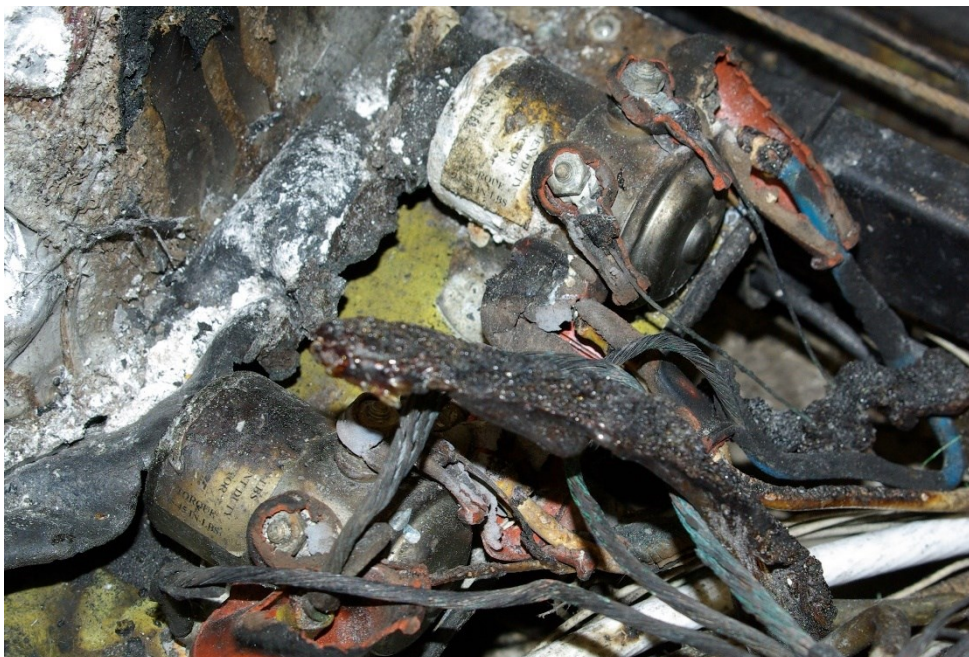
It was observed that the outer surface of one of the relays was corroded, very probably due to the degradation of the adjacent battery.

Figure 31: Contactors situated in front of battery
Source: BEA

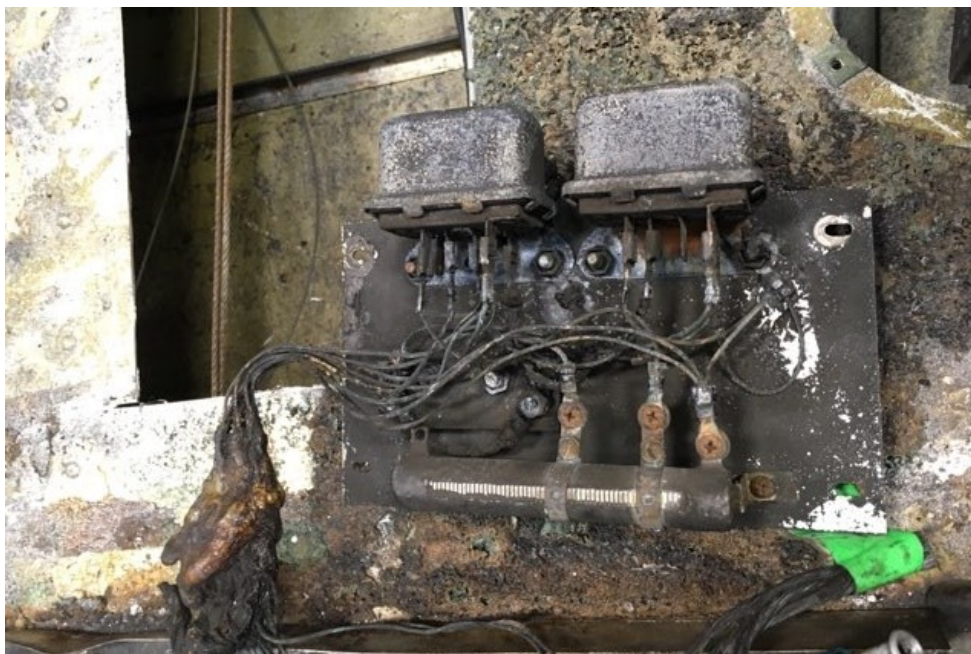
- The electrical assembly, comprised of the two relays and the variable resistor, was in position. The associated conductors were in place (**Figure 32**), their insulation had been destroyed by the high temperature. Despite the insulation being destroyed, the core of these conductors remained flexible. These observations did not indicate an electrical problem on these components³.

Figure 32: Electrical assembly removed from right partition
Source: BEA

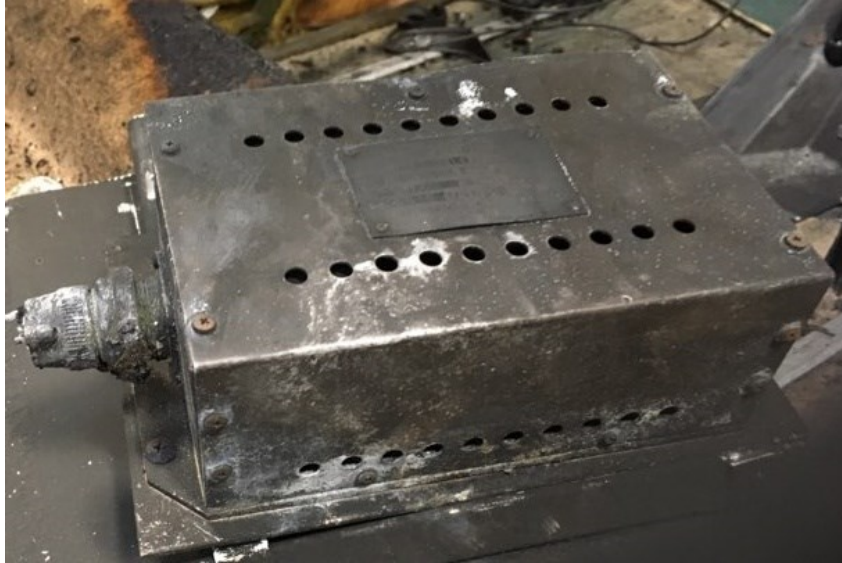
- The 12 V – 24 V converter was in position. No conductor was associated with this assembly (**Figure 33**). These conductors were found in the area around the battery. The insulation of these conductors had been destroyed by the high temperature. The core of these conductors remained flexible.

Figure 33: 12 V - 24 V converter removed from right partition
Source: BEA

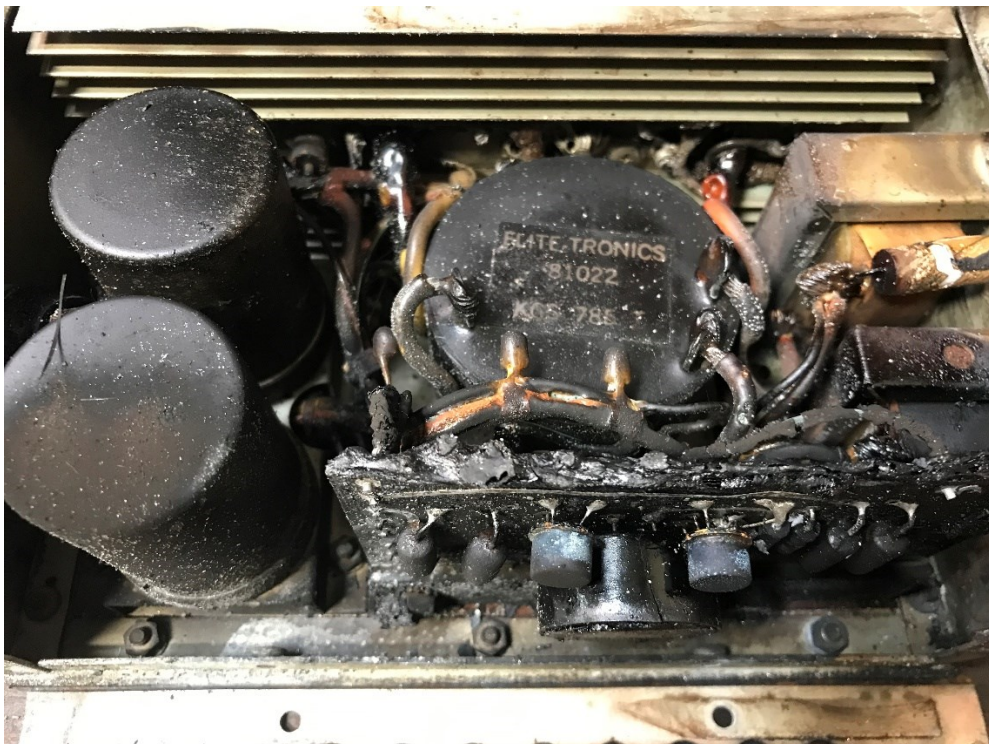
A smell of burning was perceived when this converter was opened. The components were damaged by exposure to a source of high heat. The casings did not show any singular area which stood out from the rest of the equipment⁴.

Figure 34: Components of 12 V - 24 V converter
Source: BEA

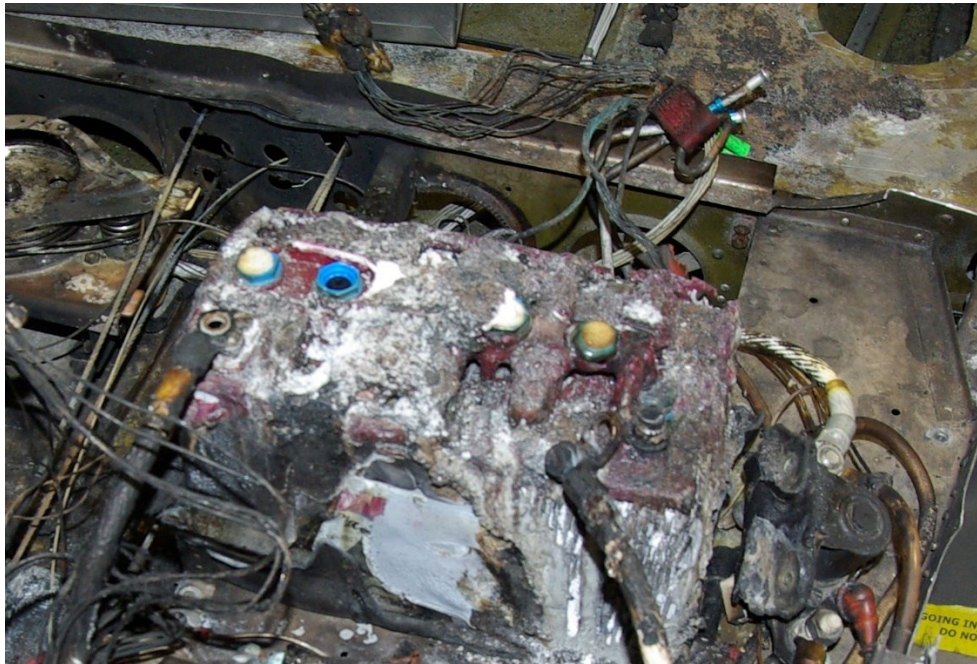
- the upper part of the battery box had melted, with material running from top to bottom, locally revealing internal components (without identified damage). The battery caps could still be identified;
- the upper part of the box, made of plastic, could still be identified with its initial grey colour. No swelling was observed in the bottom two thirds of the battery.

In the lower part of the battery, a contrast was observed between the sector on the negative terminal side and the sector on the positive terminal side (**Figure 50** and **Figure 51**). There was more damage on the positive terminal side.

Figure 48: Battery
Source: BEA

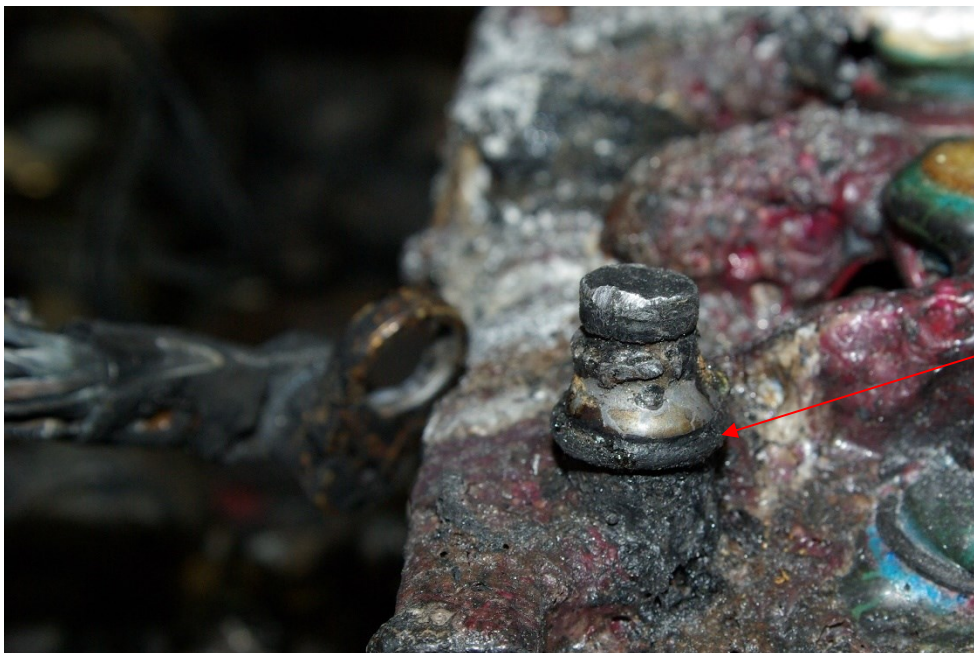
The positive terminal of the battery was partially destroyed (**Figure 53**). Signs of melting were observed level with this terminal. The associated conductor was no longer connected. Part of the terminal was still integral with the end of the conductor and had therefore separated from the battery (**Figure 54**).

The O-ring ensuring the leaktightness of the battery was still in position and had not ruptured.

Figure 53: Positive terminal of battery
Source: BEA

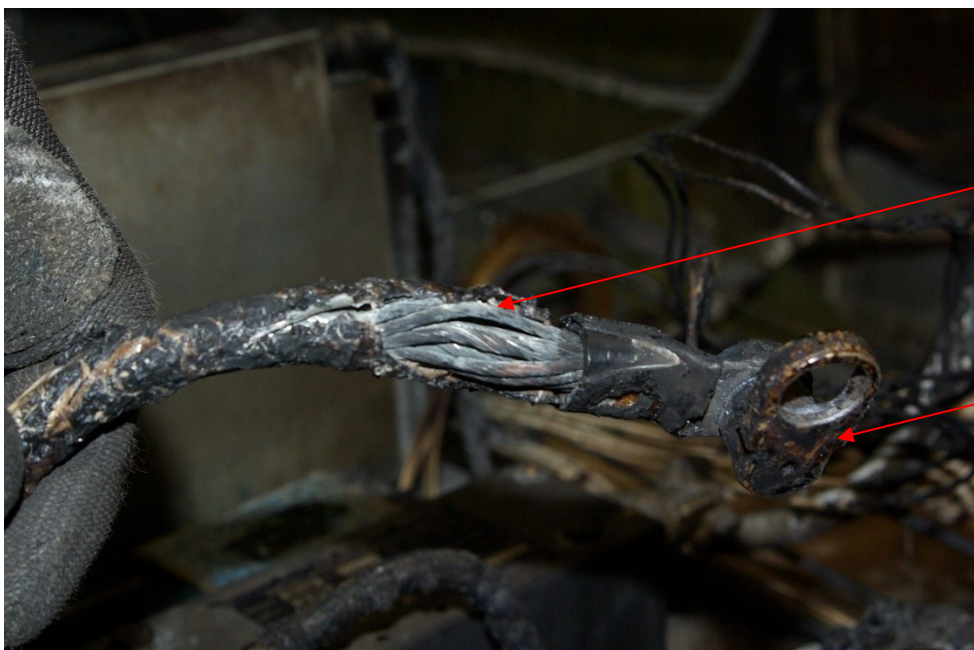
The insulation of the conductor normally connected to the positive terminal of the battery was damaged level with the lug. The electrical cable also seemed to have “swollen” and to be oxidized in this area (**Figure 54**).

When repositioning this conductor on the positive terminal of the battery, it was observed that substantial force was required and that the end of the conductor, on the battery side, was under high stress loadings (**Figure 55**). The stress loadings created can very probably be explained by the rigidity and length of the conductor (large section, diameter varying between 9.1 and 9.9 mm) and by the shape which had to be imposed on it to ensure its connection with the battery terminal.

Destruction of insulation and "swelling" of conductor core

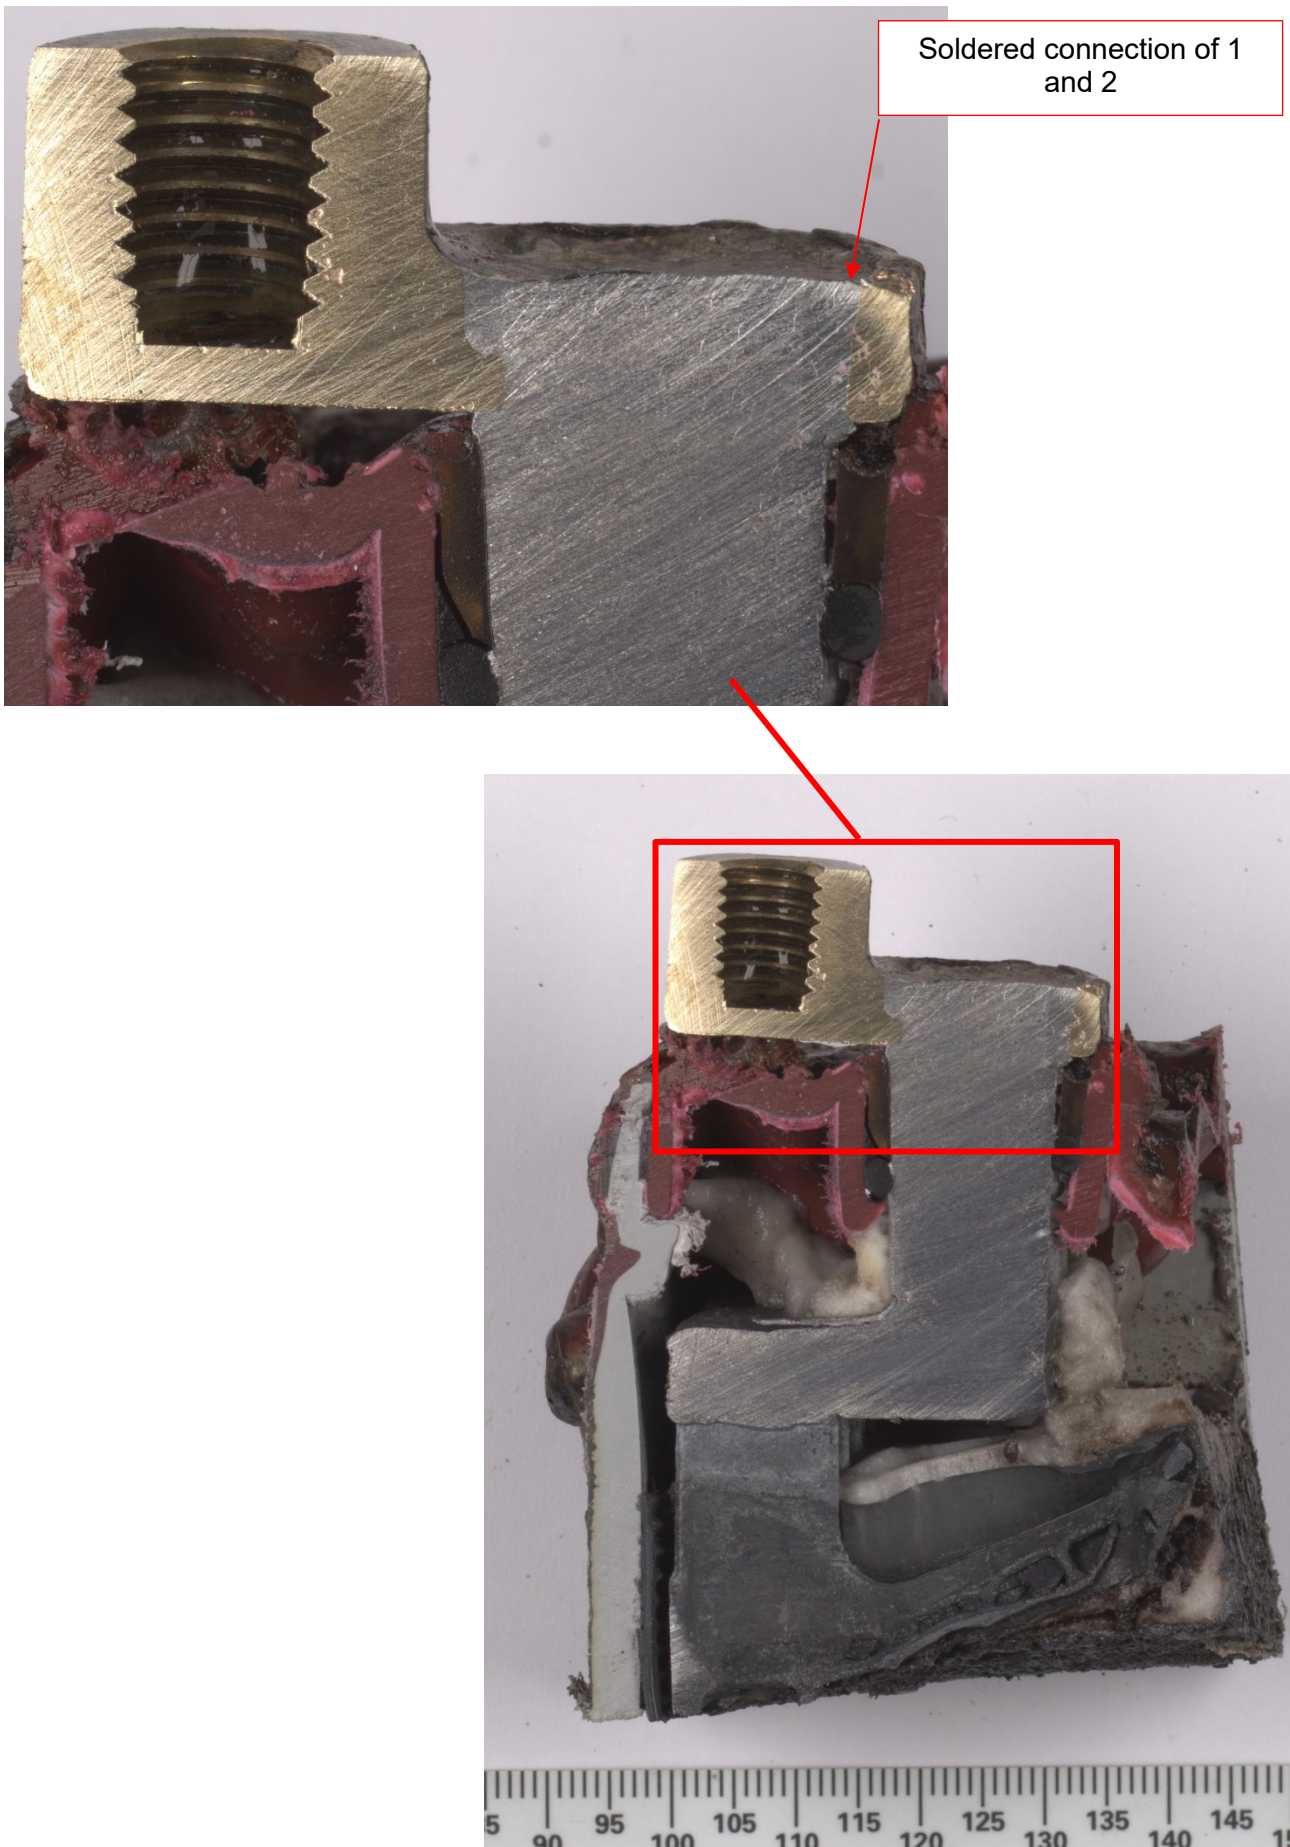
There was no damage on the negative terminal. The various components were in position. The soldered connection was intact (**Figure 59**).

Figure 59: Cross-section of negative terminal
Source: BEA

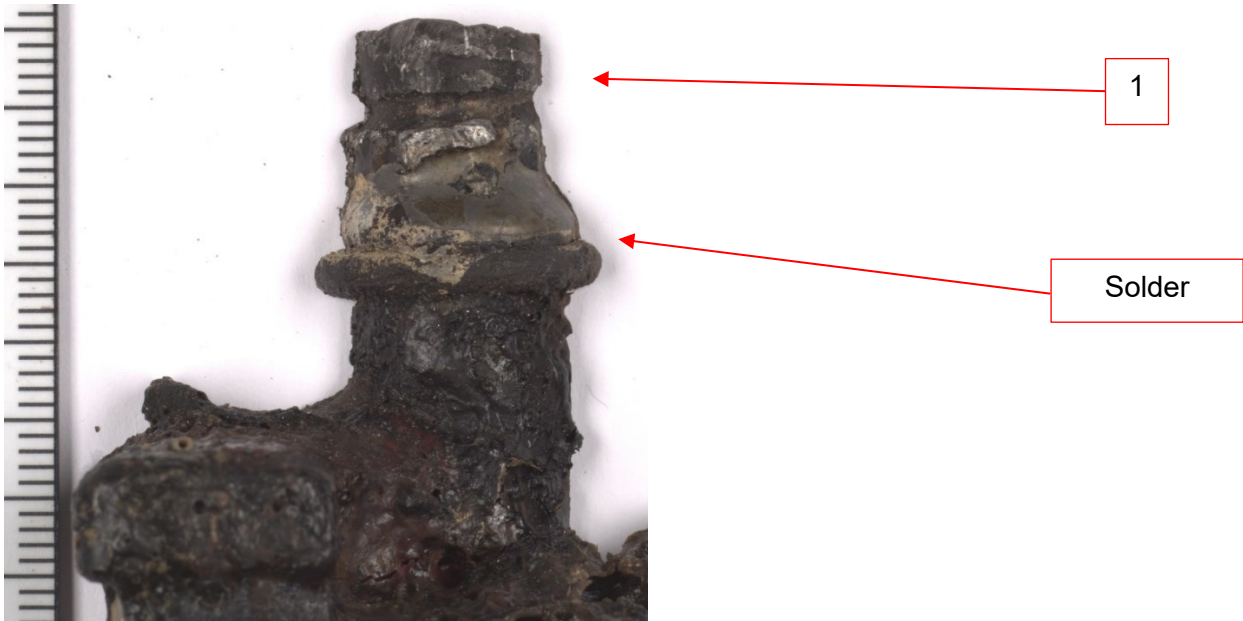
- the solder which normally makes components 1 and 2 integral with each other (**Figure 56**) was not in its normal place. The solder seemed to have run downwards (**Figure 60, Figure 61 and Figure 63**);
- the epoxy sealant was no longer present;
- arc type damage was observed in one of the section planes, level with the connection between the terminal and the battery cells (**Figure 62 and Figure 64**);
- item 2 had stayed connected to the conductor.

Figure 60: Positive terminal

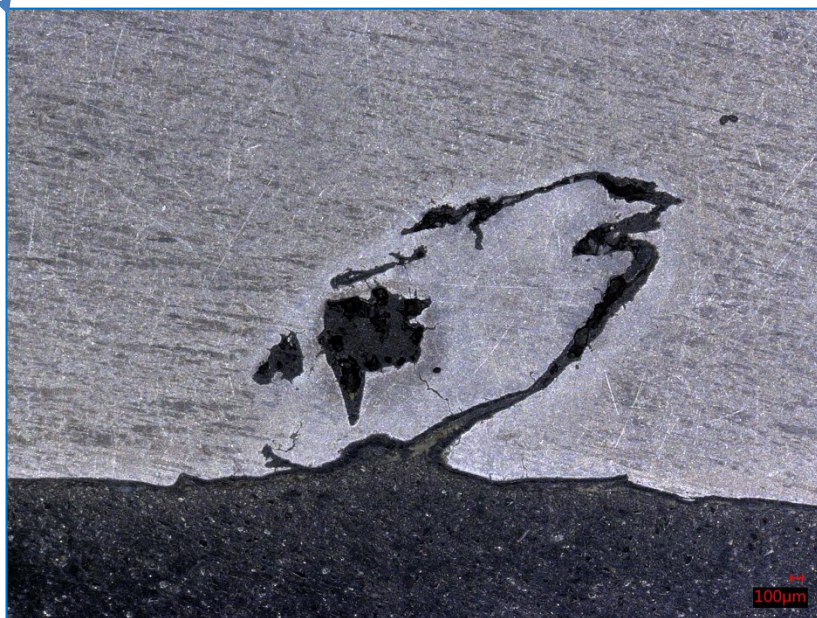
Figure 64: Arc type damage within positive terminal
Source: BEA

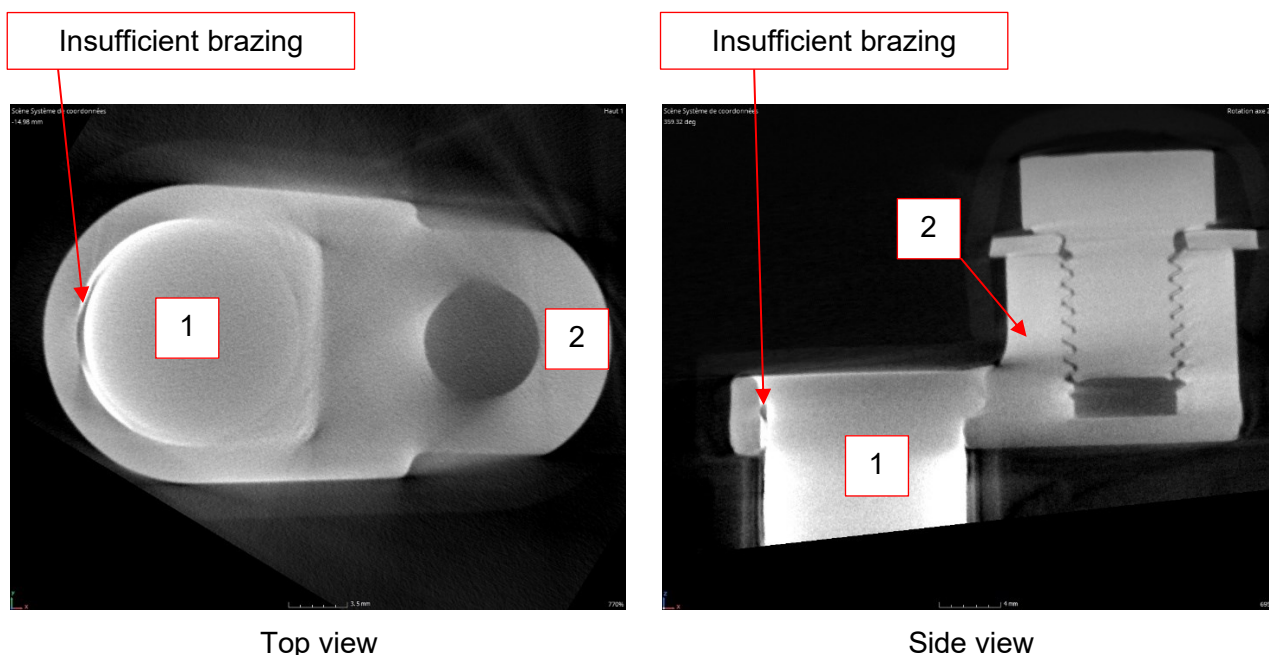
Insufficient brazing was observed locally in line with the negative terminal (**Figure 80**).

Figure 80: Negative terminal
Source: BEA

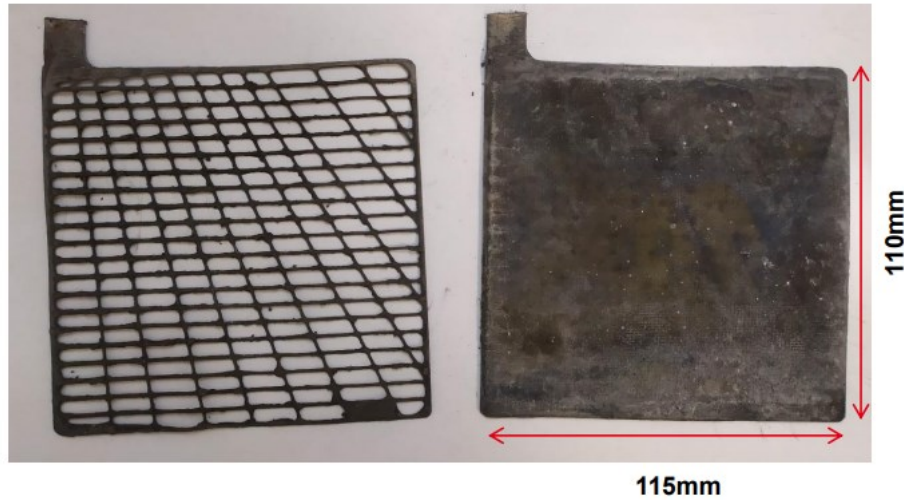
The negative plates were in very good condition with a homogeneous appearance (**Figure 91**).

Figure 91: Example of negative plate
Source: INES CEA

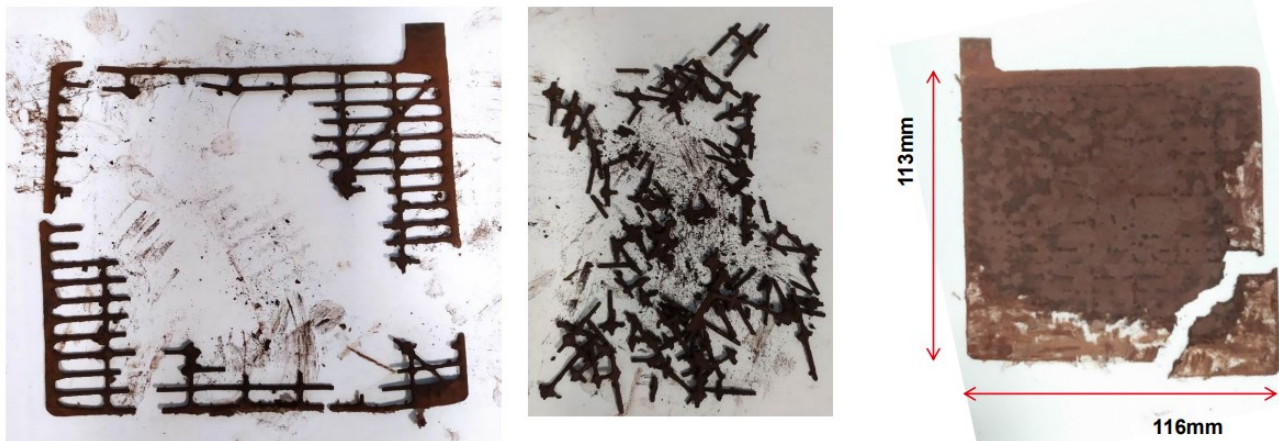
According to the CEA specialists, this degraded state of the positive plates may explain the battery's low capacity measured in the laboratory.

Figure 92: Example of positive plate
Source: INES CEA

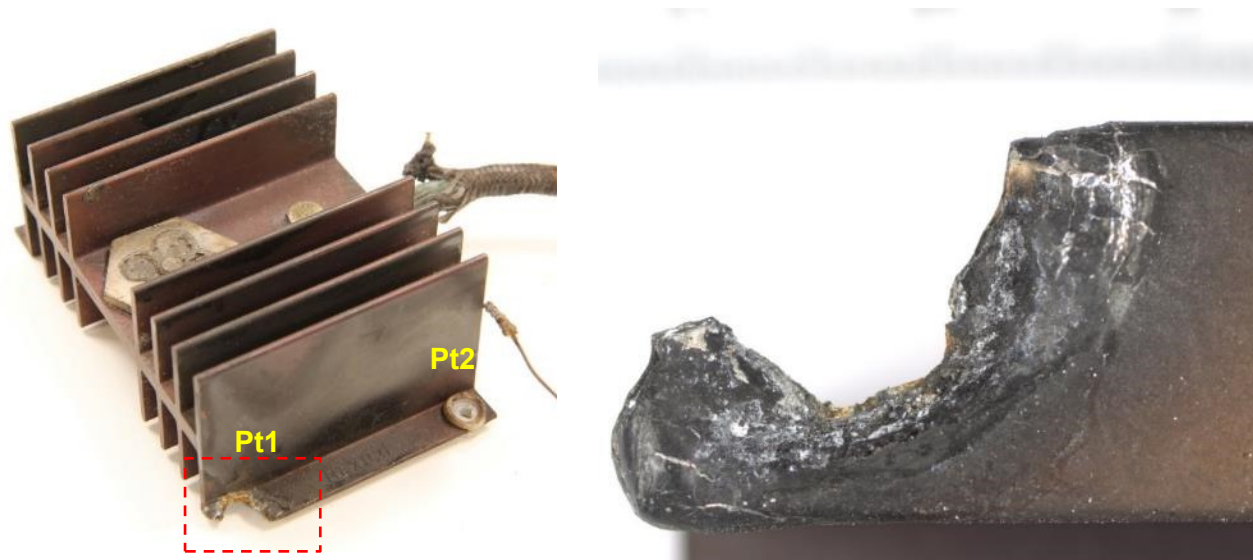
The corner of the metal cooler with thermal effect damage (in line with Pt1) was examined in the BEA laboratory.

Figure 107: metal cooler and detail view of damaged area

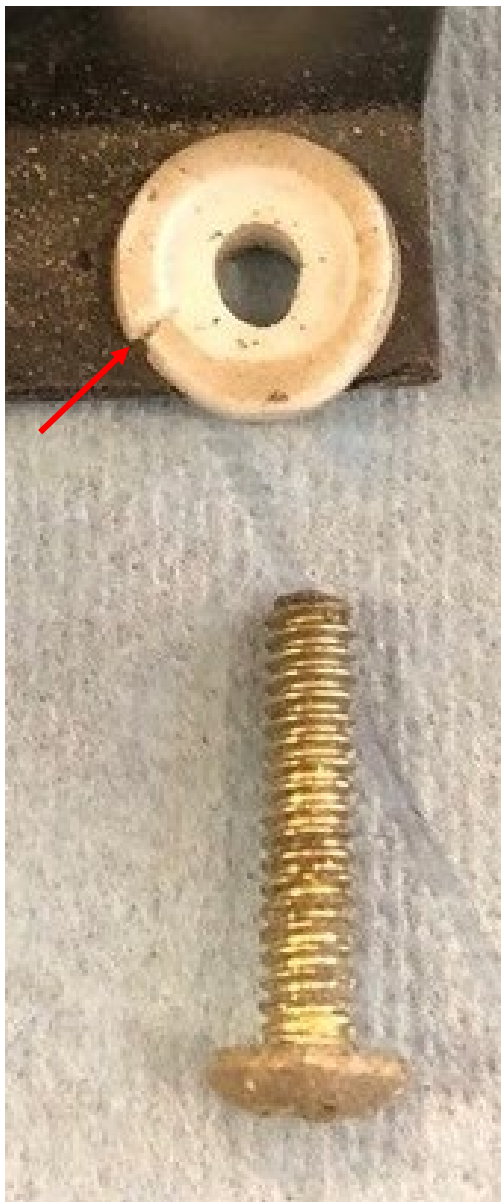
Figure 111: Cracked upper flange of insulating washer
Source: maintenance workshop for HB-PPB

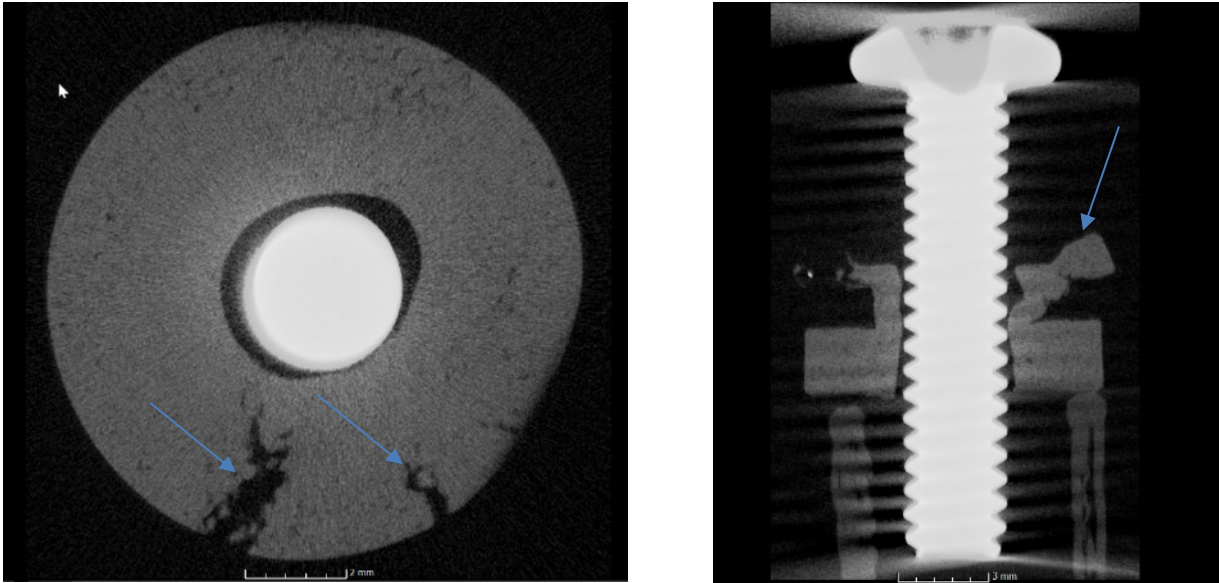
Figure 113: Example of screw and washer observed – the washer shows cracks (LH side) and plastic deformations (RH side)

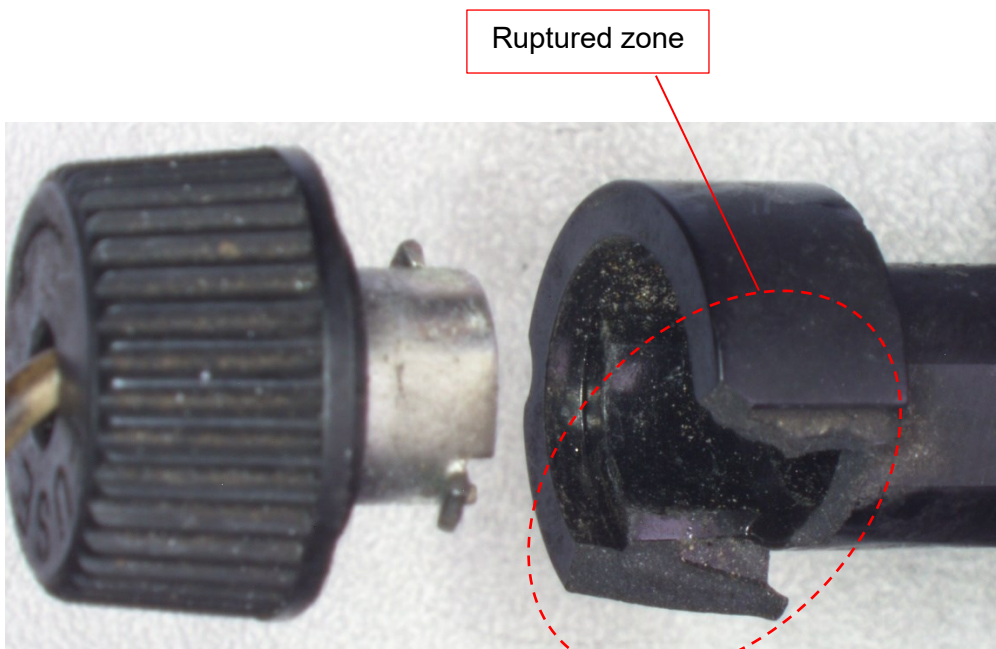
Figure 146: Ruptured zone of fuse holder (item 12)
Source: BEA
