Take-off with an erroneous centre of gravity

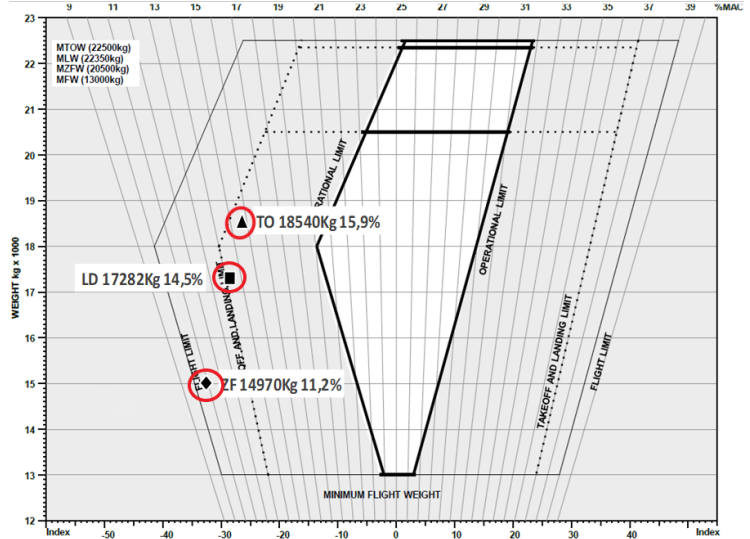
- During flight preparation, the captain communicated changes in weight and index to the ground staff for finalization of the LTS.
- Ground staff incorrectly corrected the DOI in the software by omitting the minus sign.
- This error led to an incorrect passenger seat allocation approved by the captain who did not identify the mistake.
- Cabin crew noticed an unusual distribution of passengers but did not inform the captain, who had just validated the weight and balance.
- After takeoff, the captain noticed the flight controls were heavy and an abnormal trim value; the error was confirmed by the airline operations center and a corrected passenger seat allocation was sent before landing, which was uneventful.

- Incomplete training of ground staff in the use of the flight preparation software used to generate the LTS.
- Time pressure due to the reduced stopover time.
- Software interface allowing modification of a DOI by any operator.
- Minus sign not prominent in the computerized LTS.
- Positive or negative DOI depending on the aircraft, which may lead to a sign or value insertion error.

- Importance of crew coordination in case of doubt or questioning.

- Importance of software configuration, especially when its use is delegated to agents less familiar with it than OCC staff.
- Training of ground staff.
