Non-stabilized approach, windshear, opposite dual inputs, hard landing, go around

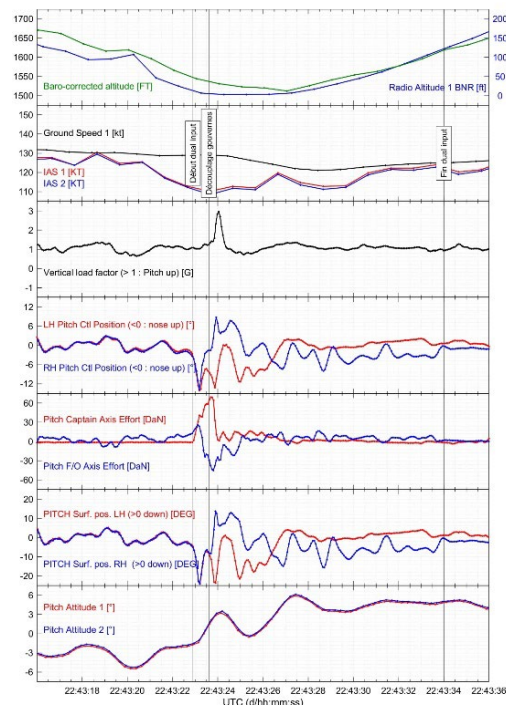
- Wind updated by AFIS: variable and tailwind component present on preferential RWY 02.
- RNP 20 approach, steep slope (4°), variable wind.
- VAPP increased due to expected turbulent air after crossing the coastline.
- Significant, high amplitude activity by the co-pilot on the power levers to control the flight path and the speed. Non-stabilized approach in IAS and Vz.
- Between 100 ft and the ground, unanticipated windshear causing the aircraft to sink.
- Uncoordinated action by the captain (PM), without a callout, leading to the elevators uncoupling.
- Hard landing, opposite dual inputs prior to flare and during the subsequent balked landing.
