Serious incident to Embraer EMD145LR registered F-HYOG on 20/10/2022 at Paris-Orly AD

## Non-stabilized approach, long landing, runway overrun

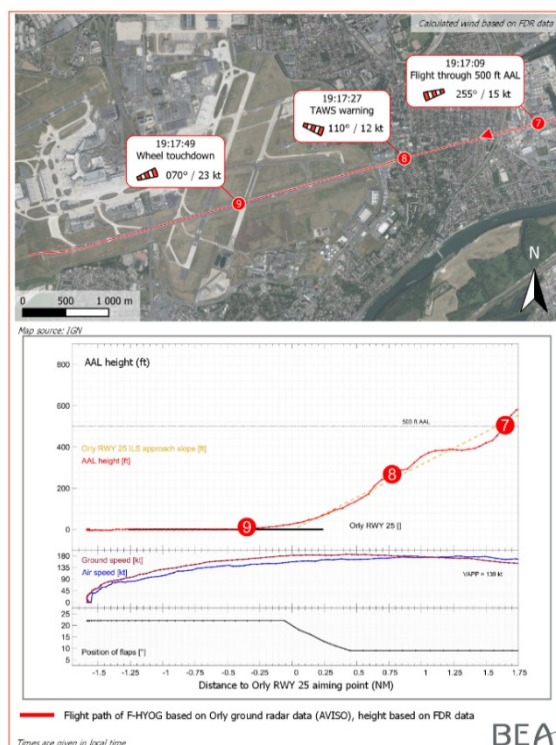
- At 240 ft AAL, a TAWS warning triggered because of the incorrect configuration for landing. The PM extended the flaps to 22°, creating lift. The aeroplane flew over the threshold with an excess of 30 kt.

- The aeroplane touched down 1,150 m after the runway threshold, with 20 kt tail wind.
- The runway was contaminated by 4 mm of stagnant water, because of a heavy storm that had just passed through. Braking was not effective, the aeroplane hydroplaned. The aeroplane skidded off the runway at 80 kt.

- @Pilots - Risks associated with storms.** In stormy conditions, wind, precipitation and runway conditions may change rapidly and available information may no longer reflect actual landing conditions. TEM for approach and landing should be associated with mitigation barriers to preserve sufficient safety margins.
