# INVESTIGATION REPORT

**Serious incident** on 22 May 2015  
at Paris - Charles-de-Gaulle  
to Boeing 777-F  
registered **F-GUOC**  
operated by **Air France**

**BEA**

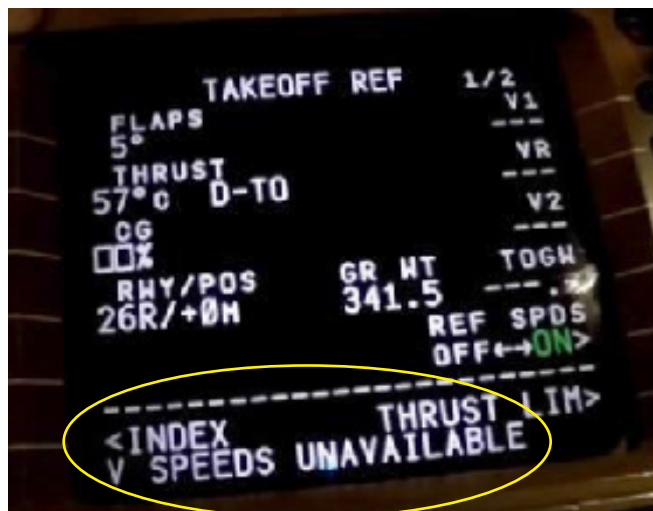
If the FMS cannot calculate the reference speeds, the V SPEEDS UNAVAILABLE message is displayed at the bottom of the CDU. It is displayed in white as are all the messages displayed on the CDU<sup>(13)</sup>.

V SPEEDS UNAVAILABLE message

Boeing informed the BEA that condition N° 4 had probably triggered the message at the time of the event.

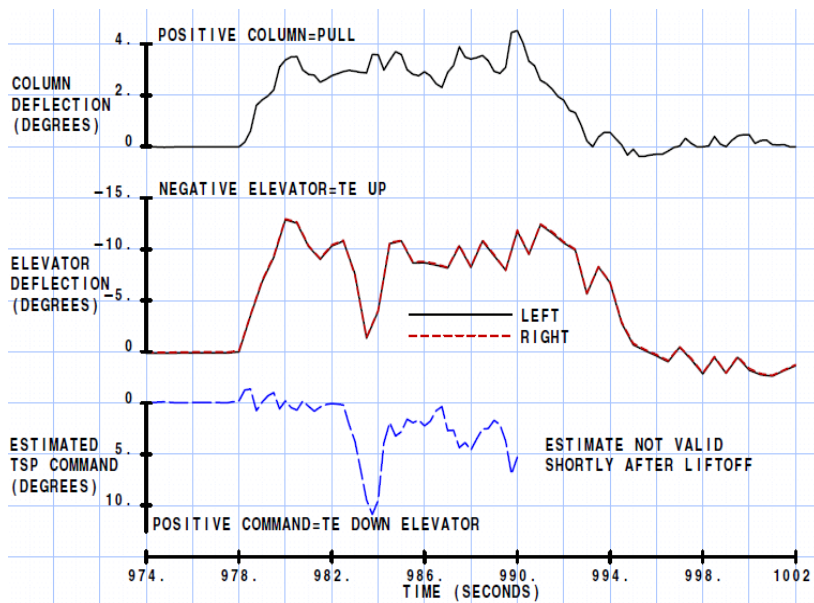
Estimated TSP (TailStrike Protection) input - Boeing calculations

Boeing concluded that the TSP was fully activated a first time around five seconds after the start of the rotation and a second time, to a lesser extent, just after take-off.

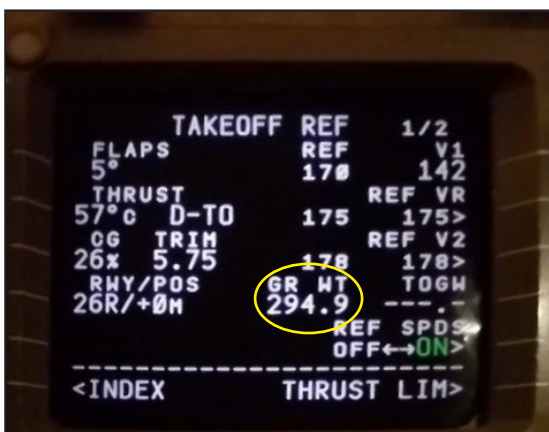
1.

The TOW entered in the OPT is erroneous: 243 tonnes instead of 343 tonnes.

- Flap configuration = 5°
- Take-off speeds V1 = 142 kt, VR = 157 kt, V2 = 164 kt

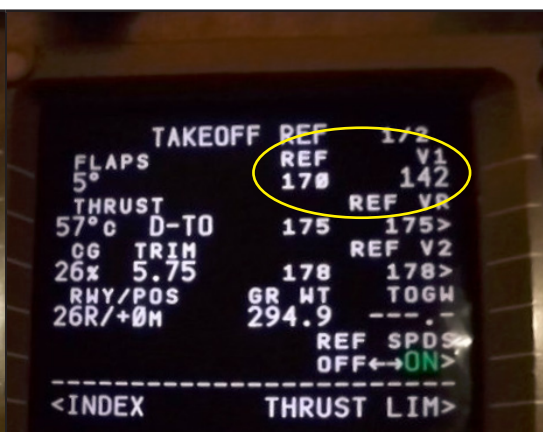
2.

Refuelling is in progress.

The GR WT is calculated by the FMS from the ZFW and the measured FOB.

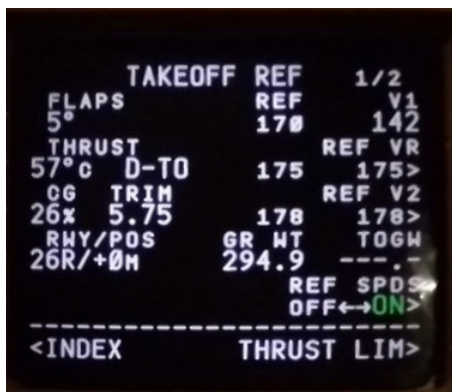
Figure 1: Example from simulation  
Reference speeds versus entered speeds

When the crew entered the speeds from the OPT, they noted that the FMS displayed significantly higher reference speeds (Figure 1). The crew thought that this difference might result from an instability of the probe measurement due to the refuelling then in progress. The Captain and the Co-pilot then performed other tasks.

The reference speeds V1, VR and V2 were calculated by the FMS and displayed on the TAKE OFF REF page. The calculation was based, in particular, on the ZFW weight entered by the crew.

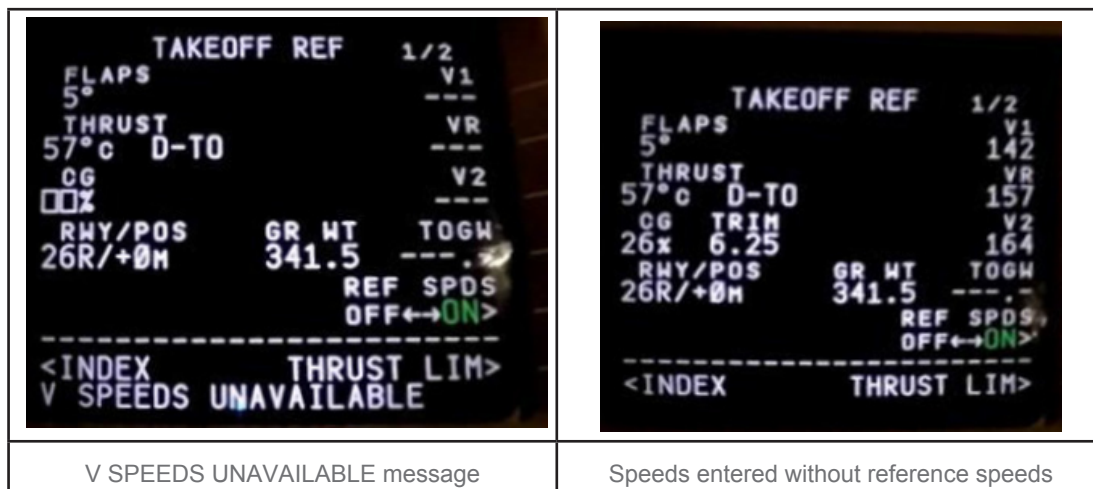
Figure 3: Screenshots of FMS  
Take-off parameters close to those of the incident

When refuelling was complete, both crew members re-entered all of the data in the FMS, starting with the ZFW. The V SPEEDS UNAVAILABLE message was displayed when all the data necessary for calculating the speeds had been entered. When they displayed the TAKEOFF REF page, the reference speeds no longer appeared. They tried to display them, without success, by repeatedly pressing the ON/OFF key corresponding to the REF SPDS function of the FMS (Figure 3).

The 5° flap configuration, the assumed temperature of 37° and the take-off speeds from the Captain's OPT were then entered. The values were as follows: V1 143 kt, VR 152 kt and V2 156 kt (instead of 167 kt, 175 kt and 179 kt for a flap configuration of 15° and an assumed temperature of 58° calculated by the OPT with a correct weight).
