INVESTIGATION REPORT

Accident to Piper PA28
registered **F-HEHM**
on 1 July 2015
at Treilles (Aude)

Collision with terrain in cruise in adverse meteorological conditions

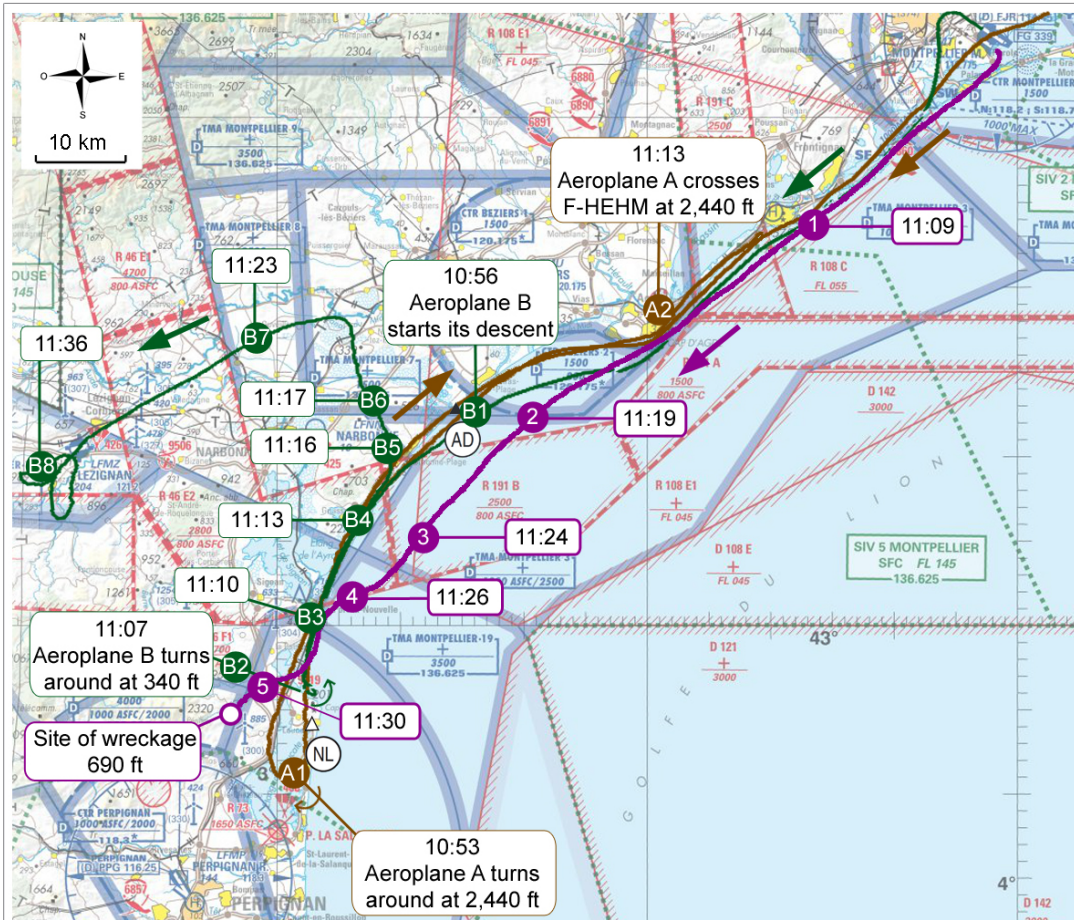
- B4 The pilot of aeroplane B advises that there are very good conditions in the region of AD
- B5 The pilot of aeroplane B asks for clearance to cross the Béziers runway axes to see whether the weather is better to the north

- B6 The pilot of aeroplane B advises that there are adverse weather conditions on the coast
- 2 The pilot of F-HM asks for clearance to descend to 2,000 ft.
The controller clears him and asks him to call back at NL

- B7 The pilot of aeroplane B says that he has very good conditions heading towards Lézignan
- 3 The pilot of F-HM asks for clearance to descend to 1,000 ft in order to pass under the cloud layer

- 4 The pilot of F-HM advises that he is at 800 ft level with the cloud layer and that he is going to descend. The controller asks him to keep VMC conditions

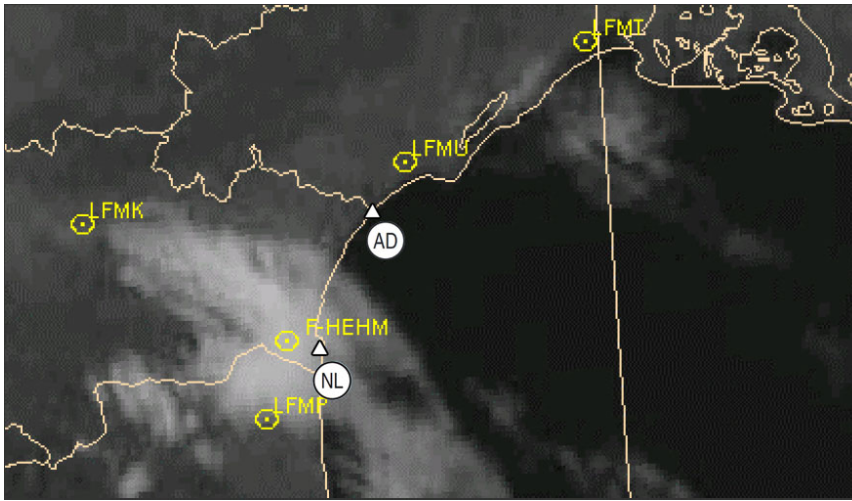
Figure 2: satellite image of 1 July 2015 at 12:00⁽²⁾

A layer of cloud covered all of the Golfe du Lion at daybreak. It broke up over the Montpellier region around 10:30 and only concerned the section between Narbonne and Perpignan at 11:00. The situation remained stable up to around 12:30.

The accident site is situated in the geographical portion where the terrain is at its highest and where the layer of cloud was the most dense.

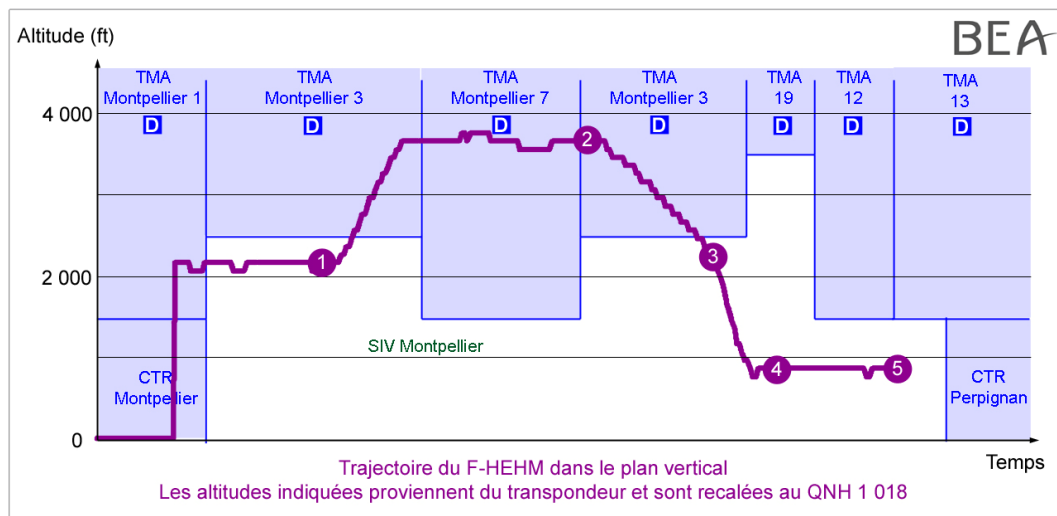
Figure 5: vertical profile of F-HEHM flight path

When he descended through 2,500 ft (point 3), he left the class D airspace and flew in class G (uncontrolled airspace) up until the accident.

The route (bearing 230°) followed by F-HEHM would have led the pilot into the Perpignan controlled airspace (class D) less than two minutes after his last radio exchange with the Montpellier Approach.

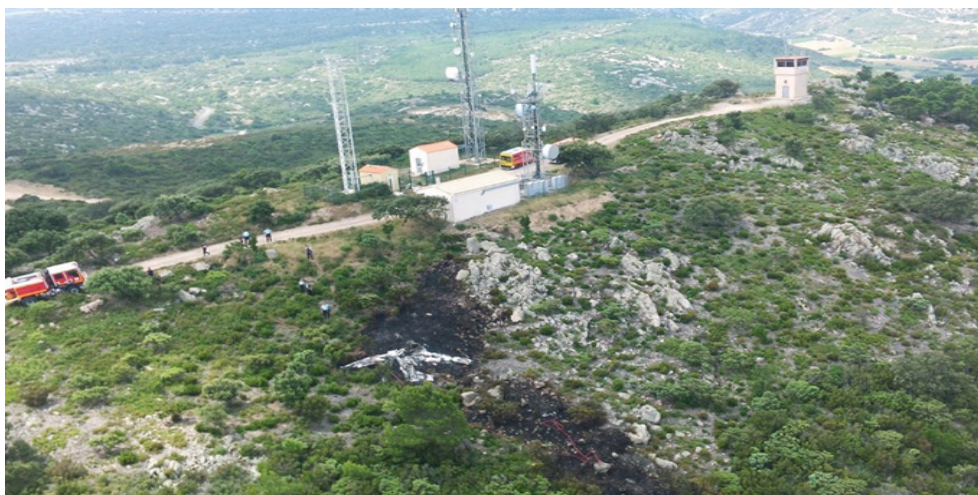
Figure 8: aerial view of the accident site

The parts found starting from the first point of impact in the vegetation showed that the aeroplane had struck the ground with its wings relatively level, bounced over around 50 m and then made a high-energy impact with the ground a second time. The aeroplane then slid over several metres towards the top of the slope before catching fire.

The parts found at the second point of impact were the propeller, engine and landing gear. The examination of the engine found that it had been producing high power at the impact.

The examination of the wreckage found that at the time of the impact with the terrain, the aeroplane was complete and the movable surfaces in place. No anomaly which could have contributed to the accident was identified.

All the damage observed on the wreckage was the consequence of the aeroplane's collision with the terrain and the fire which followed.

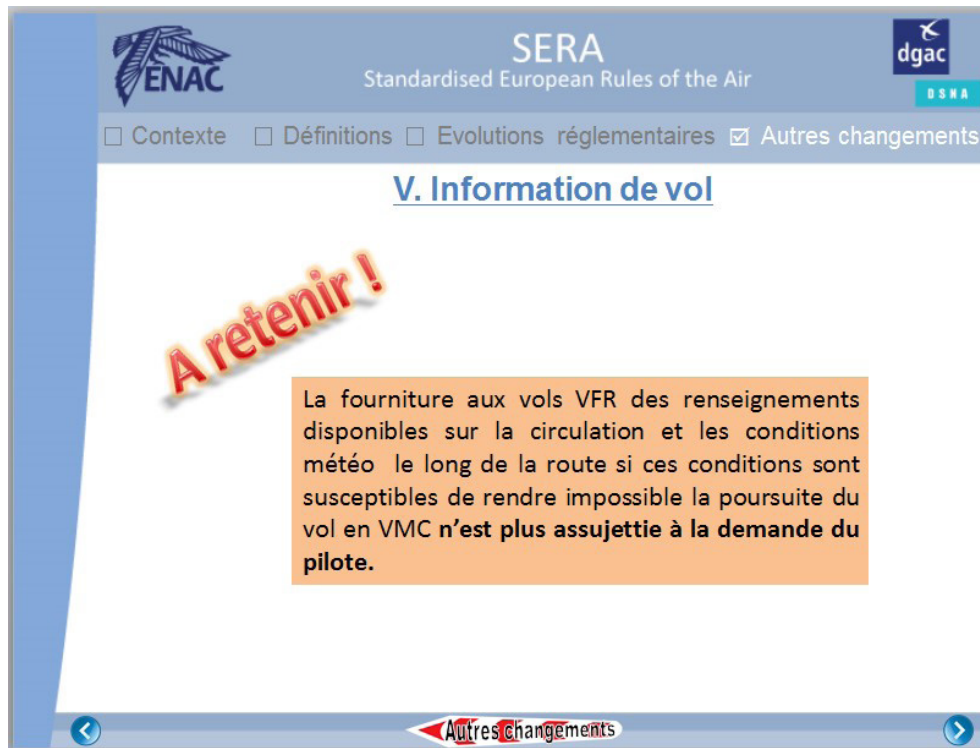
Figure 9: Excerpt from ENAC/DSNA training presentation

The presentation and training carried out by ENAC contained a section on the new aspects of the SERA for the flight information service and, in particular, the fact that in the case of adverse meteorological conditions for the VFR flight, it is now no longer only provided on pilot request (example of slide in Figure 9).

These elements are not quoted in the supplementary training documents issued by the Montpellier control unit and distributed to controllers locally (SERA Briefing and SERA booklet).

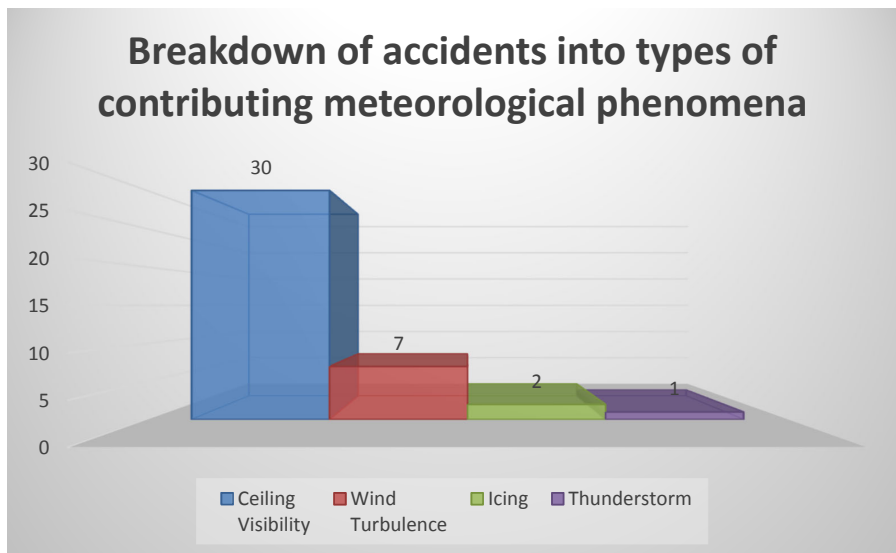
Figure 13: breakdown of accidents into types of contributing meteorological phenomena

Note: Of the 30 accidents linked to reduced visibility or adverse cloud cover, 25 involved aircraft flying under VFR. They caused the death of 53 people.
