**In-flight loss of control in a turbulent atmosphere,
collision with vegetation, then the ground**

Aircraft	Pipistrel Taurus 503 microlight identified 34-ABF
Date and time	13 July 2015 at 16 h 15 ⁽¹⁾
Operator	Private
Place	Eyglis (05)
Type of flight	General aviation
Persons on board	Pilot and one passenger
Consequences and damage	Pilot fatally injured, passenger seriously injured, microlight destroyed

This is a courtesy translation by the BEA of the Final Report on the Safety Investigation. As accurate as the translation may be, the original text in French is the work of reference.

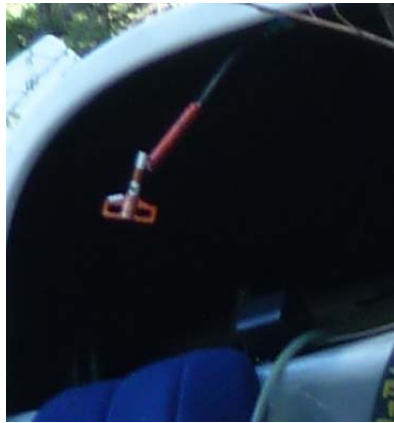
The emergency parachute was stowed in its housing and its control handle was found outside its sheath, which was itself torn from its support on the fuselage. This suggests that it had been activated by one of the occupants. Before the takeoff, the safety pin had been removed. It was attached to the ignition key ring on the instrument panel.

Emergency parachute control handle

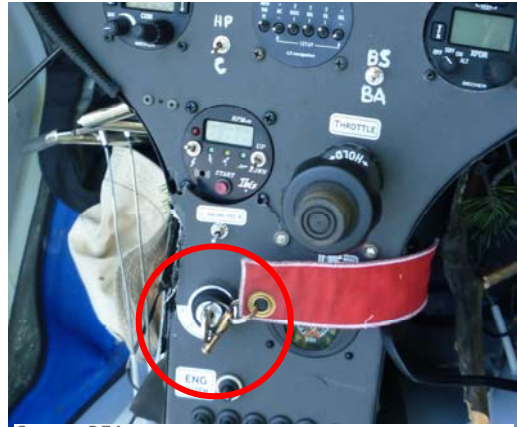
Parachute safety pin

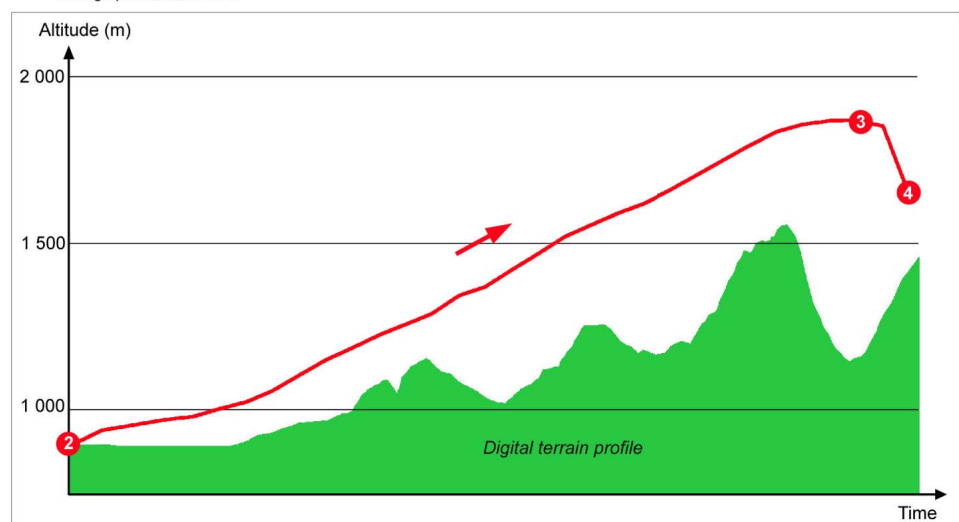
— Flight path of 34-ABF based on data from Colibri

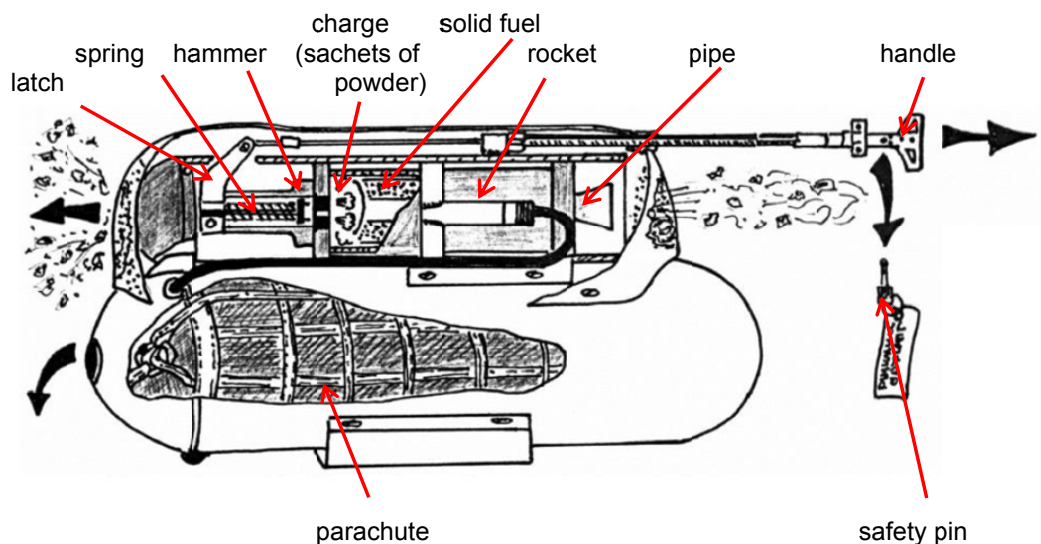
Emergency parachute pyrotechnic system

Disassembly of the system by deminers confirmed the absence of the two safety devices for transport (pin and screw) and that the mechanisms functions were no longer hindered.

Observations made on the system after the accident confirmed that the passenger had used the system. However, the sachets had not been pierced, a sign of a failure in the percussion mechanism.

Functional tests of the hammer/charge subsystem for the emergency parachute were undertaken with the assistance of the system manufacturer. Each time, the system functioned normally. It was not possible to reproduce the failure of the system seen at the time of the accident. The cause of this failure was not identified. An assembly error during the re-assembly of this system in the factory during the revision is one possibility that cannot be eliminated.
