Accident to the Robin DR400-120
registered **F-HGUY**
on 3 April 2016
at Rennes Saint-Jacques (Ille-et-Vilaine)

This is a courtesy translation by the BEA of the Final Report on the Safety Investigation published in March 2020. As accurate as the translation may be, the original text in French is the work of reference.

Hard landing, collapse of landing gear in solo training flight

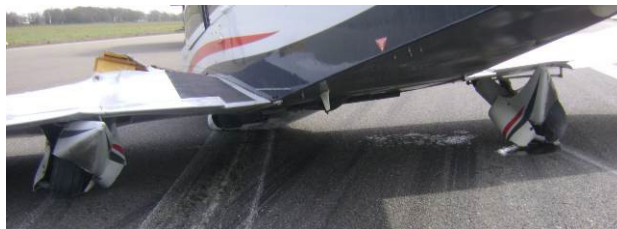
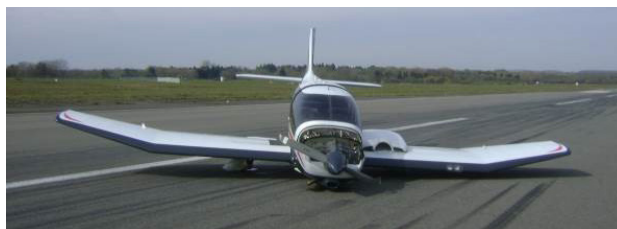
The solo student pilot took off from runway 10 to perform runway circuits with the authorization of the club's instructor. In the left-hand downwind leg, he configured the aeroplane with the flaps set to the take-off position. On final approach, after correcting the approach slope at an estimated altitude of 700 ft, the pilot said that the aeroplane was stabilized with a speed of 140 km/h. The wind reported by the controller was 140° at 11 kt. At wheel touchdown, centred on the runway axis, with reduced power, the pilot felt normal contact with the runway. He added that the aeroplane bounced. On making contact with the runway again, the nose landing gear bent under the fuselage and then the main landing gear failed, piercing the wings. The aeroplane slid and came to a halt on the runway at approximately 300 m from the touchdown zone markings of runway 10.

The final approach was carried out with the flaps set to the take-off position and with an increased speed. This increase in speed by the pilot (140 km/h) to take into account the crosswind component was excessive with respect to the actual wind conditions (a maximum crosswind of 7 kt and headwind of 9 kt). Even if the excessive speed contributed to the bounce, starting the flare too high because of the different visual references linked to an upward sloping runway could also have been the cause. When the aeroplane regained height after this bounce, the pilot may have made nose-down inputs to land. It is also possible that the aeroplane stalled. The contact of the nose and then main landing gear with the runway, greater than the structural limits, led to them collapsing.
