Serious incident to the Boeing 777-200ER
registered **N777AS**
on 5 June 2016
at Paris - Le Bourget (Seine-Saint-Denis, France)

This is a courtesy translation by the BEA of the Final Report on the Safety Investigation published in December 2019. As accurate as the translation may be, the original text in French is the work of reference.

Non-stabilized approach, activation of GPWS warning, horizontal tail and wing strike with ground during go-around

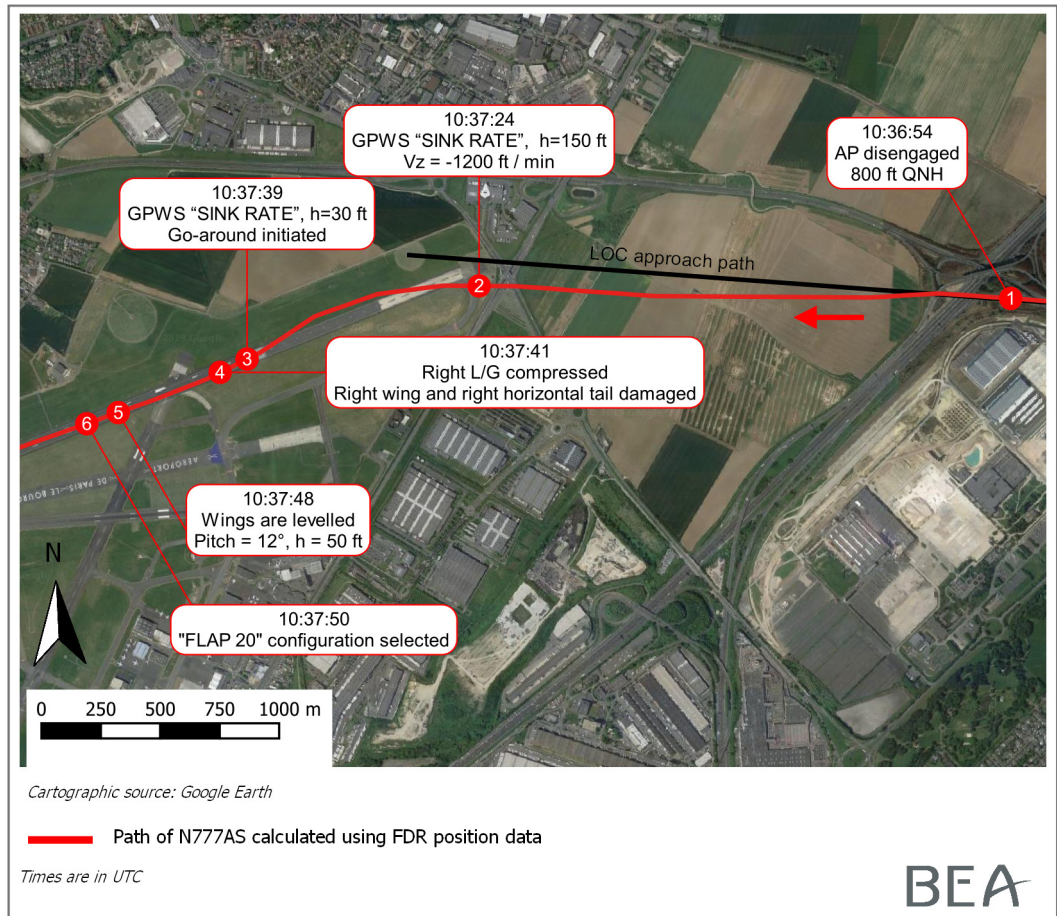
Figure 1: Final path of N777AS

The autopilot was disengaged by the crew just before flying through the MDA⁽⁶⁾ which was 800 ft (614 ft AAL⁽⁷⁾, see point ❶ of Figure 1 below).

Two seconds later, the GPWS warning "SINK RATE, SINK RATE"⁽¹⁰⁾ was triggered ❷. The descent speed was then around -1,200 ft/min and the height around 150 ft RA. The N1s were at 38 % and decreasing. The PF increased his nose-up input. The thrust levers progressively moved forward.

At 10:37:27, the aeroplane overshot the runway centreline with a left bank angle of 19° and a height of around 100 ft RA. The speed was 137 kt and decreasing.

At 10:37:38, the aeroplane flew over the threshold of runway 25 at 50 ft RA, with a right roll of 4° and a vertical speed of around -1,000 ft/min (17 ft/s). The pitch was stable at 2.6°.

One second later, a new GPWS warning “SINK RATE, SINK RATE” was triggered^③.

At 10:37:41, the right main landing gear was compressed^④. The maximum vertical acceleration recorded was 1.96 g. The pitch was 10° and the right roll around 16°.

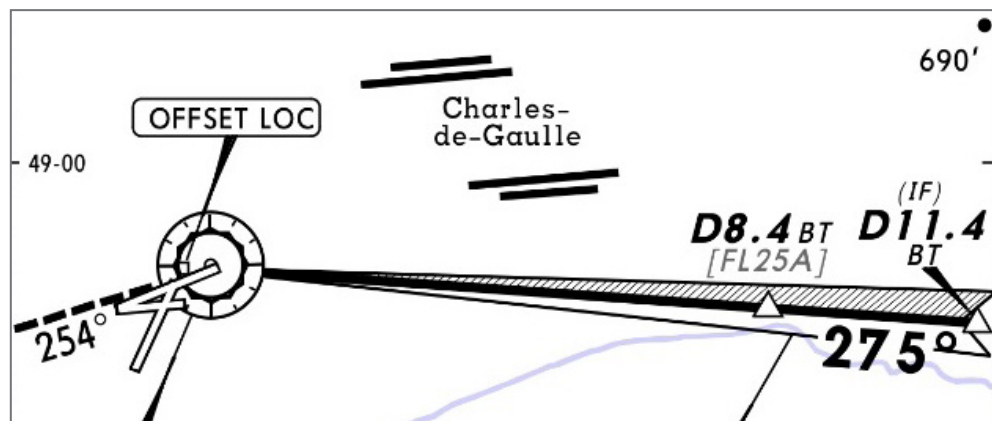
Figure 2 : Taken from Jeppesen chart used by crew for runway 25 LOC A approach

So as not to interfere with the approach paths of the Paris-Charles de Gaulle airport, the LOC A approach path of runway 25 is set at 275, offset by 26° with respect to the runway centreline which is set at 249. The FAF⁽²⁰⁾ is at an altitude of 3,000 ft. The MDA⁽²¹⁾ is 800 ft (614 ft AAL) for a category C aeroplane such as the N777AS.

It should be noted that for a category-D aeroplane such as the Boeing 777-300 with characteristics not very different from those of the N777AS, the MDA is 890 ft QNH (704 ft AAL). For an aeroplane of this category and in the conditions of the day, the probability of acquiring the visual references at the decision altitude was low and would have in all likelihood led to an aborted approach.
