INVESTIGATION REPORT

Serious incident

on 27 June 2016

Near mid-air collision between
Airbus A319 registered **F-GRHX**
operated by **Air France**
and Airbus Helicopters AS532
registered **F-ZWBS**

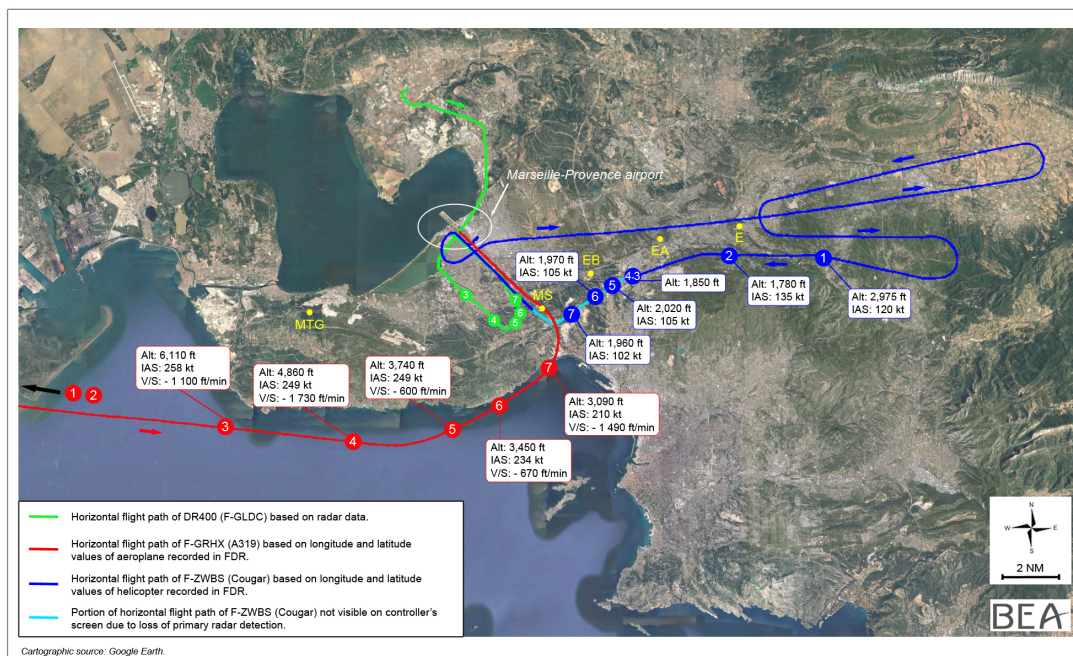
At 15:52:54 (point ③), the approach controller cleared the crew of the A319, if they were in sight of the preceding traffic, to carry out a left-hand visual approach to runway 31R and then cleared them to descend to 4,000 ft QNH. The crew read back this message.

Between 15:52:56 and 15:53:50, the Cougar crew started hover flight (points ③ and ④). At 15:53:11, there was no radar contact on the helicopter on the controller’s display. It was at 1,850 ft⁽⁶⁾. This position and altitude information was not given to the tower controller by the crew.

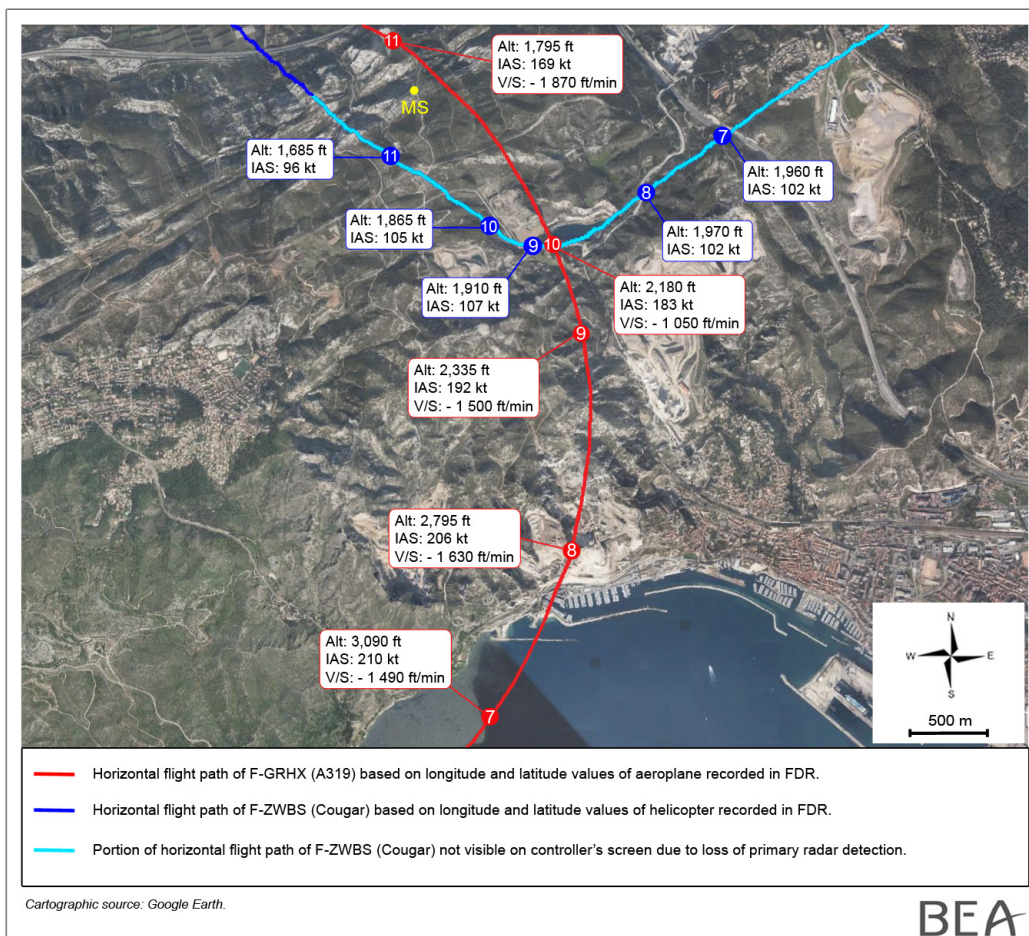
At 15:55:44 (point ⑦), the tower controller again asked the Cougar crew to report when they had visual contact on the DR400. The Cougar crew replied that they will call back and requested the position of the DR400. The controller replied that the latter was on a long final for runway 31L.

At 15:55:56 (point 8), the crew of the A319 took the first opportunity given to them on the tower frequency⁽⁸⁾ to indicate that they were arriving on final for runway 31R. The tower controller asked them to report on short final for runway 31R and informed them of “two traffic on parallel, a DR400 followed by a helicopter.” The crew read back the message.
