Accident to the Cessna 172S Skyhawk
registered **N615VB**
on 26 September 2016
at Marie-Galante (Guadeloupe)⁽¹⁾

Loss of control during final approach in thunderstorm conditions

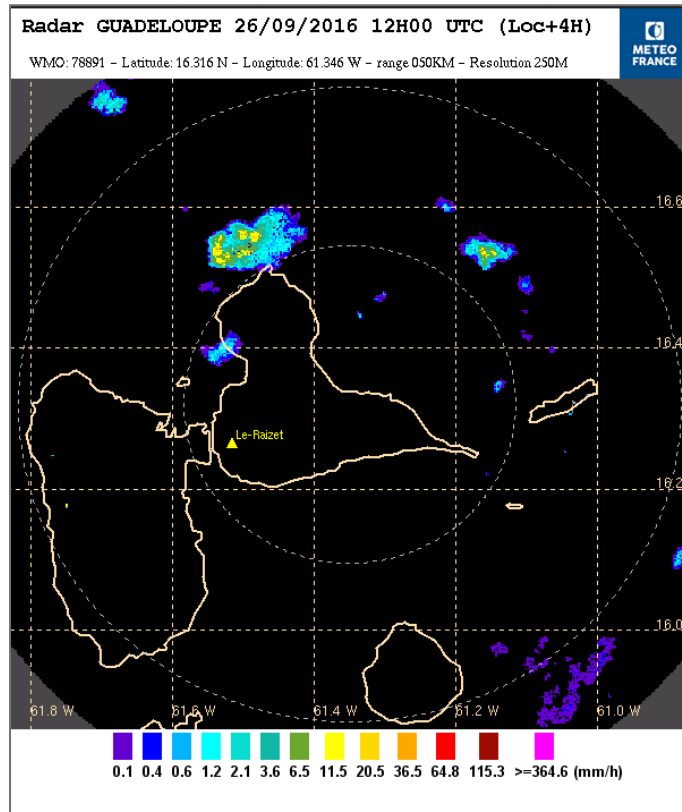
Guadeloupe weather radar image

At the end of the night of 25 to 26 September 2016, a cloud mass associated with a tropical wave had spread over an area immediately south of Guadeloupe. It gave rise to numerous storms north of Martinique and east of Marie Galante.

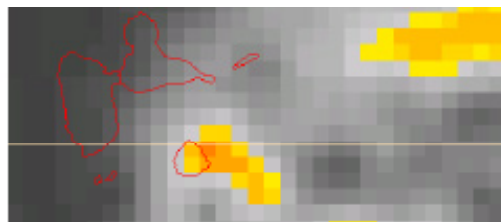
Météo France images at 09:00

The detailed study of the satellite imagery shows that the clouds associated with this wave were heading northwards. At 08:30, the clouds had already covered Marie Galante. It can be seen that at 09:00, considerable thunderstorm activity had very rapidly developed over Marie Galante. At 09:30, this thunderstorm activity was still present and spreading towards the east coast of Basse Terre.

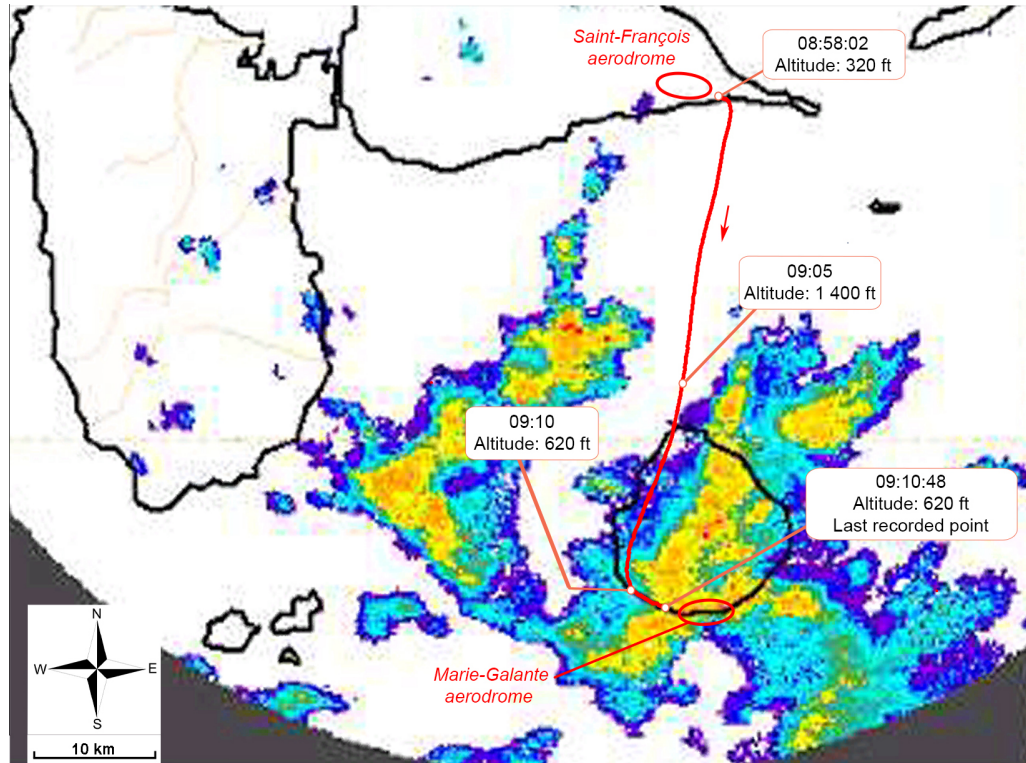
— Flight path of N615VB based on data from the Guadeloupe secondary radar from 08:58:02 to 09:05

The pilot took off for a flight of around twenty minutes, the meteorological conditions at departure being clement. He then passed between two cloud masses, heading south. The cloud mass situated to the east of his flight path, heading westwards, progressively compromised his chances of turning around. The pilot continued the flight along the Marie-Galante coastline and found himself at the heart of a second cloud mass with electrical activity and rainfall.

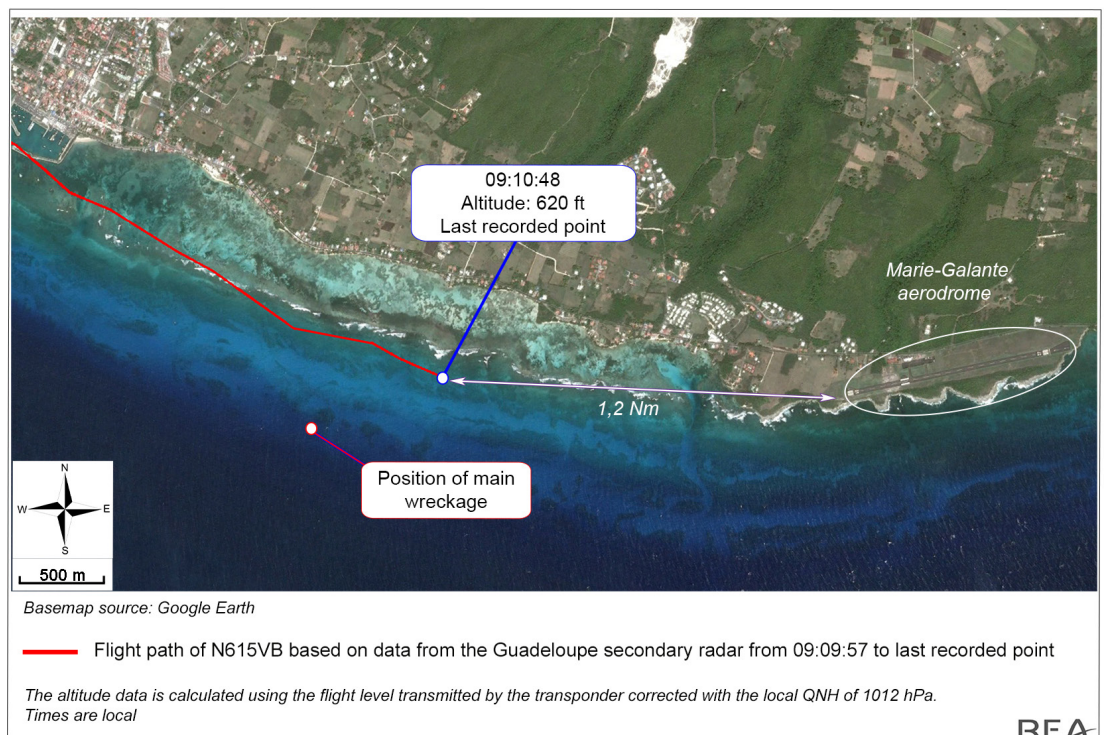
When the SAR operations were stopped, searches for the wreckage were privately funded by one of the families of the victims. These searches were unsuccessful. However, the wreckage was discovered around one month after the accident, during an exercise carried out by emergency service divers, in a zone situated half a nautical mile southwest of the last radar detection. The site of the exercise had been deliberately chosen, on advice from the pilot’s family based on the description of the flight path provided by a witness who had seen the aeroplane during its fall.

The position of the wreckage on the ocean floor, with respect to the last radar detection, shows that the pilot had probably abandoned the idea of landing and had started turning around by making a right turn.
