Accident to Skyleader 200
identified **47-XW**
on 17 June 2017
at Parisot (82)

**Loss of control during a stall exercise,
collision with the ground**

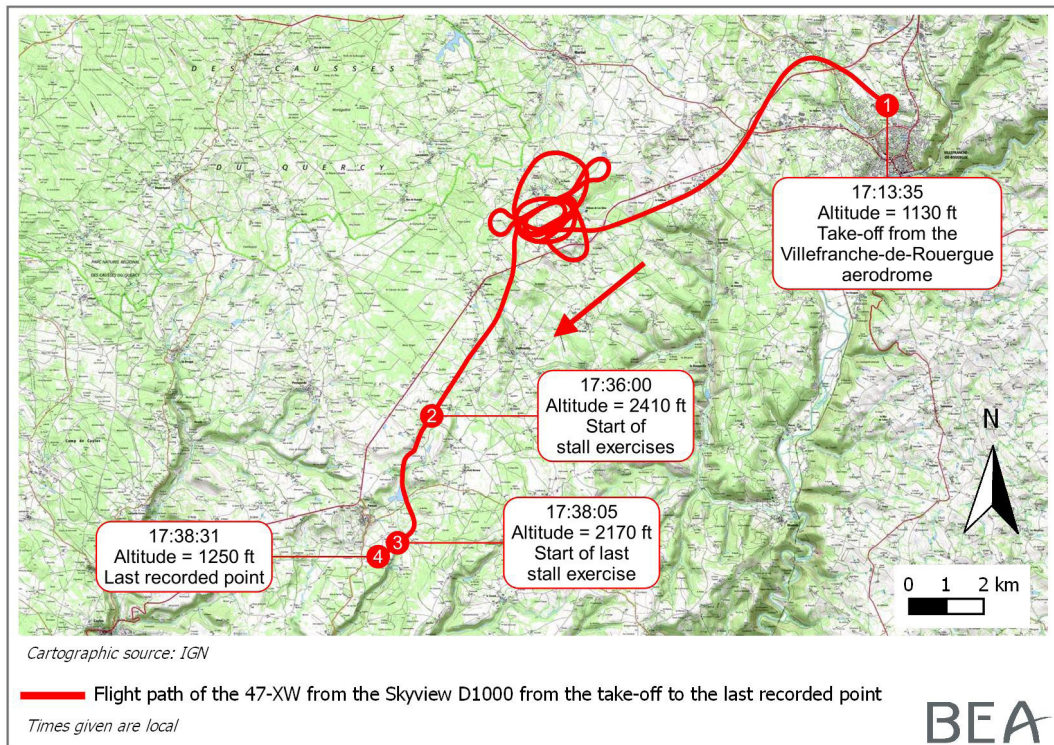
During the last exercise, the ULM made more than three complete rotations around its roll axis accompanied by significant movements around its pitch axis.

The aircraft struck the ground with a steep nose-down attitude in a field and came to a halt against a hedge of bushes.

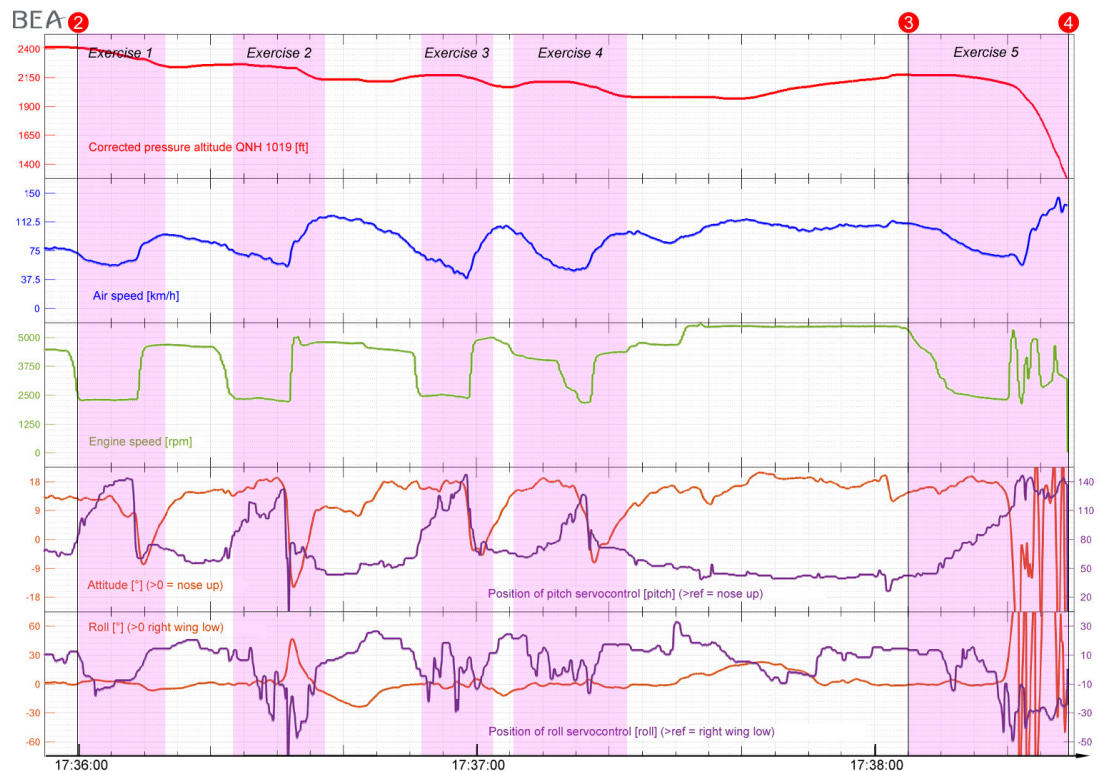
Stall nos. 1, 3 and 4 do not show significant roll motion. Stall no. 2 indicates a right roll movement (up to about 45°) associated with a short movement of the control column to the left.

Stall no. 5 did not result in a nose-down input. Left roll inputs were also recorded as the aircraft engaged a rapid right-hand rotation. The load factor recorded in the last moments reached 4 g.

The minima indicated airspeeds are close to the stall speed values indicated in the flight manual (from 56 to 71 km/h according to the position of the flaps, at maximum weight).
