Accident to the Ultramagic T180⁽¹⁾
registered **F-GTBL**
on 25 June 2017
at Sandillon (Loiret)

This is a courtesy translation by the BEA of the Final Report on the Safety Investigation published in December 2019. As accurate as the translation may be, the original text in French is the work of reference.

**Tree strike at end of approach,
go-around, emergency descent,
hard landing, basket upset**

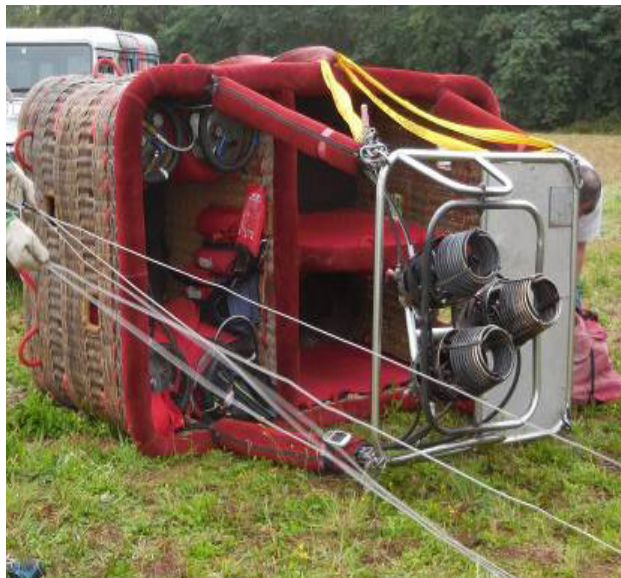
Figure 1: Ergonomy of compartments of F-GTBL basket

The wicker basket (Figure 1) is rectangular in shape with a maximum carrying capacity of nine people. It is composed of two lengthwise compartments which can each accommodate up to four passengers⁽⁸⁾ and a compartment at right angles to these, reserved for the pilot, the flight controls and the fuel tanks.

The passenger compartments are equipped with four handholds⁽⁹⁾ on the long side, which can be held onto during the landing.

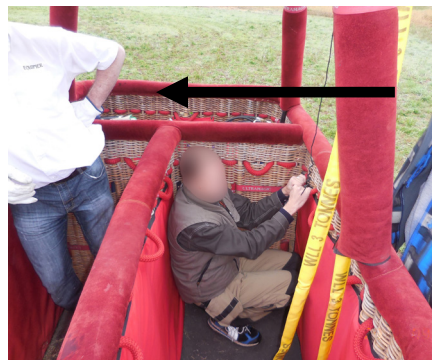
Figure 2: Operator demonstration

The left photo (Figure 2) shows one of the company pilots demonstrating the position that passengers must adopt before landing (in the direction of the arrow). This demonstration is carried out during the pre-flight preparation, this position is then repeated by the passengers during the flight and adopted on the pilot's command before landing.

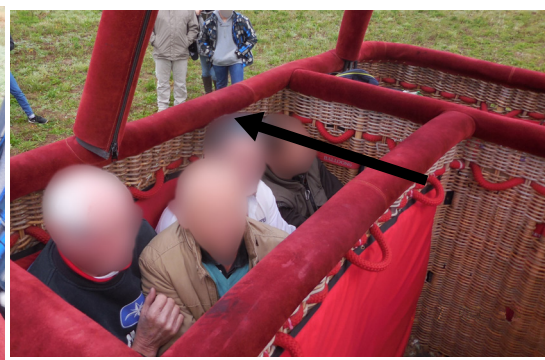
Figure 3: Operator demonstration

The right photo (Figure 3) shows that four adults of a standard size do not have room to press their backs in full against the longitudinal wall of the basket.

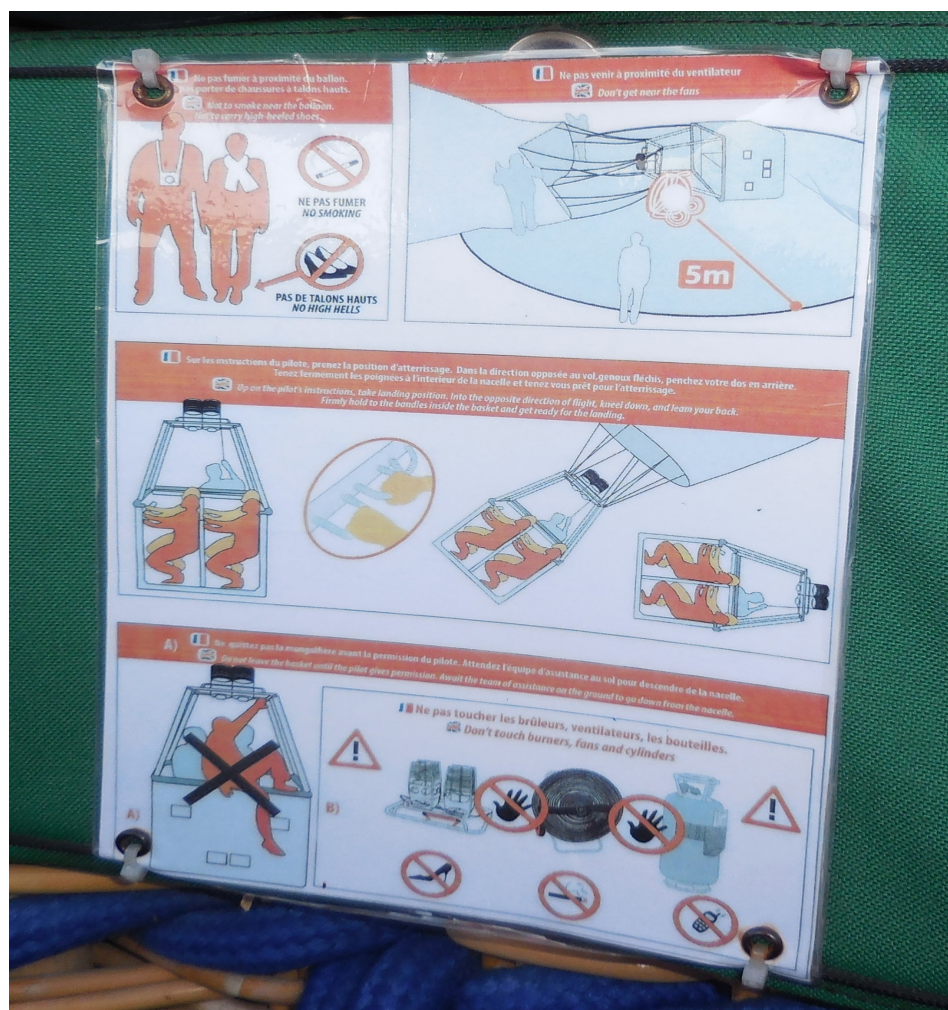
Figure 4: Information panel displayed in a basket belonging to the operator

- ❑ Other baskets belonging to the operator had a safety instructions panel for the passengers (Figure 4), recalling, in particular, the position to be adopted for landing. This instruction panel shows in a basket with several passenger compartments, a side-by-side position, with backs pressed against the partition.

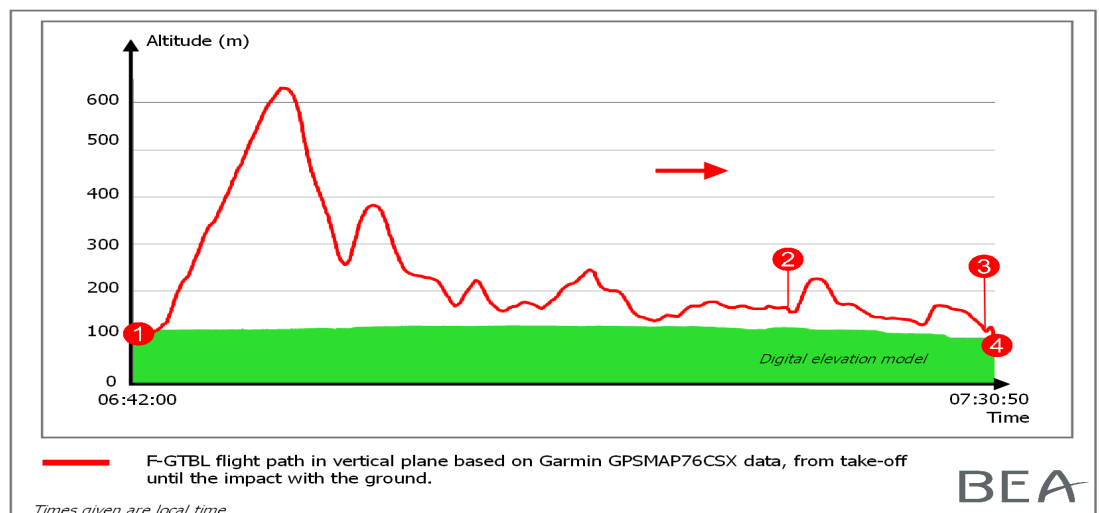
Figure 5: Path of F-GTBL

- points 1 and 4 correspond to the take-off and landing;
- during the second half of the flight, the horizontal path is more erratic;
- two more significant descents⁽¹⁷⁾ (points 2 and 3) are visible. The last one (point 3), at the end of the approach, is followed by the climb corresponding to the activation of the burners and quickly stopped by the opening of the RDS valve.

⁽¹⁷⁾The considerable drop rate in these descents is due more to the vertical air flows experienced by the pilot in the air mass surrounding the balloon than to a standard controlled descent.

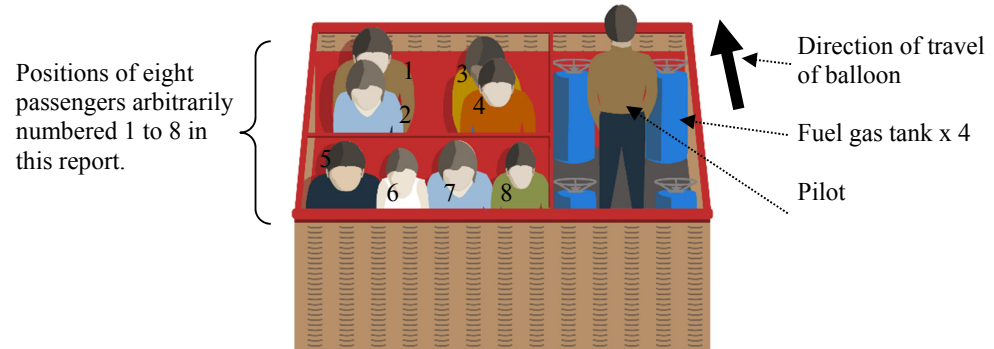
Figure 6: Diagram of situation in basket at time of landing

Passenger 8 specified that before landing, the passengers of the front compartment⁽¹⁸⁾ were positioned two by two, one behind the other and those in the rear compartment, next to each other.

Passenger 1 said that for the landing, he had his arms around passenger 2, with his legs apart whereas passenger 3 had his arms around passenger 4, with his legs together. He added that he thought that this tandem position better protected the passenger, embraced in the event of the basket tipping over, in comparison to the side-by-side position.

Passenger 3 said that he had shoes which protected his ankles, he said that he broke his ankle when the basket collided with the ground. He added that the pilot called out twice, just before landing, "squat down, it's going to hit hard."

When the basket collided with the ground, a passenger broke his ankle, he had adopted a tandem position with legs together, another passenger was situated in front of him.

- ❑ Lastly, the legs-together tandem position adopted by a passenger for the landing, with another passenger in front of him, probably contributed to the injury despite wearing suitable shoes. In this position, during the acceleration experienced on the basket coming into contact with the ground, an excess load may have been applied to the ankles of this passenger because of the transfer of part of the weight of the other passenger.
