Accident to the Schempp Hirth "Ventus-2CxT" glider⁽¹⁾ registered **G-TABB** on 14 July 2017 at Val des Prés (Hautes-Alpes), "Crête de Peyrolle"⁽²⁾

Time	Around 16:55 ⁽³⁾
Operator	Private
Type of flight	General aviation
Persons on board	Pilot
Consequences and damage	Pilot fatally injured, aircraft destroyed

Loss of control in flight, collision with the terrain, slope soaring flight

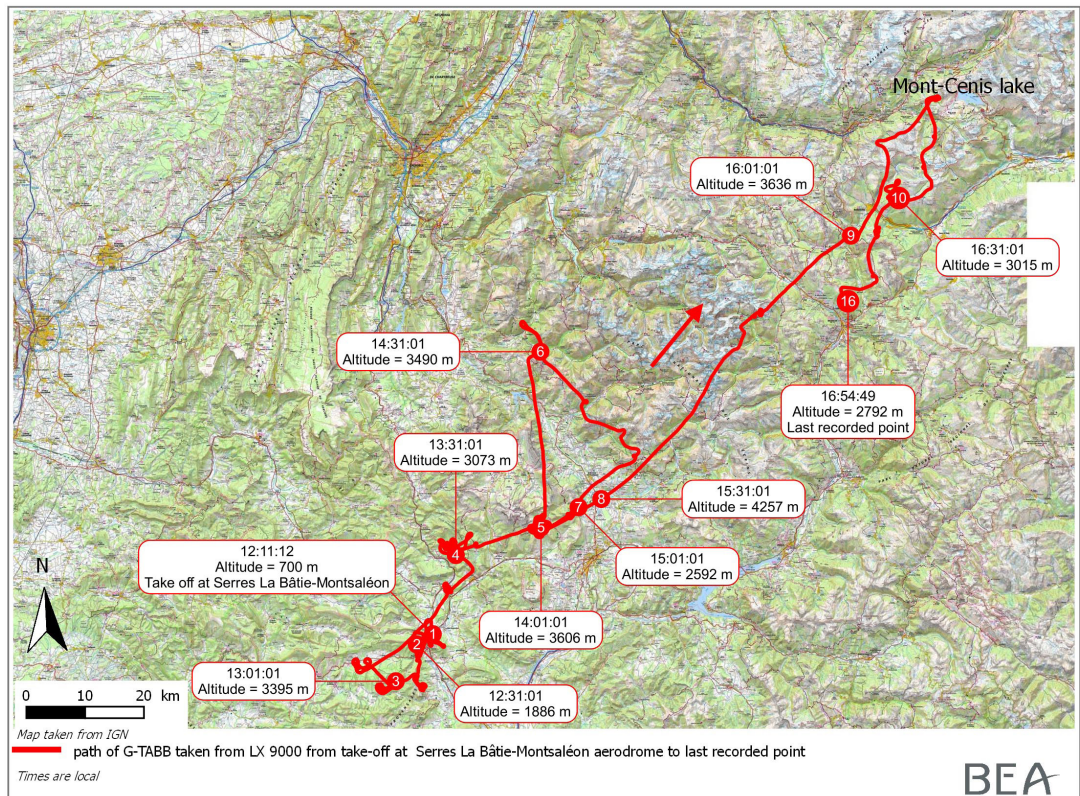
The search operations took place throughout the night and the next day. The wreckage of the glider was located at an altitude of 2,470 m on the north-east slope of the Crête de Peyrolle, 130 m below the ridge.

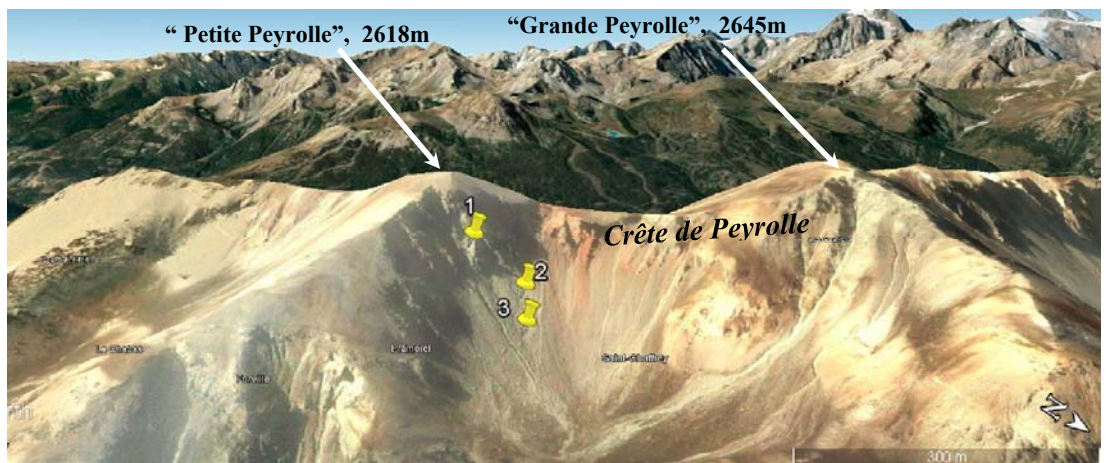
Overall view of accident site

The examination carried out two days after the accident showed that the major part of the wreckage was situated at the initial impact point, at an altitude of approximately 2,470 metres, in a small combe (point 1 below). No impact marks with the terrain were observed at an altitude higher than the place where the wreckage was found. Fragments of the left wing were found further down (points 2 and 3 below), in an adjacent combe.

The examination of the site and the wreckage showed that the fuselage front section and right wing tip of the glider had struck the mountain slope at a considerable horizontal speed. At the time of the impact, the glider heading was between 300° and 330° with a steep bank angle to the right, greater than 45°.

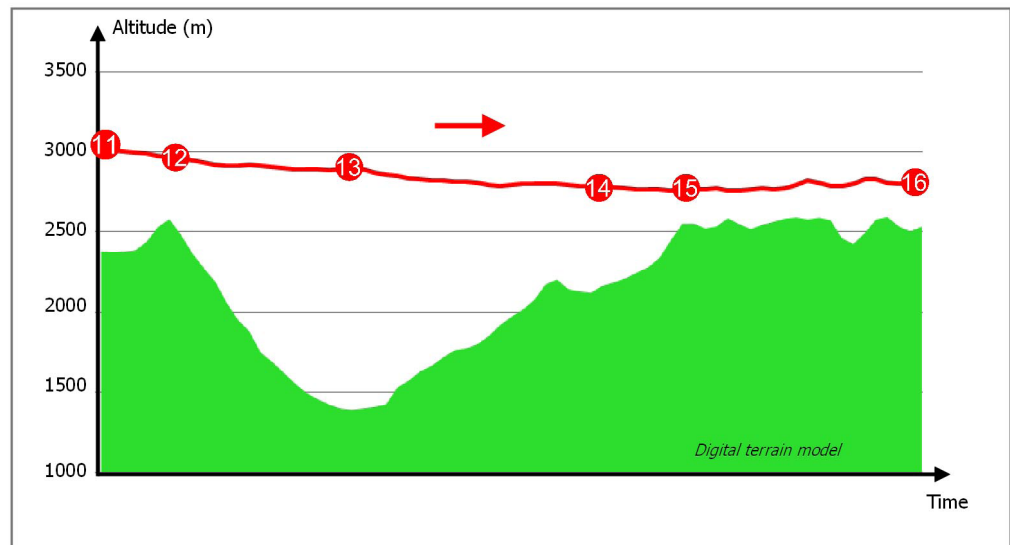
Path of G-TABB taken from LX 9000 from 16:49:30 to last recorded point

At 16:53:29, the pilot reached the Crête de Peyrolle situated near Briançon (Hautes-Alpes), he then followed its west slope at an altitude of approximately 2,770 m. Thirty seconds before the end of the recording, the glider climbed just before changing the direction of its path to the left. The glider crossed the ridge between the Grande Peyrolle peak and the Petite Peyrolle peak to reach the east slope and then turned to the right. It then flew around the Petite Peyrolle peak (altitude 2,618 m) via the south in descent and returned to the west slope of the ridge.

During the very last seconds of the recorded path, the altitude of the glider, in a right turn, was diminishing. The radius of turn decreased and the True Air Speed⁽⁷⁾ dropped from 123 km/h to 89 km/h. The last recorded point at 16:54:49 showed the glider at an altitude of 2,792 m between the Grande Peyrolle peak and the Petite Peyrolle peak. The glider was over the west slope of the ridge, with a heading of 066° facing the ridge pass (altitude 2,542) with a TAS of 89 km/h which corresponds after calculation, to an IAS of around 75 km/h⁽⁸⁾.

The bank angle of the glider during the last turn, calculated from data, varied between 20° and 40°.
