**Accident** to Robin DR401-155 CD  
registered **F-GNXT**  
on 25 August 2017  
at Vinon (Var)

<b>Time</b>	12:25 <sup>(1)</sup>
<b>Operator</b>	Manosque-Vinon flying club
<b>Type of flight</b>	General aviation
<b>Persons on board</b>	Pilot
<b>Consequences and damage</b>	Aeroplane severely damaged

**Non-stabilized approach, bounced landing,  
failure of nose landing gear**

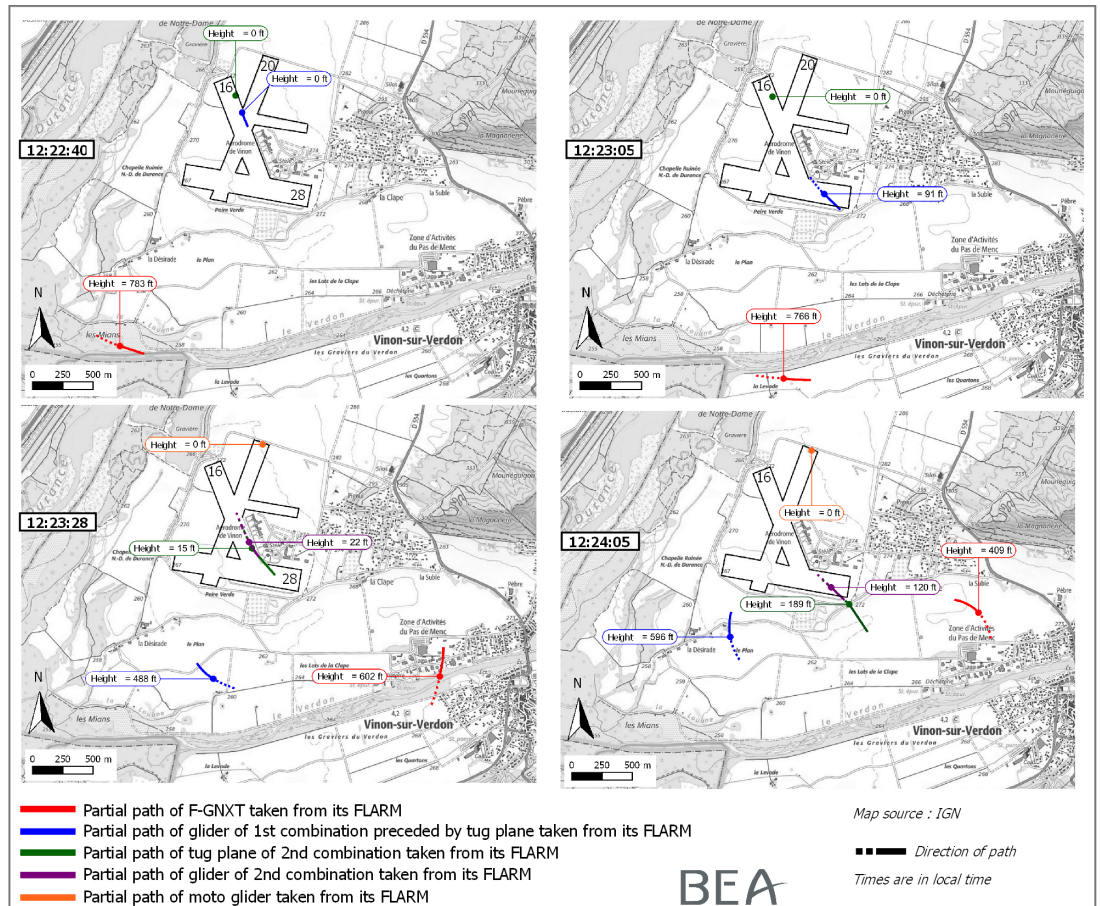
Figure 1: real time positions of aircraft

When he was at a height of around 800 ft at the beginning of the downwind leg for runway 28, a tug plane towing a glider (combination) took off from runway 16 (see Figure 1, at 12:22:40). In the middle of the downwind leg, the F-GNXT pilot saw the combination climbing in his 10 o'clock below him (see Figure 1, at 12:23:05). Believing that the aircraft were on conflicting flight paths, he immediately reminded the starter and tug pilot on the A/A frequency of his presence in the aerodrome circuit for aeroplane runway 28. He received no reply. The combination then made a right-hand climbing turn.

When the F-GNXT pilot turned into the base leg, the pilot of a second tug plane towing a glider took off from runway 16 (see Figure 1, at 12:23:28).

When F-GNXT arrived in the last turn at a height of around 400 ft, the first combination were still performing a right-hand climbing turn south of runway 28 at a height of 600 ft to head northwards to the glider release sector situated to the north-east of the aerodrome. The second combination crossed runway 28 and were at a height of 120 ft also in a right-hand climbing turn. A motor glider was aligned on runway 20 and the pilot was about to take off (see Figure 1, at 12:24:05).

On coming out of the last turn, the F-GNXT pilot saw the second combination climbing below him. He hesitated going around, momentarily interrupted the descent and then decided to continue the approach by off setting his aiming point to the right to land on the unpaved runway. As the aeroplane was high on the approach slope, the pilot corrected the slope, configured full flaps and completely reduced thrust. He was slow to flare and was surprised by the first bounce of the aeroplane.

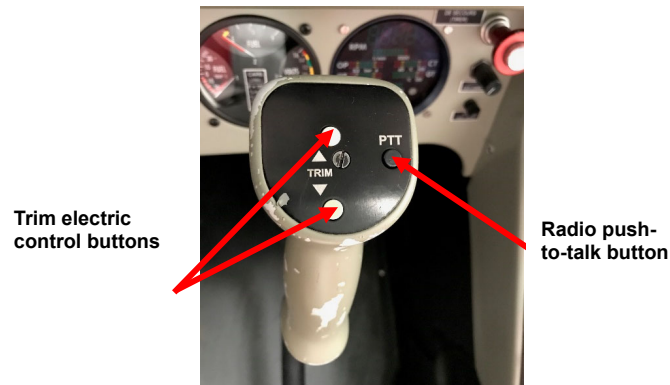
Figure 2: top of F-GNXT stick

There are three buttons on the top of the stick (see Figure 2). The first two are positioned one under the other practically on the centreline of the stick. They control the electric trim. The third button is situated on the right side, it is the radio PTT.

*Note: Several reports had been made in the club following confusion between the buttons, the trim button having been pushed instead of the PTT button.*

He declared that he had made several announcements on the A/A frequency, the first time when two minutes from being overhead the aerodrome, then in the downwind leg and finally in final. He said that he was right handed but confirmed that in a traffic pattern he holds the stick with the left hand as he keeps the right hand on the power control. He added that in the past he had already mistaken one of the trim control buttons and the PTT. He does not exclude the hypothesis of a confusion between the buttons.

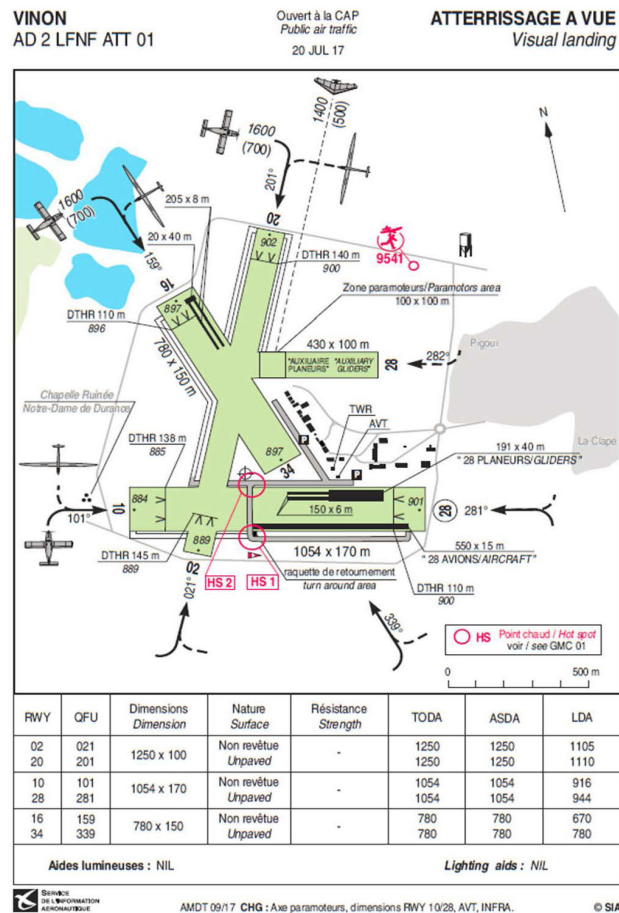
Figure 3: VAC chart in force

The aerodrome has three intersecting grass runways and auxiliary runway 28 exclusively reserved for the landing of gliders. Preference is to be given to runway 28 when the wind is less than 2 m/s.

Several non-conformities were observed during this inspection. One of these was the “potentially major” deviation<sup>(17)</sup> linked to the simultaneous use of runway 28 by aeroplanes when gliders were engaged on it. It was also observed that no aerodrome operating instructions had been put in place by the operator. Each flying club wrote its own instructions and the aerodrome operator did not have knowledge of them. The inspection focused on the simultaneous use of a runway by several aircraft and did not identify the possibility of activities coexisting on intersecting runways.

- **The operator of Vinon aerodrome, working with the users associations based at the aerodrome, define the co-activity procedures at this aerodrome and inform users using the most appropriate channels, of the associated management rules.**  
**[Recommendation FRAN-2019-005]**
- **The DSAC, working with the Aviation federation safety boards, carry out a campaign to make aerodrome operators aware of the risks linked to co-activity and in particular those concerning the use of intersecting runways, and encourage the operators to locally define the associated management measures.**  
**[Recommendation FRAN-2019-006]**
