INVESTIGATION REPORT

Accident to the AIRBUS A380-861

registered F-HPJE

on 30 September 2017

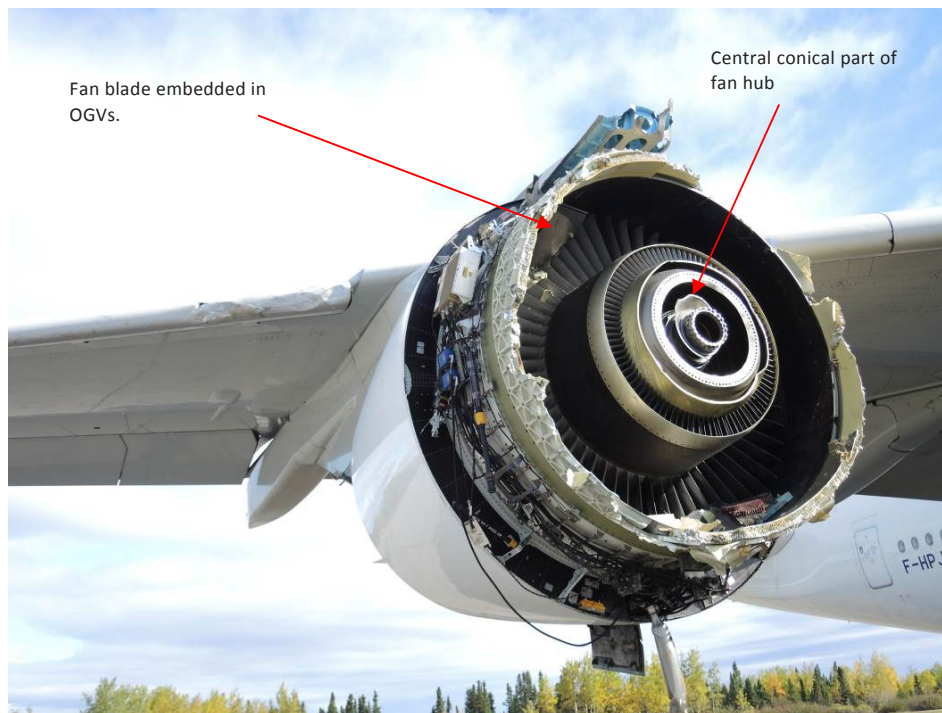
Figure 4: Damaged F-HPJE engine No 4 at Goose Bay

Engine No 4 was damaged ([Figure 4](#)): the major part of the fan hub, the majority of the fan blades, the inlet cone, the air inlet (over 2.5 m) and the right and left engine cowlings were missing. The fan case isogrid was missing with the remaining material petaled outward between 4 o'clock and 6 o'clock as well as between 8 o'clock and 12 o'clock⁽⁶⁾. The central conical part of the hub was still attached to the low-pressure turbine shaft. The hub fracture surface was matte with a granular appearance on nearly all of its circumference. The hub was blocked and could not be rotated. Various pieces of debris were found in the engine and on the runway: attachment bolts, pieces of honeycomb, pieces of fan blade and two pieces of the front cone. A fan blade was found embedded in the outlet guide vanes (OGVs). The other damage observed on the engine also seemed to be the result of the failure of the fan hub.

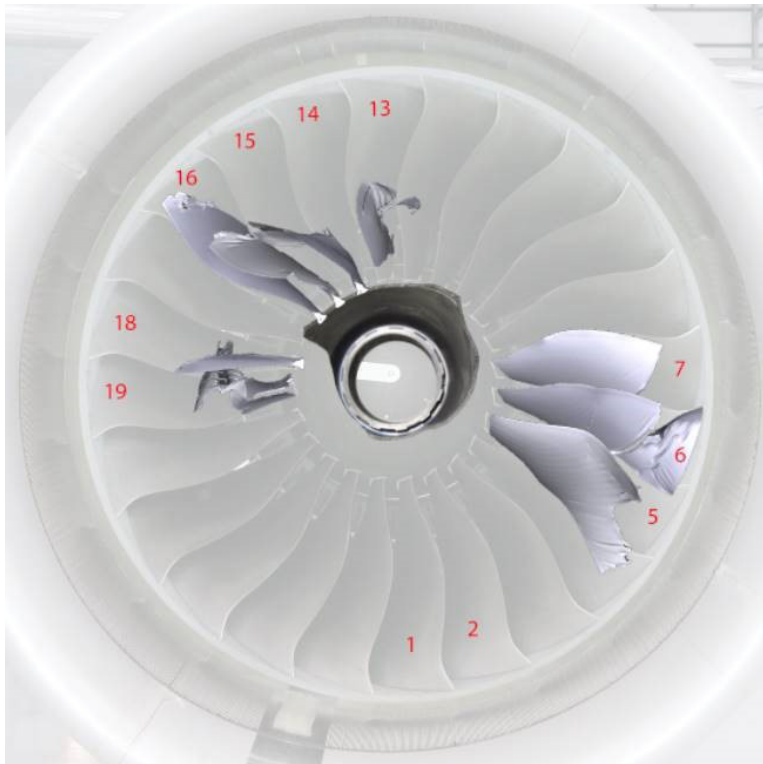
Figure 7: Illustration of fan blades found, when their position is known. Blades 5, 6, 7, 13, 14, 15, 16 and 19 were found on the Greenland ice sheet. Blade 18 was found embedded in the OGVs. The fragments found in the engine at Goose Bay no longer had any identification numbers and could not be positioned on the engine. Position 1 was chosen arbitrarily at the bottom of the engine for illustration purposes.

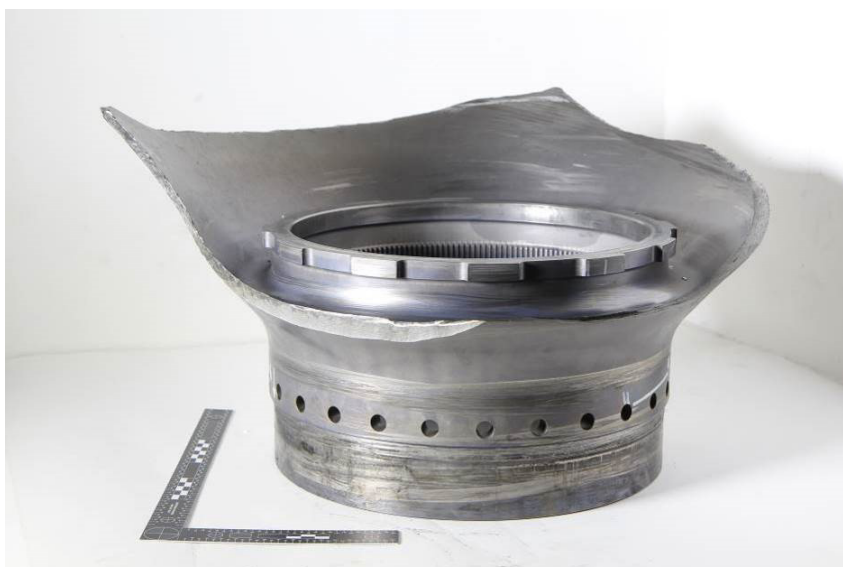
Figure 11: Hub fragment after its removal from damaged engine

The central conical part of the hub ([Figure 11](#)) was still attached to the low-pressure turbine shaft. The fracture surfaces were visually examined and by means of a Scanning Electron Microscope (SEM). They were characteristic of a sudden failure due to overload. The examination of the material's microstructure and its chemical composition did not find any anomaly. The examinations carried out on this fragment were not able to identify the cause of the hub failure.

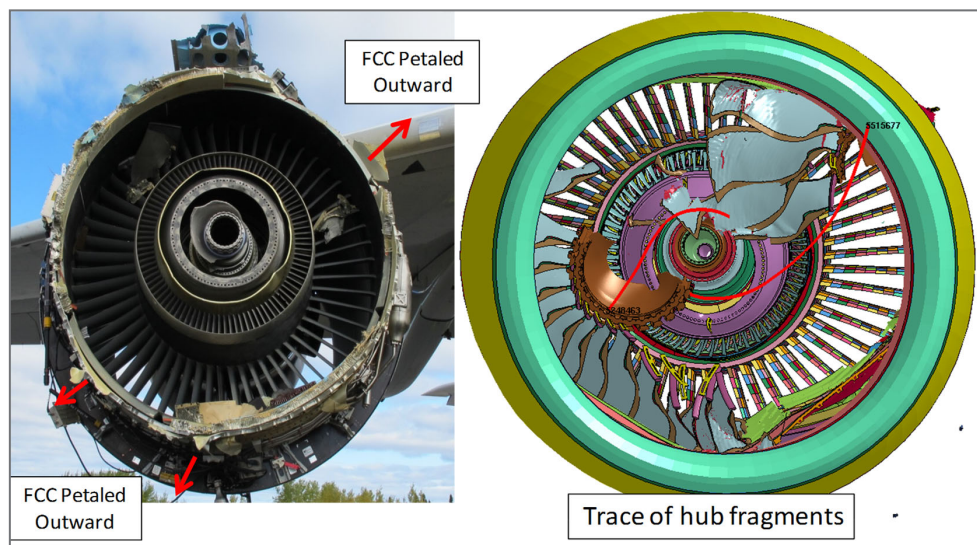
Figure 13: Simulation of fan hub “bore to rim” failure

The collateral damage and part fragmentation associated with the fan hub “*bore to rim*” fracture in the simulation were consistent with the hardware findings observed on engine No 4. In particular, the fan containment case damage, Kevlar® belt damage, low pressure compressor drum front face damage patterns, and the condition of the fan blades recovered both from the ground in Greenland and in the engine ([Figure 13](#)) supported this scenario.

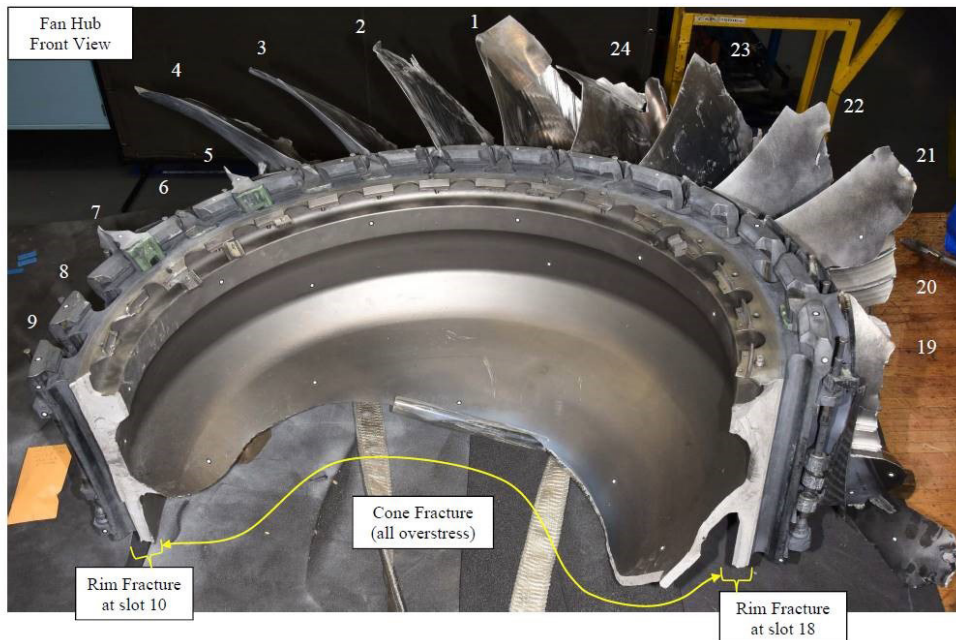
Figure 16: fan hub fragment found in Greenland during phase III. The slot numbers are given in white. The fracture surface extends from the bottom of slot No 10 to slot No 18, passing through the conical part of the hub (yellow line).

The examination determined that the hub failure was caused by a LCF⁽¹⁹⁾ cracking process which originated in the part's subsurface. The origin of the crack was located practically in the centre of slot No 10 ([Figure 17](#)), around 14 cm (5.6 inches) behind the front face of the hub and 1.4 mm (0.055 inches) below the surface of the slot bottom. No material quality (composition, microstructure) or manufacturing related anomaly was found.

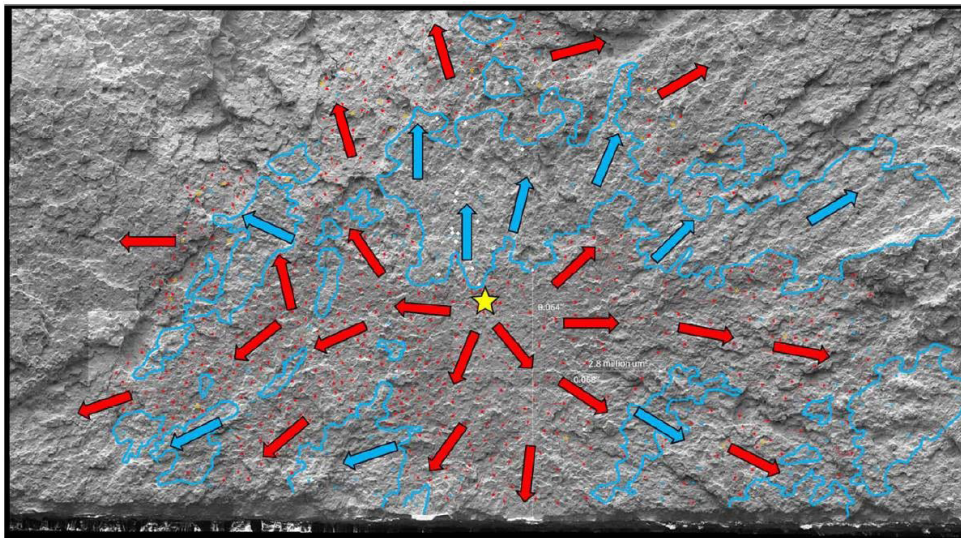
Figure 18: SEM detail view of origin of fracture. The red arrows show the crack growth direction in the faceted regions and the blue arrows the growth direction in the striated regions. Areas where the striations are predominant are outlined in blue. The orientations obtained confirm the existence of a primary origin at 1.4 mm below the surface of the slot bottom (yellow star) in a predominantly faceted region.

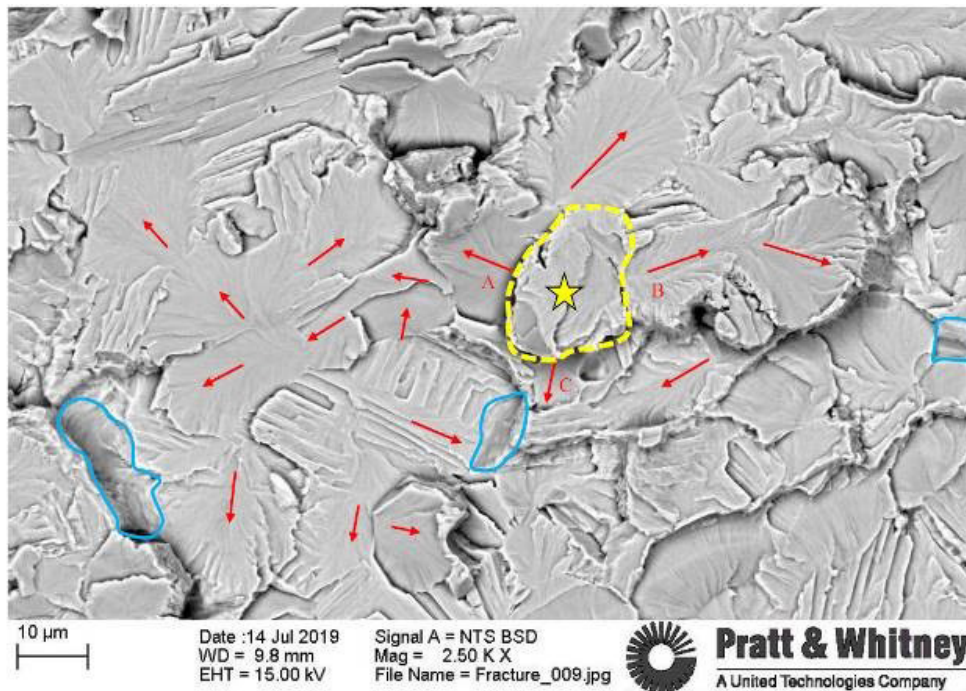
Figure 19: SEM view of origin of fracture (faceted growth region). The red arrows indicate the growth directions. The grains A, B and C exhibit a crack progression direction away from a small area covered by a flap (yellow dotted line). The grain under the flap was revealed using a Focus Ion Beam (FIB).

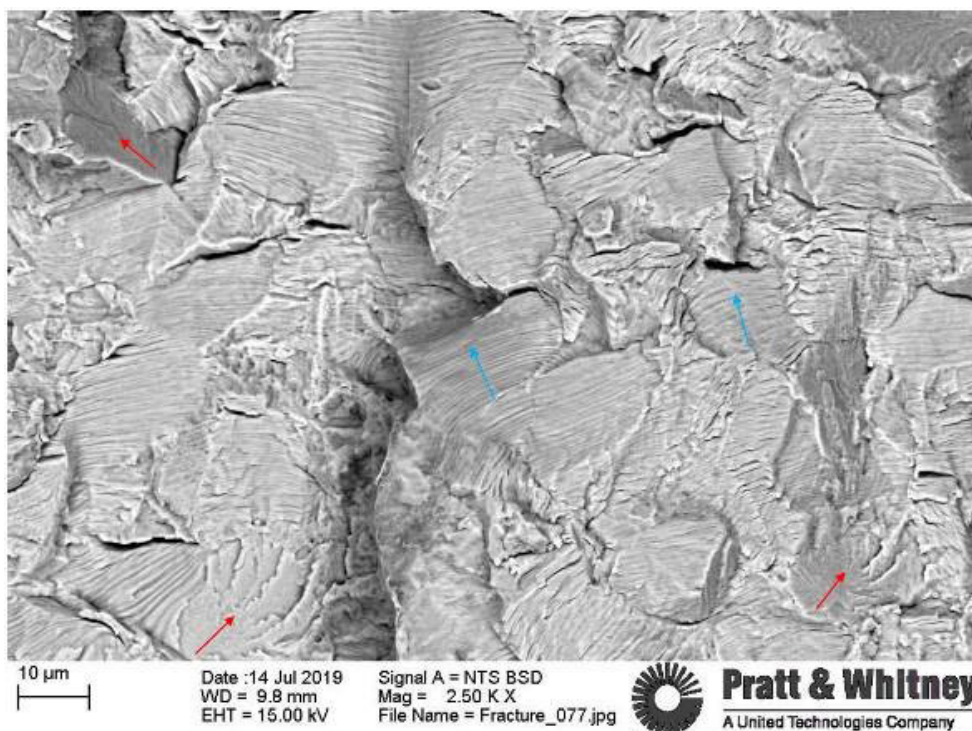
Figure 20: SEM view of a predominantly striated region. The crack progression direction in the striated regions is shown by the blue arrows. Near-cleavage facets were also present (red arrows).
