Accident to Tusker wing - Funflyer tandem trike powered paraglider identified 52GJ

on 28 January 2018

at Dompierre-sur-Charente (Charente-Maritime)

Collision with surface of water

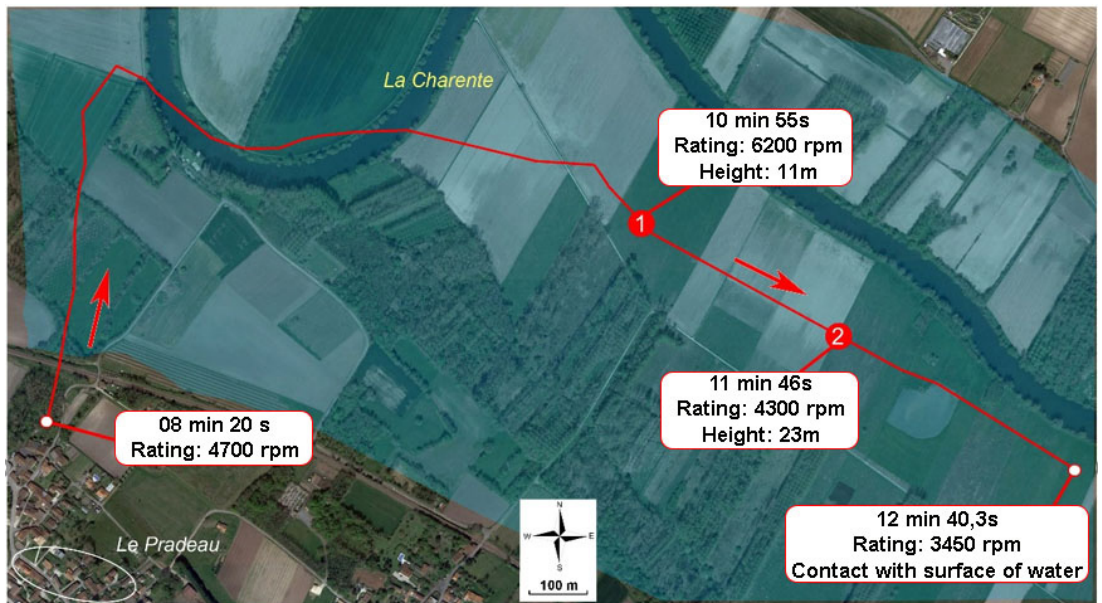
Figure 1: path of powered paraglider

The pilot took off from a field situated south of Lieu-dit Le Pradeau in Charente-Maritime. He carried out several manoeuvres at low height and then flew towards the river Charente. He flew over the fields flooded by the Charente for about four minutes. Two minutes before the end of the flight, the pilot descended, a first time, to a height of around 6 m above the water and then climbed to a height of 23 m (point 2 of Figure 1). The pilot then continually descended for around one minute before coming into contact with the surface of the water.

- Estimated end of 52-GJ's path based on analysis of video recording
- : Zone flooded by the river Charente
- ① : Maximum engine rating reached during flight over the water surface
- ② : Maximum height measured during flight over the water surface

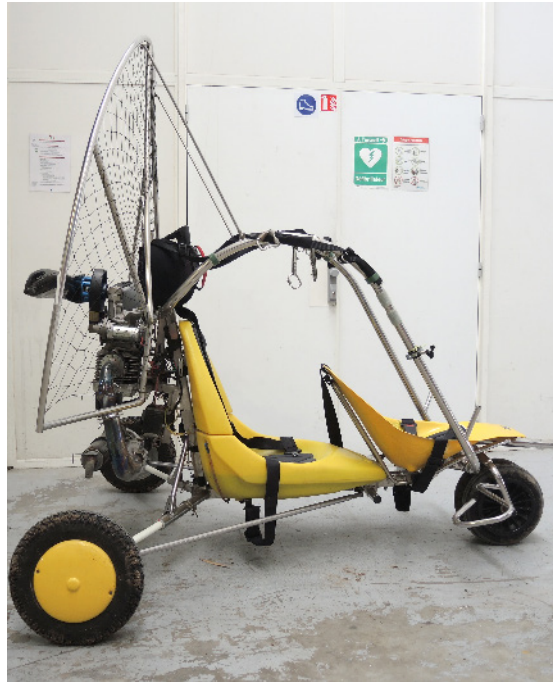
Figure 2: trike assembly, right side

The trike was not damaged. The examination did not reveal any singularity which could be linked to the occurrence of the accident.

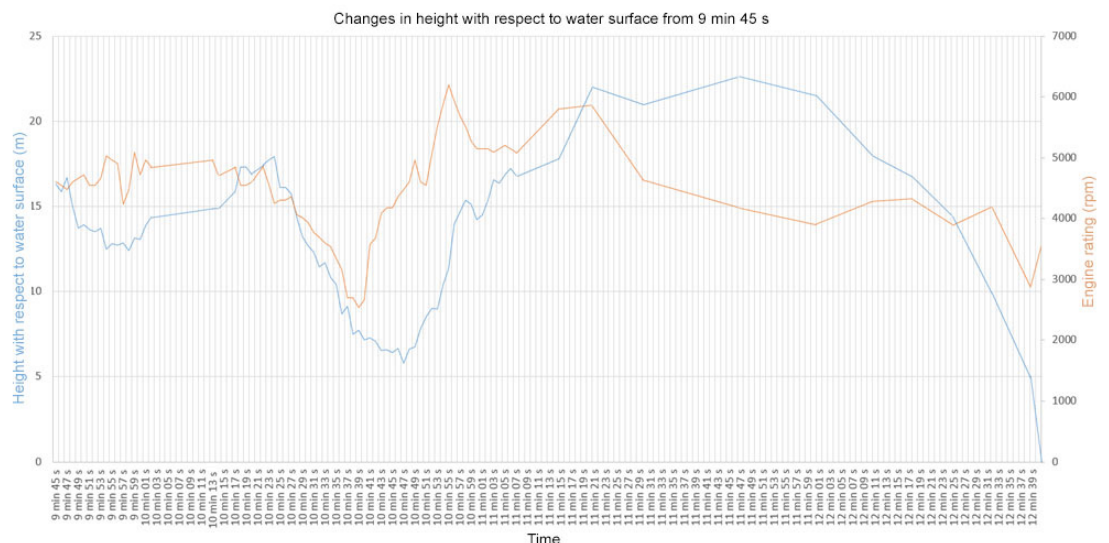
Figure 4: height with respect to water surface and changes in engine speed

This analysis was able to establish that around 1 min 15 s before contact with the surface of the water, the engine speed progressively decreased to values in the region of 4,000 rpm⁽²⁾. Around four seconds before contact with the surface of the water, the engine speed dropped to around 3,000 rpm before increasing again. This reduction was concomitant with the pilot adjusting the angle of the camera. At this point, the aircraft was at a height of less than five metres above the surface of the water.

The height of the powered paraglider with respect to the water surface was estimated using the videos from the drone and onboard cameras. The changes in the powered paraglider's height and engine speed are shown in Figure 4. The regulations impose a minimum flight height of 500 ft (150 m) above the ground for VFR flights outside of congested areas or over an open-air assembly of persons.
