Accident to the Dyn'aero MCR01 ULC identified 21ABU

on 24 February 2018
at Trignac (Loire-Atlantique)

Asymmetric flap extension on final, loss of control and collision with ground

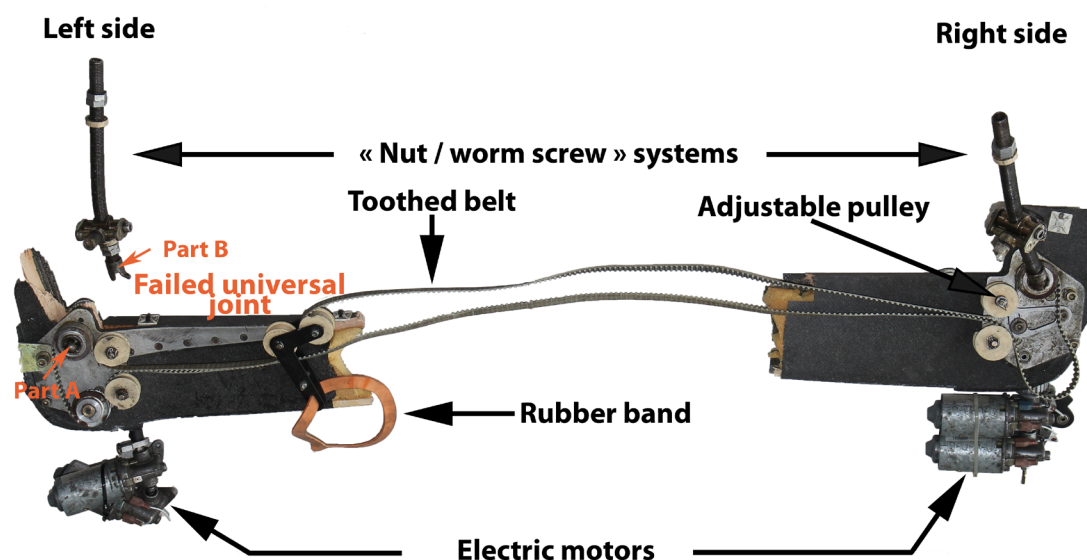
Figure 1: flap control system taken for examination at the BEA Materials and Failure Analysis Laboratory

Both worm screws were found to be bent. The position of the nuts on these screws indicates that the right and left flaps were in an asymmetrical position when the aircraft hit the ground. The right flap was in the 1/3 down position while the left flap was in the retracted position.

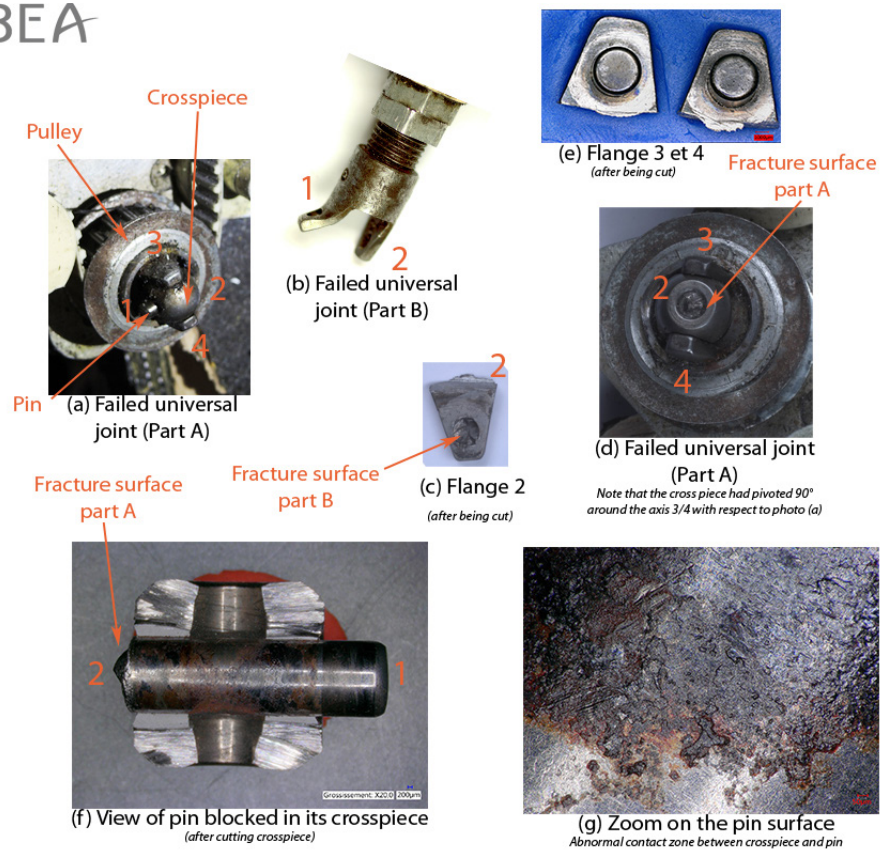
On the left side of the aircraft, the examinations of the universal joint pin showed that it probably failed due to fatigue as a result of the alternating torsional stresses caused by the jamming of the pin in its crosspiece⁽⁶⁾. This jamming was due to abnormal friction (lubrication problem, pollution, etc.) between these two parts and the inability of the system to evacuate the wear debris generated (see Figure 2). A longitudinal metallographic section showed that the fatigue failure occurred in a heat-affected zone (HAZ). This is because the pin is welded into its flange.

The intergranular profile of some of the cracks observed on the right-hand side and of certain areas of the fracture face observed on the left-hand side may be indicative of the presence of cracks as early as the manufacture of the universal joints, which were generated during the welding process.

Figure 2: examination of the left-side universal joint

Following this accident, SE Aviation issued an update to the maintenance manual accompanied by a service bulletin requesting that the universal joints on the flap control systems on all relevant MCRs be checked every 50 hours. The DGAC issued a newsletter relating to this accident to notify owners of the changes made by SE Aviation⁽¹¹⁾.

SE Aviation also proposes that the flap control system be replaced with a more robust system.

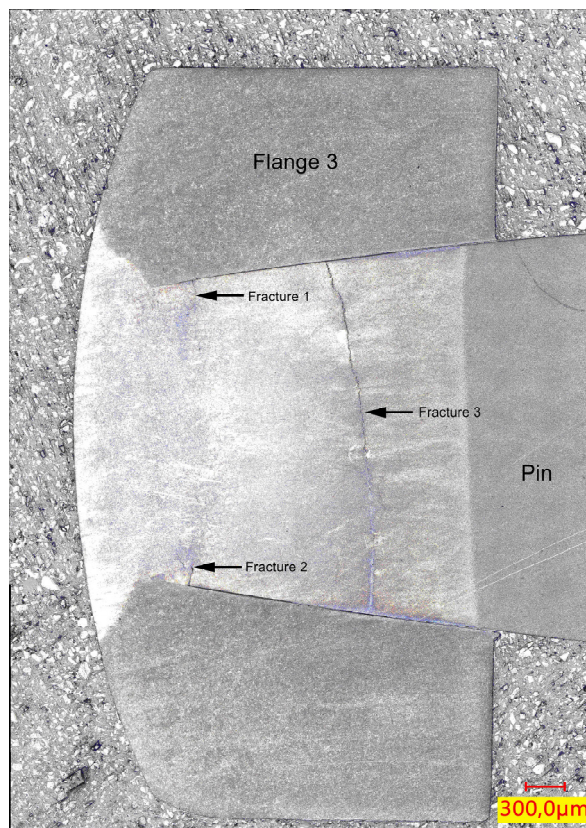
On the right side of the aircraft, the cross type universal joint pin showed slight wear, but could still rotate freely within its crosspiece. A longitudinal metallographic section (see Figure 3) of the pin revealed the presence of cracks in the zone affected thermally (HAZ) by the weld.

Figure 3: longitudinal metallographic section of the right-side pin after 4 % Nital etching
Note the presence of cracks in the HAZ
