Accident to the amateur-built microlight gyroplane identified 85ALT

on 6 April 2018
at Flavacourt (Oise)

Loss of control during take-off, collision with the ground, during a flight after modification of the aircraft

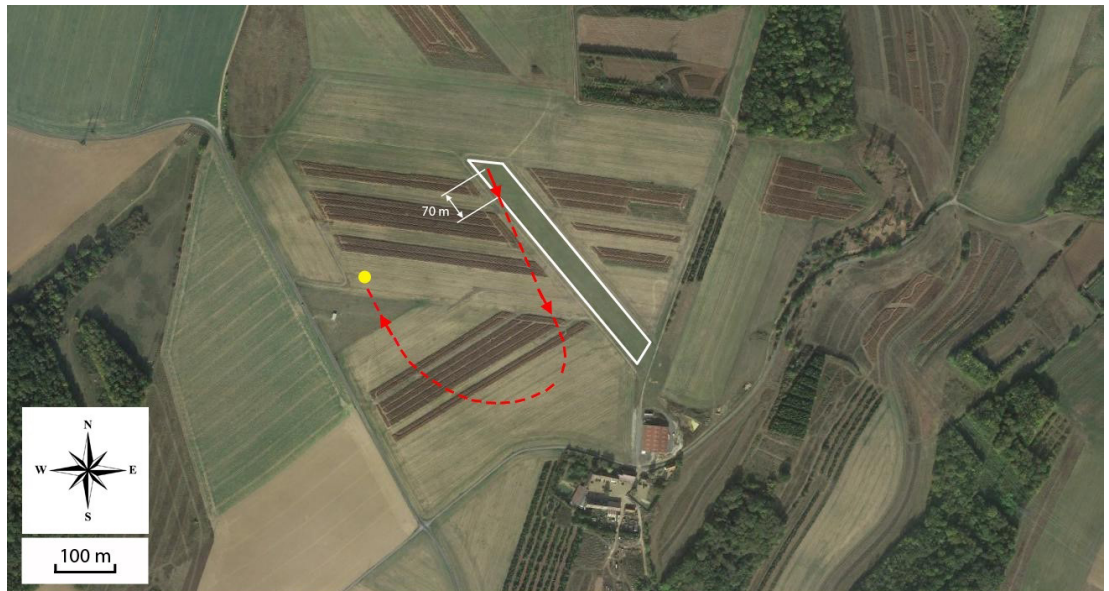
Figure 1: position of the wreckage

The pilot took off from runway 14⁽²⁾ of Flavacourt microlight platform for a check flight following installation of a full cockpit canopy and a modification to the tail assembly carried out by himself. As soon as the wheels left the ground, the gyroplane yawed to the right and then gained height. It turned and progressively banked to the right as it climbed. The gyroplane then suddenly rolled to the left and onto its back, fell and hit the ground approximately 300 m to the right of the threshold of runway 14.

The pieces of the wreckage were grouped together in a field suitable for a forced landing. The microlight hit the ground with a nose-down attitude and on its right side.

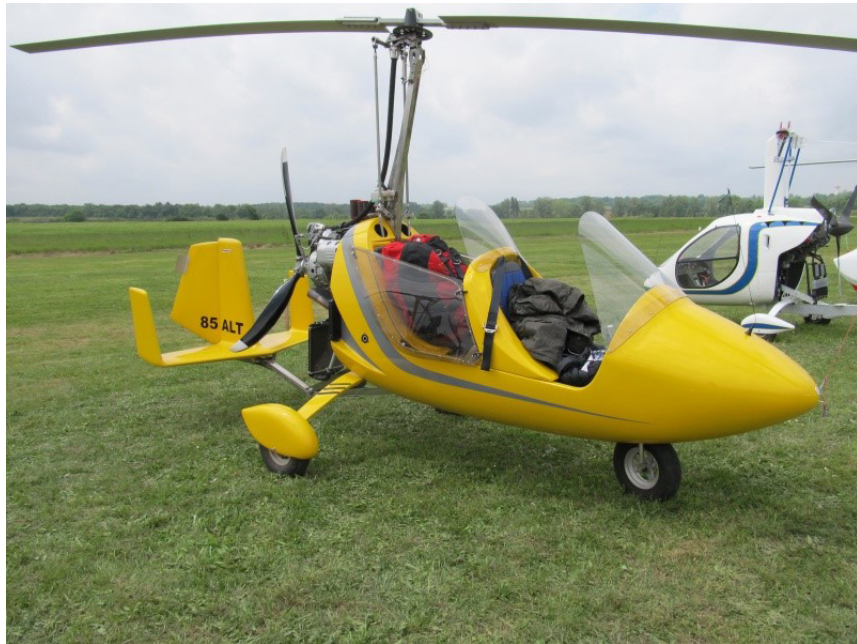
Figure 2: photo of the gyroplane before installing the cockpit canopy and modifying the tail assembly

The builder of the 85ALT sold the gyroplane to the pilot involved in the accident in July 2016. He stated that the microlight had logged around 100 flight hours at that time. He said that the gyroplane's behaviour was standard, although its yaw control required significant rudder inputs. He added that he had shifted the rotor attachment laterally to take into account the direction of rotation of the BMW power plant, which is the opposite to the Rotax 912 and 914 engines that usually equip gyroplanes. In addition, this BMW engine is about 20 kilograms heavier than the Rotax 912 engine.

Exchanges between the pilot involved in the accident and gyroplane builders/pilots revealed that the pilot had encountered landing and take-off difficulties on his first flights. He had noticed that, during take-off, the gyroplane adopted a significant nose-up attitude and "*veered heavily*" to the right. The pilot had to adopt a hard nose-down input during take-off. He had measured an aft centre of gravity that was significantly outside the centre of gravity envelope of gyroplanes. He had made numerous modifications to the gyroplane. The main modifications were:

- Modification to the rotor's longitudinal position to improve the centre of gravity.
- Modification to the rotor's lateral position to improve the behaviour of the gyroplane when there were engine power fluctuations.
- Addition to the tail assembly of two movable vertical fins linked to the rudder. Before the accident flight, the pilot had blocked these two fins.
- Installation of a cockpit canopy comprising aluminium posts, plexiglass and a metal roof.

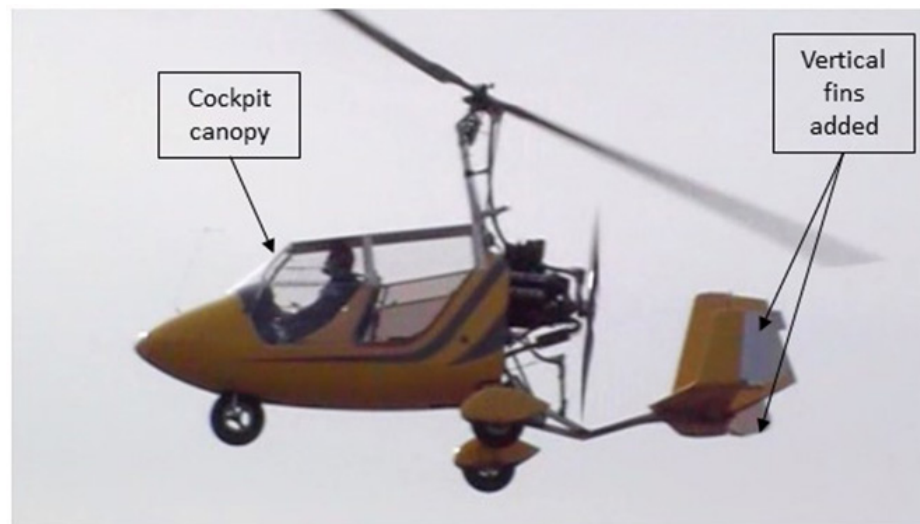
Figure 3: image taken from the accident video

- ❑ The engine was producing power continuously until the loss of control.
- ❑ The rotation started after a take-off run of about 50 m. The nose-up attitude was very sudden.
- ❑ As soon as the wheels lifted off the ground, the microlight yawed to the right despite the deflection of the left rudder pedal.
- ❑ Once in flight, the microlight exited the lateral boundaries of the runway after travelling approximately 70 m from the beginning of the take-off run.
- ❑ During its climb, the microlight continued to make a banked turn right with the rudder still deflected to the left.
- ❑ After a turn of approximately 180°, the rudder returned to a near-neutral position and the microlight rolled left onto its back.

The last major modification made to the microlight was the addition of a cockpit canopy, which was probably motivated by the plan to take paying passengers on maiden sightseeing flights. The cockpit canopy caused a deterioration in the yaw behaviour of the microlight, which was already difficult to fly. In this configuration, the rudder probably no longer had the control to counteract engine effects during take-off, even with full rudder deflection.

During take-off, the pilot did not reduce power and the microlight climbed while continuing to veer right even though the pilot had applied left rudder. Under these conditions, the pilot lost control of his aircraft.

This occurrence illustrates the importance of the pilot familiarizing himself with an aircraft after significant modifications have been made, whether they are considered major or not. Amateur constructions can display specific features and it is essential during the initial flight to establish a programme explaining the purpose of the flight, its limits and to anticipate possible technical difficulties (engine failure, failure of a control surface, etc.). It may be useful to proceed in stages, first by carrying out a low-speed and then a high speed run. If the behaviour of the aircraft is satisfactory and if the runway allows it, it may also be advisable to land immediately after the wheels have left the ground in order to assess the effectiveness of the control surfaces. Then a full take-off is possible.
