Accident to the YAKOVLEV - YAK18-A registered F-AZYK

on 8 April 2018

at Lens Bénifontaine (Pas-de-Calais)

Barrel roll at low height on the fringe of an air rally, collision with the ground, close to the public

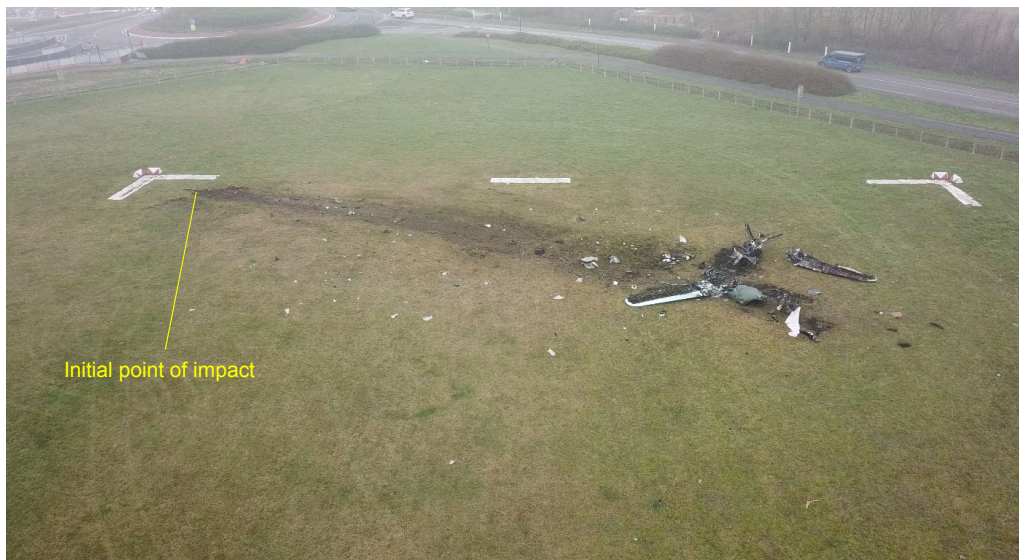
Figure 1: aerial view of the accident site - photo by GTA SR drone

The examination of the site and the wreckage found that the aircraft had collided with the ground in a nose-down attitude and with significant energy. At the moment of impact, the aircraft was intact and the engine was producing power.

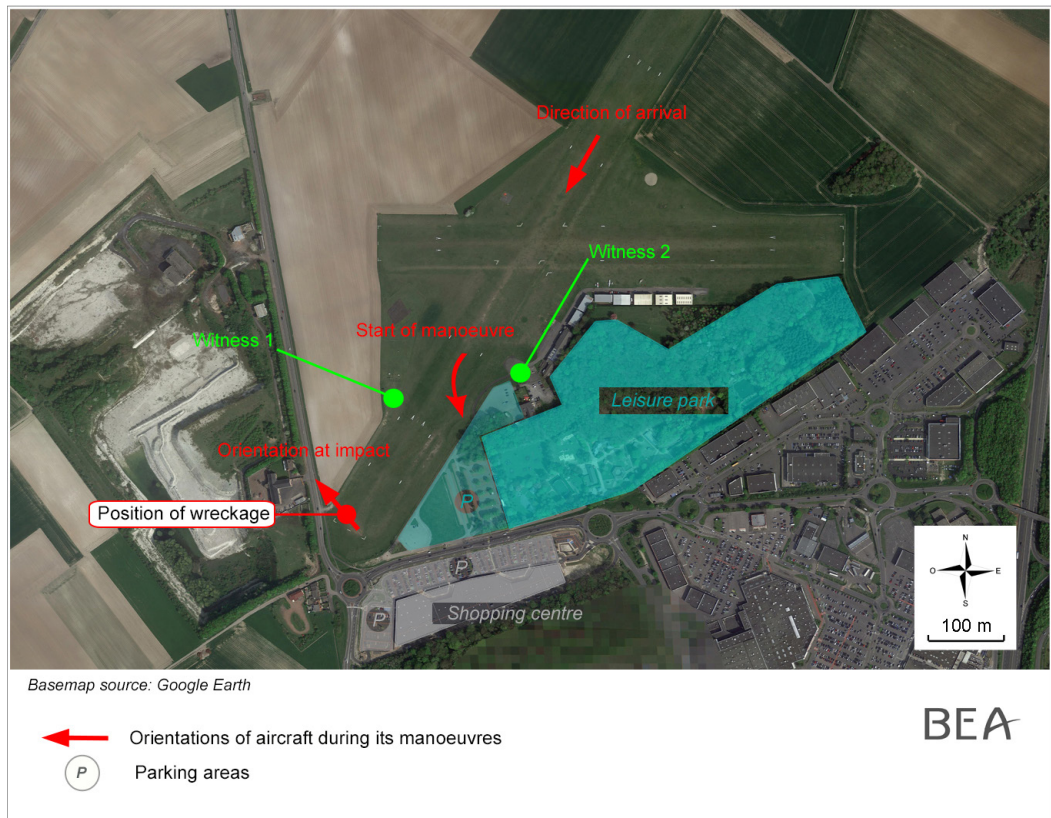
- the Yak18 was travelling at a speed of more than 110 kt before starting its manoeuvres;
- after a low pass, the Yak18 started a half-roll to the left, probably controlled, followed by a half-loop;
- the aircraft's final path was over or nearly over the parking areas of the leisure park and shopping centre south of the threshold of runway 03.

Figure 2: overview of the aerodrome and the aircraft's manoeuvres
