Accident to the Aquila AT01 registered **D-ERLM** on 08 May 2018 at Marnaves (Tarn)

Collision with trees in adverse meteorological conditions, fire

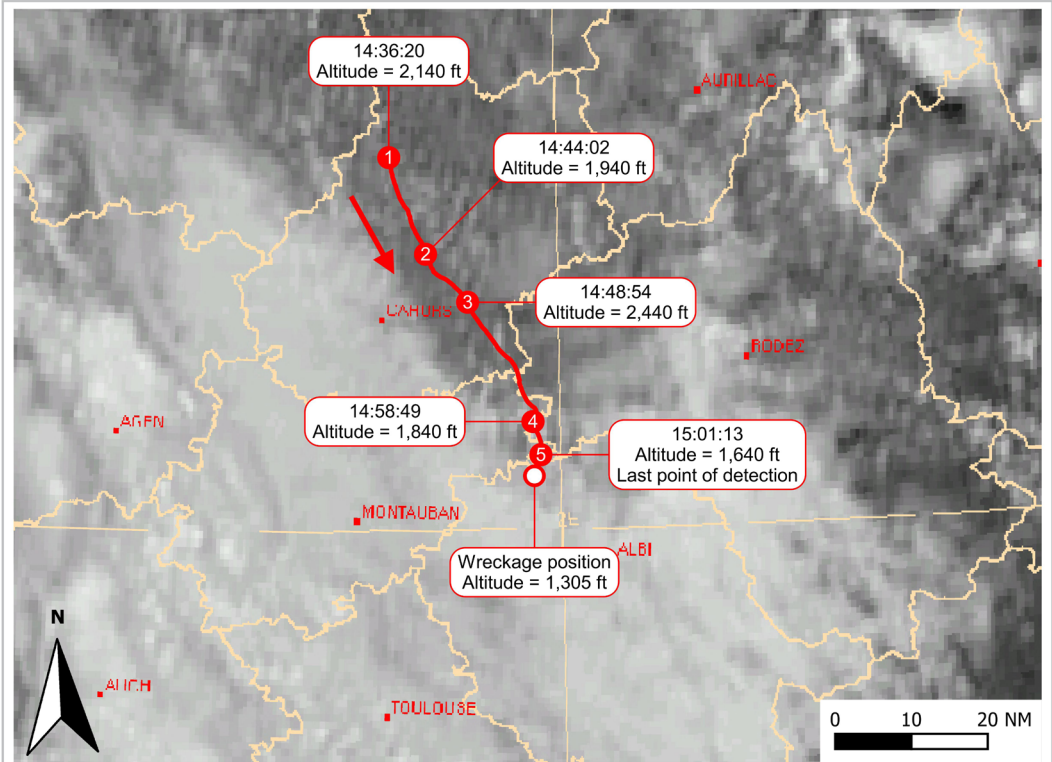
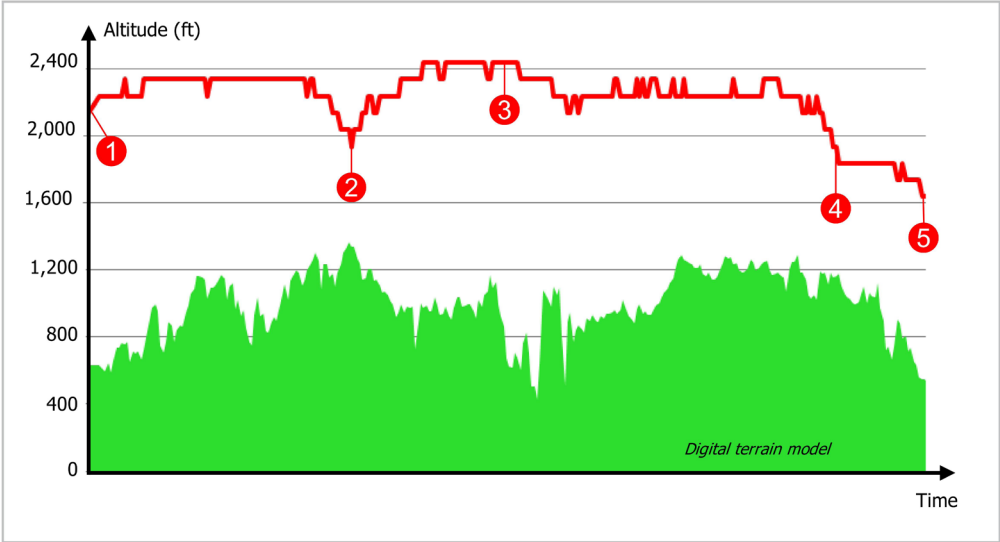
Path of D-ERLM based on data from Auch secondary radar, from 14:36:20 to last point of detection

After a flight time of 2 h 45 min and close to his destination, the pilot was confronted with low ceilings and poor visibility. He descended, probably to fly under the cloud layer in an area where there is high ground. The aeroplane then collided with the terrain.
