Accident to the PILATUS - PC6 - B2H4 registered F-GOCC

on 27 July 2018

at Bouloc (Tarn-et-Garonne)

In-flight collision between a parachutist (wingsuiter) and the drop aeroplane, during descent

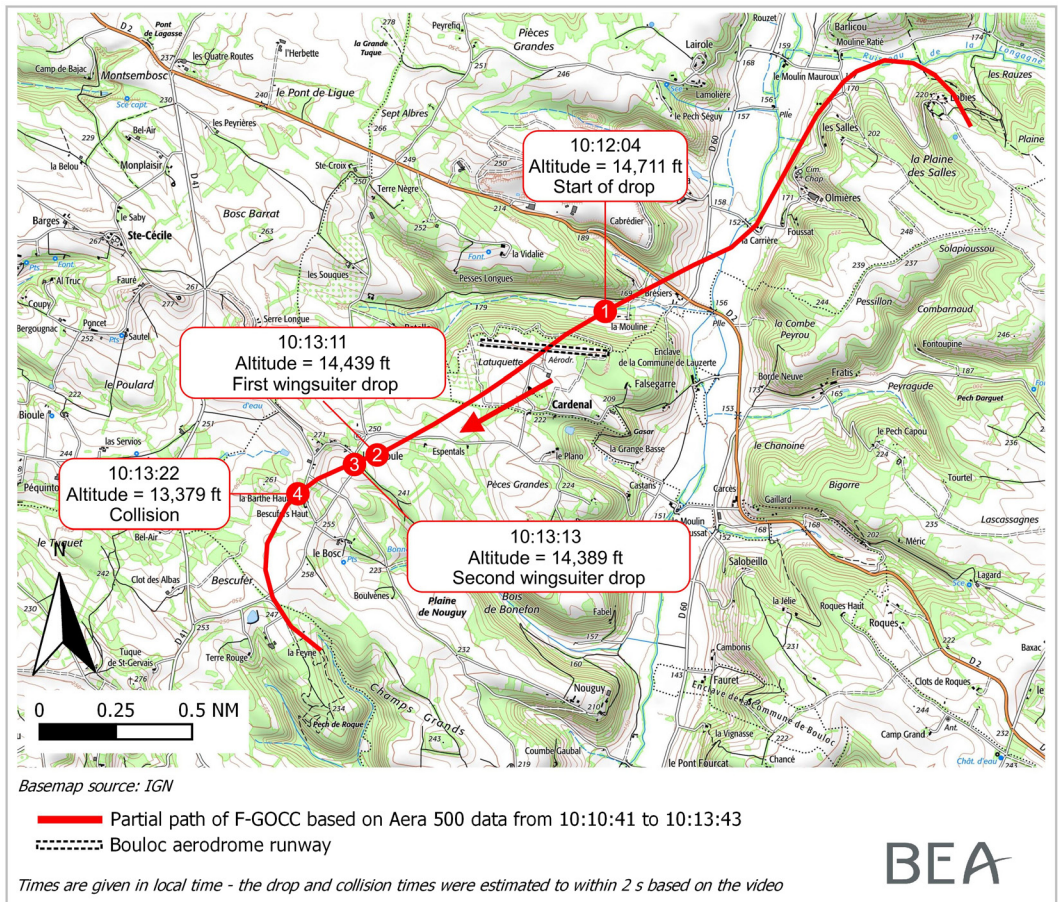
Figure 1: path

An analysis of the data on the GNSS receiver and WS2’s camera confirmed that eleven seconds elapsed between WS1 exiting the aircraft and the collision. WS1 was dropped at about 14,400 ft and the collision occurred at about 13,400 ft. The gradient of the Pilatus’s path increased significantly after dropping WS2 (two seconds after WS1). The path of the Pilatus was a straight-line descent between the last drop point and the collision with the wingsuiter. Its attitude was estimated to be about 50° for the first few seconds of the descent⁽⁶⁾ and its average vertical speed was in excess of 5,800 ft/min between ② and ④ and 6,700 ft/min between ③ and ④. The pilot initiated a left turn after the collision, while still descending.

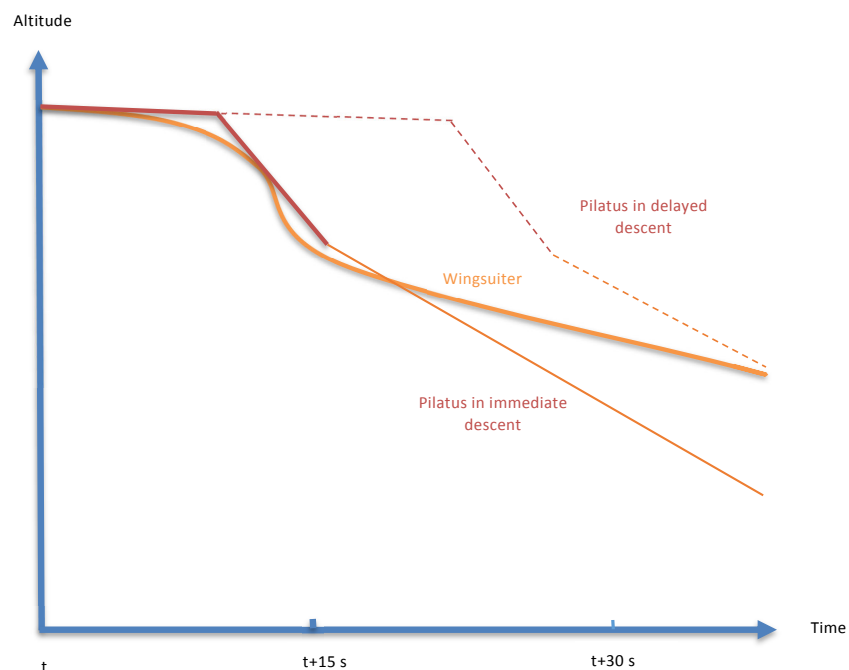
Figure 3: usual theoretical vertical descent profile for a Pilatus and a wingsuiter

The parachute drop is often made with the aircraft on a slight descent and with a negative attitude in order to increase the distance between the horizontal stabiliser and the parachutists. A Pilatus PC6's descent until the approach to the aerodrome is then usually performed at a high vertical speed (V_z) of between 3,500 and 5,500 ft/min. The V_z is the result of the parameter that determines the descent, namely the indicated airspeed. This equates to a slope in respect of the ground of approximately 20 to 30°.

By way of comparison, the slope of a wingsuiter in respect of the ground ranges from approximately 10° when he exits the aircraft, 35° after 15 seconds of descent and 20° in stabilized flight.

When the wingsuiter was in his acceleration phase, he had no possibility of detecting and, therefore, avoiding the Pilatus, which was arriving from behind and above him.

The BEA was informed by some club officials that a descent delayed by a few seconds after dropping the wingsuiter allows for vertical paths to be separated if no lateral separation from the parachutists is specified.

The Midi-Pyrénées parachuting school informed the BEA that it had amended its documentation and was applying these instructions and that it was asking its pilots to adjust their power to maintain level flight for 10 to 20 seconds after the wingsuiter drop to ensure sufficient longitudinal and vertical spacing.
