Accident to the Autogyro MTO Sport 8.4 Turbo identified 34AKC⁽¹⁾

on 3 August 2018
at Lansargues (Hérault)

Loss of control in flight, collision with ground, fire

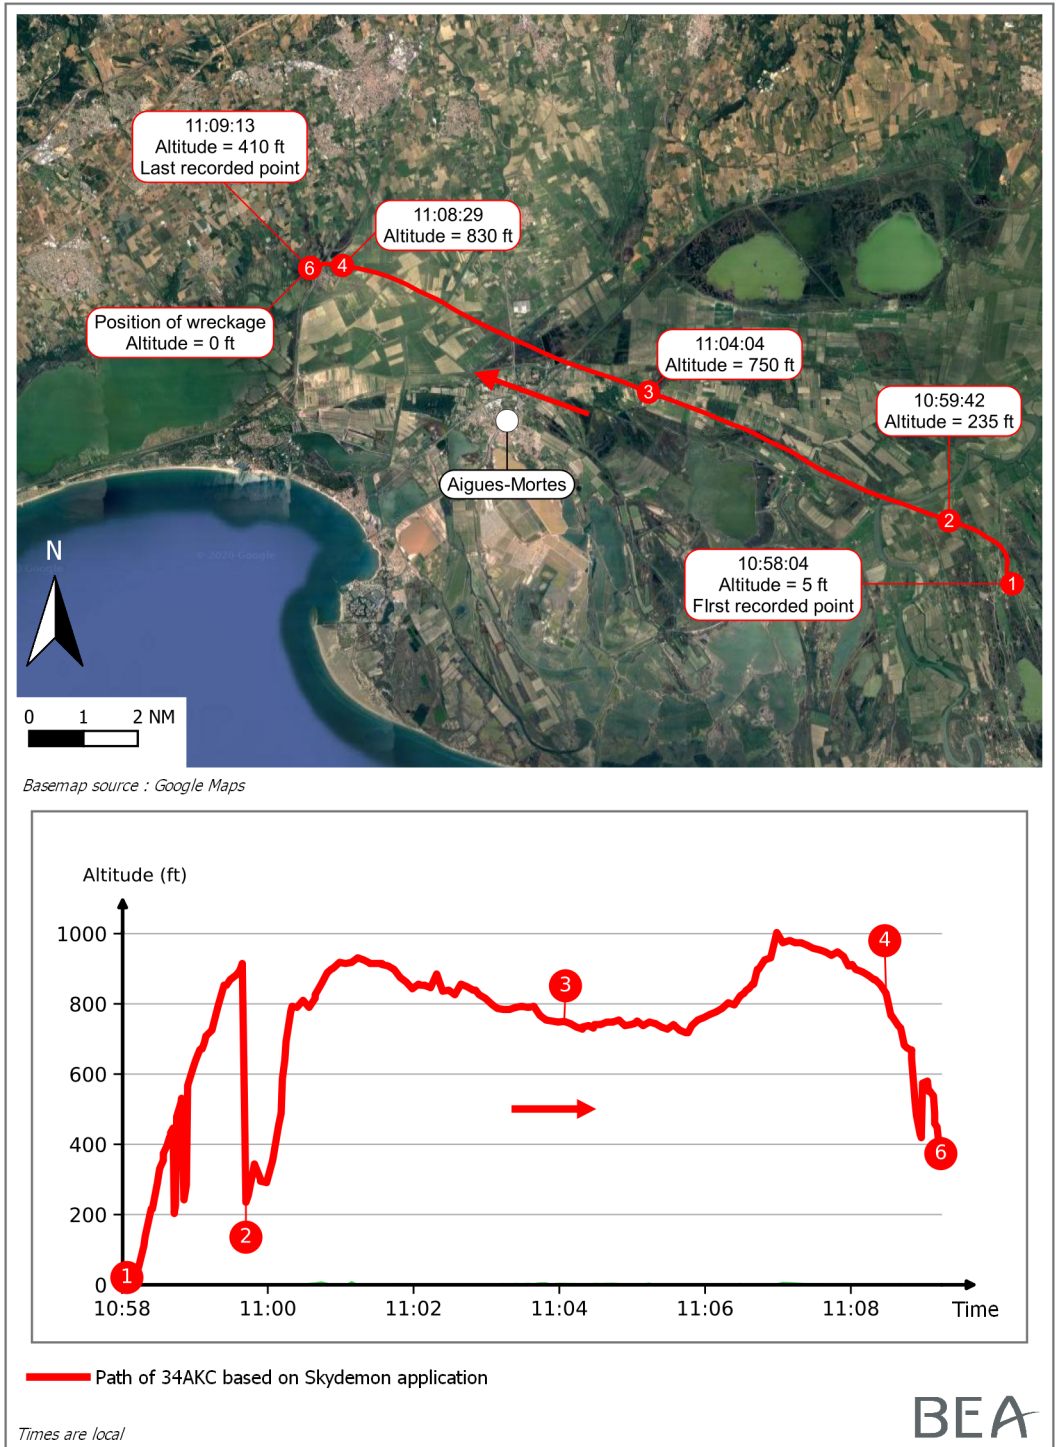
Figure 1: path based on GPS data

The pilot took off at around 11:00 (point ❶ of figure 1) from a private runway situated in the Saintes-Maries-de-la-Mer commune (Bouches-du-Rhône), bound for Montpellier-Candillargues airport (Hérault).

Around two minutes after the take-off, the gyroplane was at an altitude of 900 ft, it then rapidly descended to 200 ft ❷ before climbing again to 800 ft. For the next seven minutes, it flew at an altitude of between 700 ft and 970 ft towards its destination ❸.

After a flight time of ten minutes, at an altitude of 900 ft, the gyroplane started a shallow descent. The descent then became steeper ❹ and at 450 ft, on approaching a marshy area and a herd of animals, the gyroplane made a steep left climbing turn ❺.

The gyroplane collided with the ground and caught fire ❻.

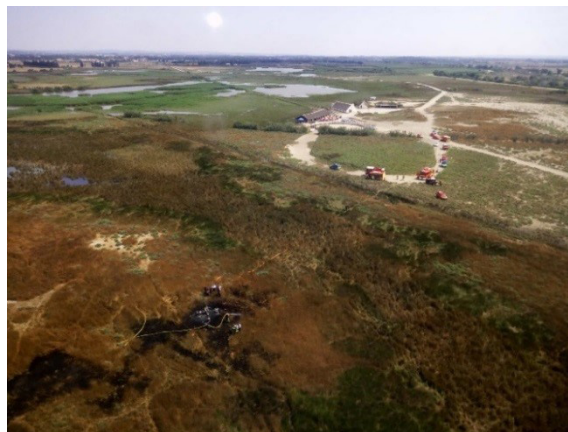
Figure 3: photograph of site and wreckage

It was concentrated in one area and had been destroyed by a fire resulting from the collision with the ground (see figure 3).

- ❑ The limited examination of the engine did not find any mechanical assembly failures.
- ❑ The fuel system, including the carburetors, was partially destroyed; its continuity and its functionality could not be confirmed.
- ❑ The damage to the propeller blades indicated that the engine was operating at the time of the impact without it being possible to determine the power output.
- ❑ The detailed examination of the flight controls did not find a failure prior to those caused by the collision with the ground; the yaw control and the pitch/roll control linkage were continuous before the impact.
- ❑ The sudden failure of the right main landing gear and the nose gear along with the damage to the main rotor blades indicated that the aircraft had a high bank angle to the right on its initial contact with the ground.
- ❑ The failures identified on the aircraft were all caused by the impact.

The examinations carried out did not find a malfunction likely to have contributed to the accident. However, the damage caused by the fire did not permit an exhaustive examination of the gyroplane and its engine.
