## Accident to the Robin DR400 – 120 registered F- GCRY

on 16 September 2018  
at Saint-Secondin (Vienne)

## Loss of radar contact while cruising, collision with the ground

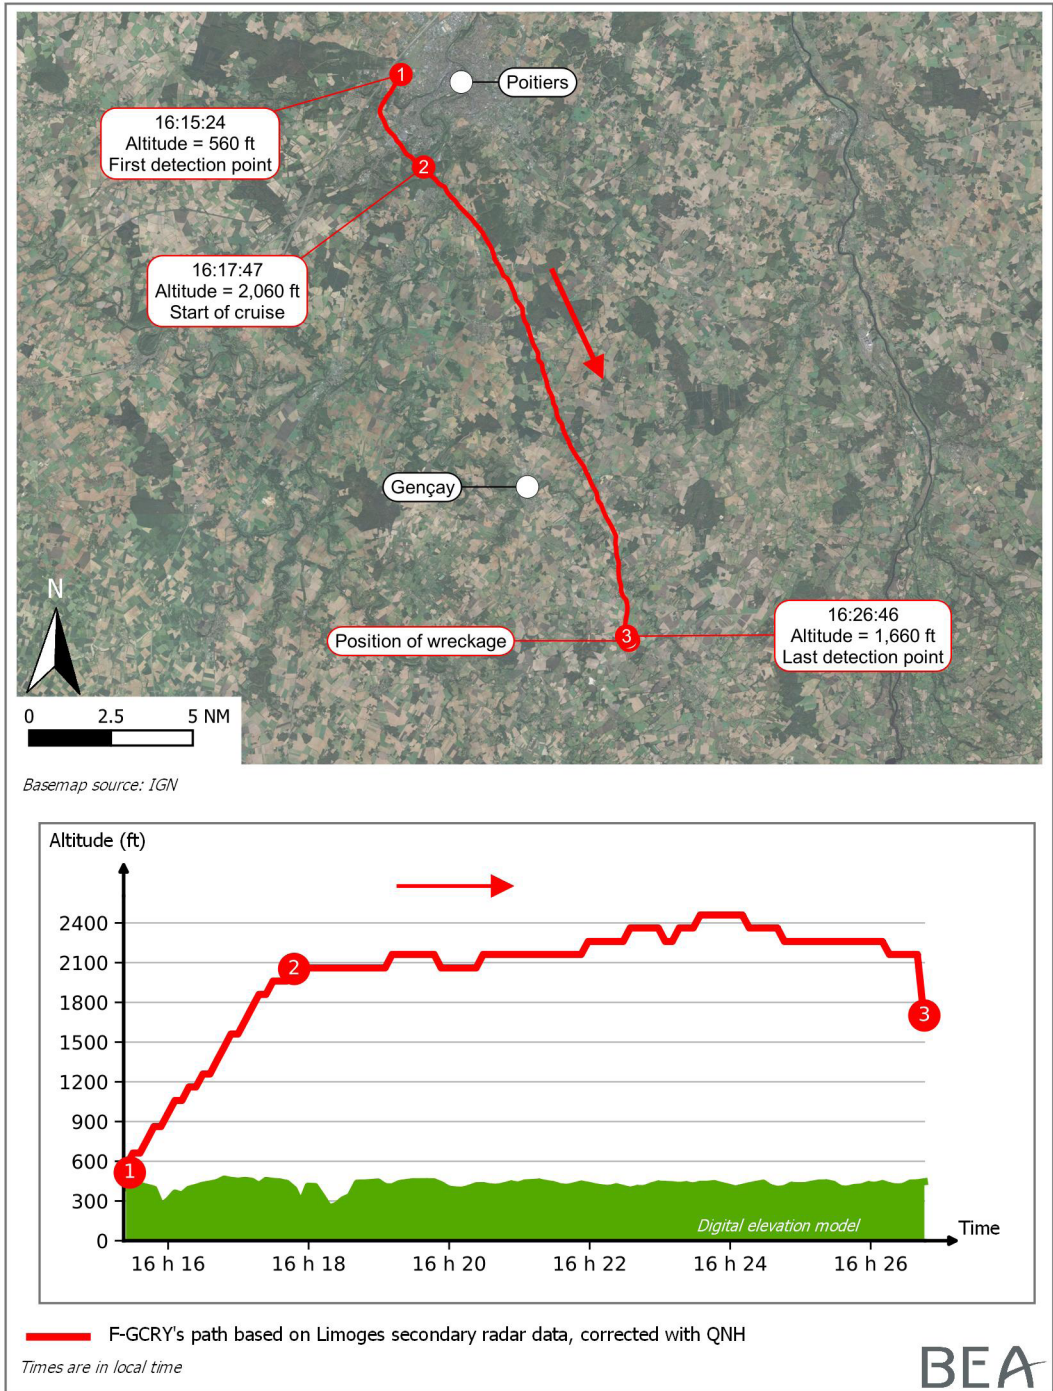
F-GCRY radar track  
(The average ground speed in cruise between points 2 and 3 was 107 kt)
