Accident

to the Airbus A330-200 registered **F-GZCI**
operated by Air France
and to the Airbus A330-300 registered **N817NW**
operated by Delta Air Lines
on 31 October 2018
at Paris-Charles de Gaulle airport

Collision between an aeroplane taxiing on a taxiway and an aeroplane at standstill, second in line at the holding point

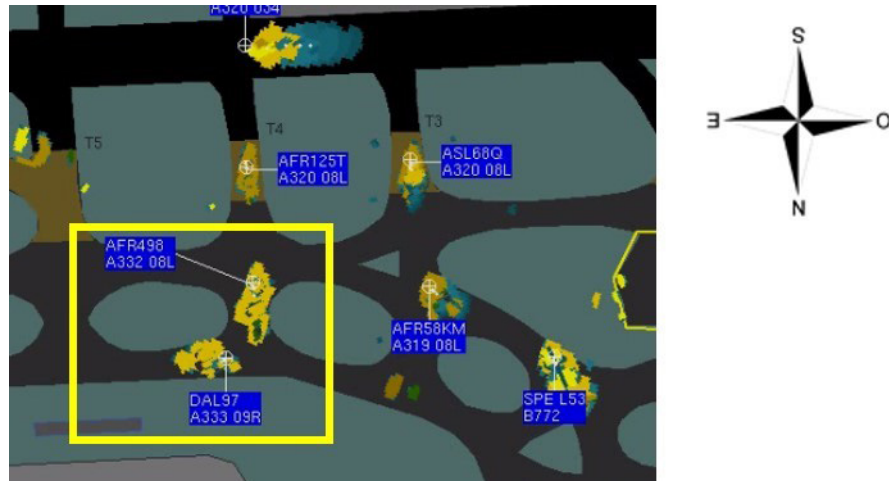
Figure 4: excerpt with annotations of the AVISO system display at 09:44:12

At 09:44:08, the captain of flight DAL97 stopped behind flight AFR498 (see Figure 4), and then resumed taxiing at a very low speed. The relief pilot called attention to the small separation margin. The captain, judging that the margin was sufficient to pass, decided to continue taxiing.

At 09:44:24, the captain of flight DAL97 told the other members of the flight crew that he estimated the distance between the two aeroplanes as ten feet.

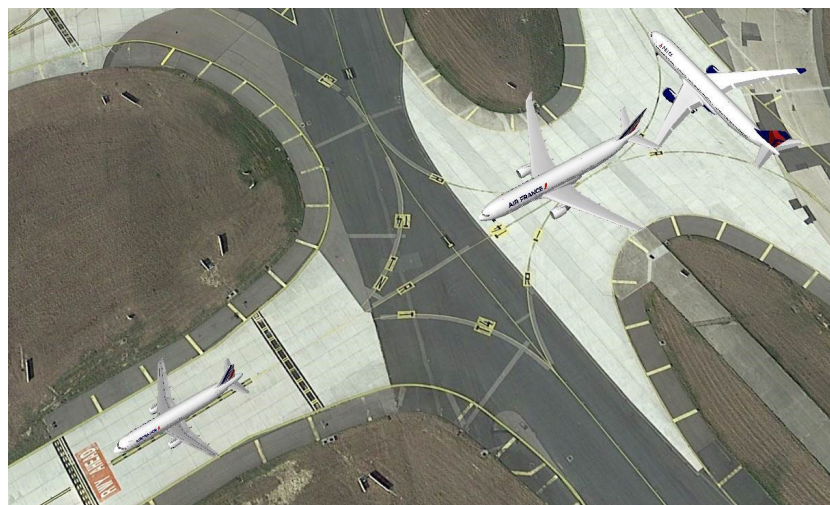
Figure 5: reconstitution of aeroplane positions on Google Earth

The AVISO system data and the examination of the aeroplane damage made it possible to determine the position of the aeroplanes at the time of the collision (see Figure 5)

While taxiing, the crew of flight DAL97 identified a possible conflict with flight AFR498 at a standstill on a perpendicular taxiway. After stopping before the junction and considering that they had enough of a margin, the crew started taxiing again. The left wingtip of the Delta Air Lines aeroplane then came into contact with the tail of the Air France aeroplane.

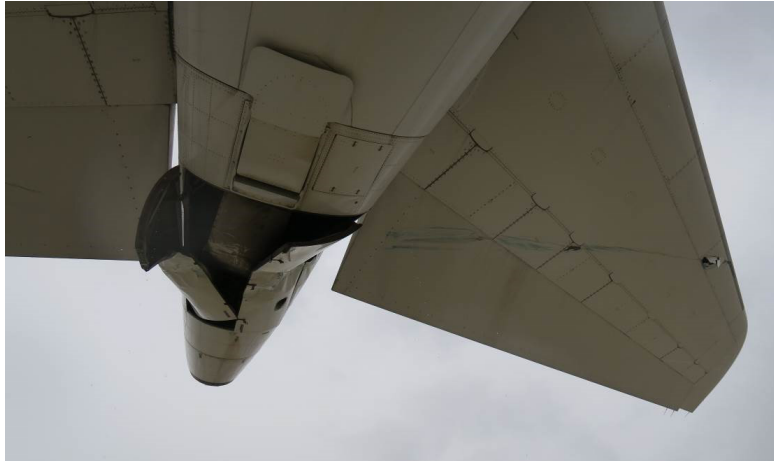
Figure 6: damage to F-GZCI

- ❑ F-GZCI: THS, tail cone and compartment of APU damaged (see Figure 6). The temperature sensors present in the tail cone were also damaged.

Supplementary examinations and analyses were carried out by the manufacturer, Airbus. It considered that the APU doors would have probably come off during or just after take-off. The asymmetry of the tail cone along with the damage to the THS caused by the collision would not have affected the handling of the aeroplane but would have led to over consumption of fuel. This over consumption would have been compensated for by the extra fuel taken on board by the captain in addition to the regulatory reserve fuel.

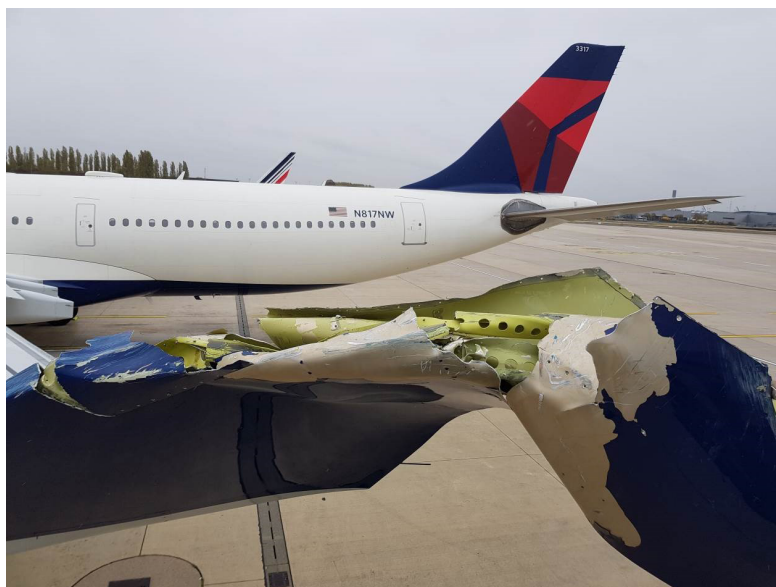
Figure 7: damage to N817NW

- ❑ N817NW: damaged tip of left wing (see Figure 7).

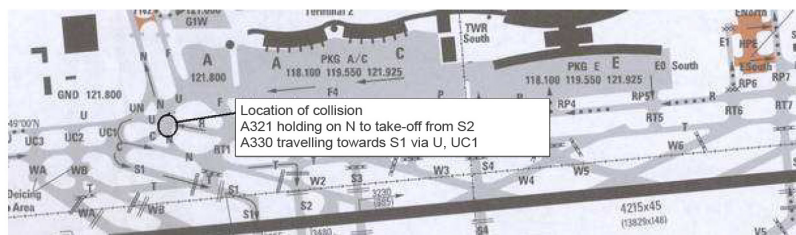
Figure 9: diagram of collision on 16 August 2006

The airport was operating “easterly operations”. The A321 was at a standstill with the parking brake applied, at the junction between taxiways N and W2, number 8 in the queue to take off from runway 08L via taxiway S2⁽¹⁵⁾. Taxiway N was congested by several medium-haul aeroplanes holding for runway 08L. The A330 taxied from F to S1 via N and UC1. The crew of the A330 slowed down and then stopped behind the A321. They then very slowly started taxiing again to pass behind it and continue on taxiway U. During the manoeuvre, the left wingtip struck the tail of the A321.

The captain of the A330 explained that he thought that he had enough space to pass behind the A321 and decided to continue taxiing while monitoring the tip of his left wing. It was only when the collision occurred that the crew saw that they had made an error of judgement.

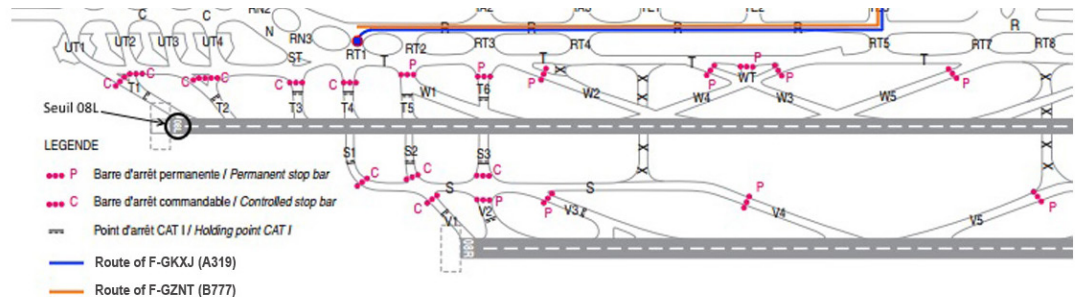
Figure 10: Diagram of collision of 11 May 2016

The airport was operating “easterly operations” in LVP⁽¹⁷⁾ conditions with a RVR⁽¹⁸⁾ of 250 m. The A320 was at a standstill with the parking brake applied, at RT1, number 2 for take-off from runway 08L via T4. The B777 was being towed on taxiway R and stopped shortly before passing behind the A320 on taxiway RT1. There were exchanges between the ground controller, the B777 attendant and the towing agent about the planes passing each other. The towing agent finally carried out the manoeuvre and the left wing of the B777 struck the tail of the A320.
