## Incident

to the Airbus A320-200 registered **F-HBNJ**  
and to the Boeing B737-800 registered **UR-PSB**  
on 11 November 2018  
in climb-out from parallel runways 26R and 27L of  
Paris-Charles de Gaulle airport<sup>(1)</sup> (Val-d'Oise)

## Loss of separation during simultaneous take-offs from two parallel runways

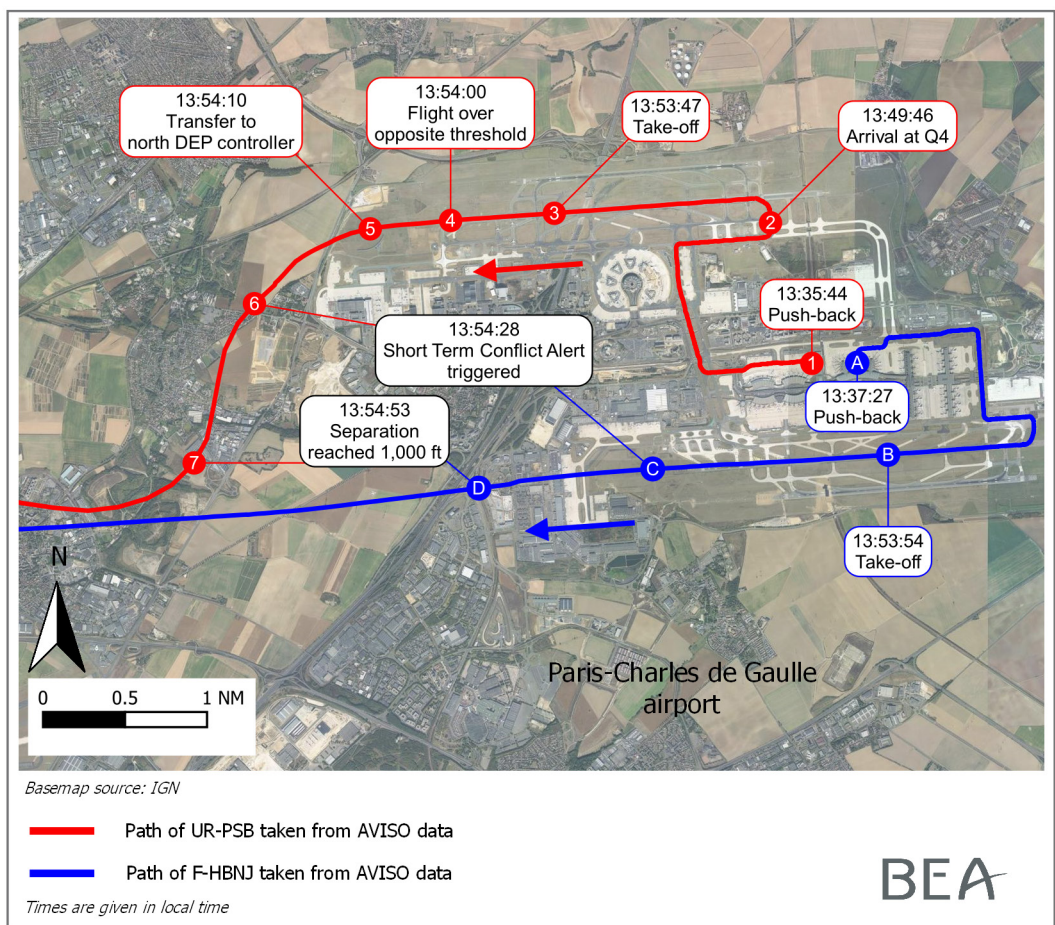
Figure 1: flight paths of both aeroplanes

At 13:53:54, a few seconds after the take-off of the B737 registered UR-PSB, the latter's flight management system changed to the LNAV lateral navigation mode. At 13:54:00, the aeroplane flew over the opposite runway threshold (point 4 on figure 1). The first officer started a left turn to follow the flight director which indicated a deviation to the left to join the path of the selected RANUX2B SID and corresponding, in particular, to the axis of runway 26R. At 13:54:10, (point 5 of figure 1), the aeroplane was correctly identified on the radar and the crew were transferred to the north DEP controller frequency. The aeroplane was still practically on the runway axis in the climb-out at a height of around 750 ft.

At 13:54:28, the STCA<sup>(7)</sup> was activated on the controller radars. At this point, AUI 3SD, in climb, was at an altitude of 1,980 ft, with a heading of 206° and a speed of 189 kt (point 6 of figure 1). AF 48KZ, in climb on the axis of runway 26R, was at an altitude of 1,650 ft (point C of figure 1). The distance between the two approaching aeroplanes was then 2.56 NM and the difference in altitude was 300 ft.

At 13:54:53, the vertical separation between the two aeroplanes reached 1,000 ft and was increasing (points 7 and D of figure 1). At 13:55:07, the south LOC controller used the general call function of the interphone to tell all the controllers that AF 48KZ was holding its altitude.

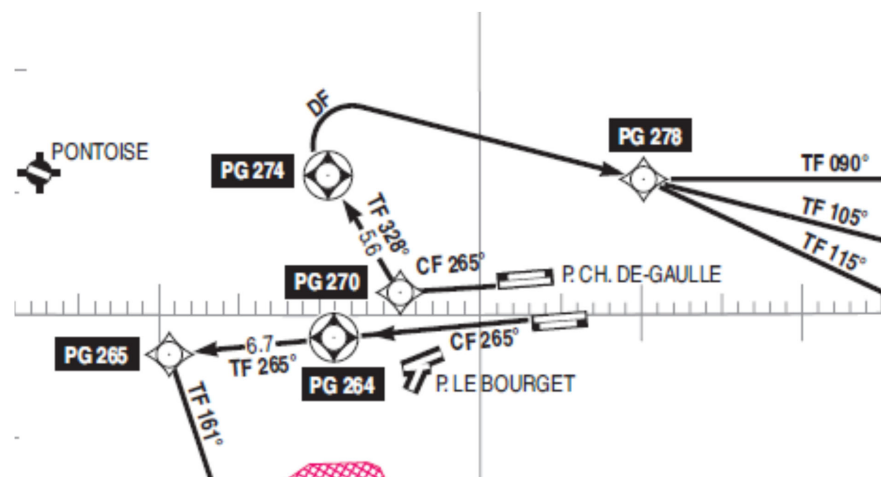
Figure 2: excerpt from AIP France AD 2 LFPG SID RWY26R-27L-RNAV-EAST chart

RANUX 2A SID (departure from north twin runways towards north of airport): runway 27L, PG 270, PG 274, PG 278.

RANUX 2B SID (departure from south twin runways towards south of airport): runway 26R, PG 264, PG 265.

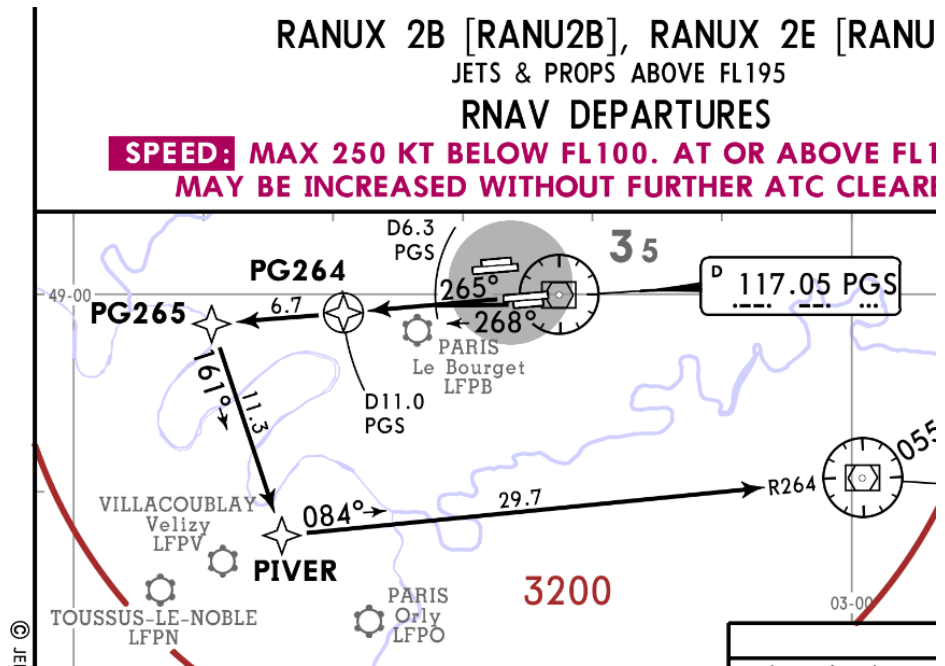
Figure 3: excerpt from JEPPESEN LFPG/CDG SID RANUX 2B chart

When taking off from runway 26L, the RANUX 2B SID procedure requires that the aircraft joins the 26R departure at D6.3 PGS (see JEPPESEN chart below). The path followed by flight AUI 3SD seems to join this point.
