Accident to the Guimbal "CABRI" G2 registered F-HRCR

on 31 January 2019

at Pierrevert (Alpes-de-Haute-Provence)⁽¹⁾

Loss of yaw control on final, collision with ground, roll-over

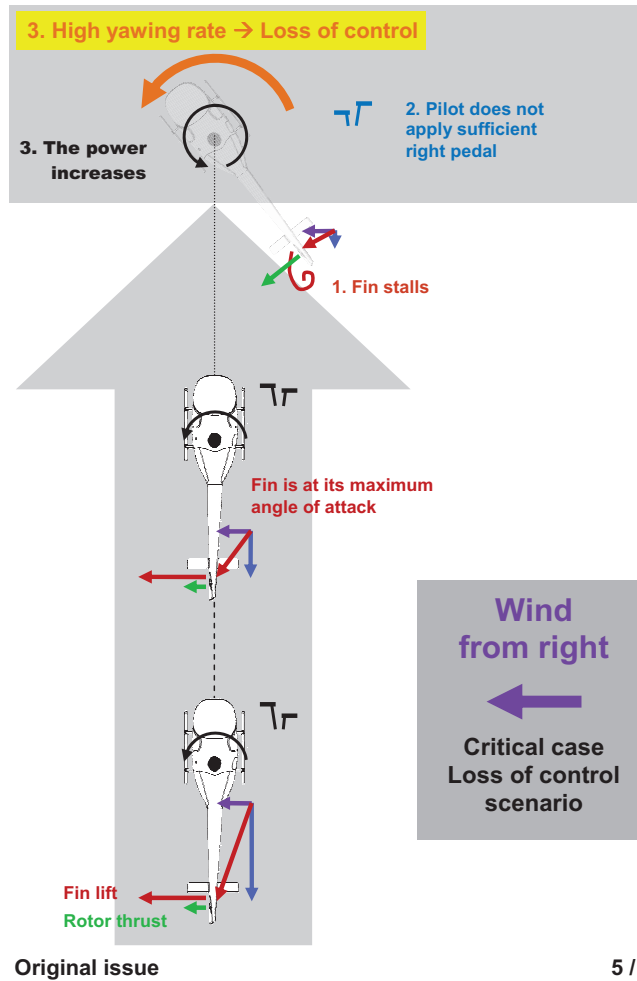
The service letter states, for example, that, when approaching the ground, if the pilot does not maintain a zero sideslip when reducing speed, this tends to cause the helicopter to depart in left yaw, requiring the pilot to apply a quick and large right pedal input. A significant aggravating factor is a crosswind coming from the right.

The pilot may, in such cases, be surprised by the departure in yaw and instinctively raise the collective lever to counter a possible descent of the helicopter, thereby accelerating the yaw to the left. If he reacts too slowly, allowing the helicopter to yaw left, he will experience additional leftward acceleration as the Fenestron passes through the wind due to the windvane effect. The combination of these factors can cause a mild to severe departure in yaw if the pilot is slow to apply enough right pedal.

Figure 1: critical case: loss of control scenario with wind coming from right

The meteorological conditions estimated by Météo-France at the accident site were as follows: mean wind of 3 knots from 060°, gusts from the north-east less than 10 knots near the ground, visibility greater than 10 km, broken clouds, temperature +3°C. These wind conditions were very similar to the critical case presented in the service letter.

This departure can always be stopped by a full right pedal input.

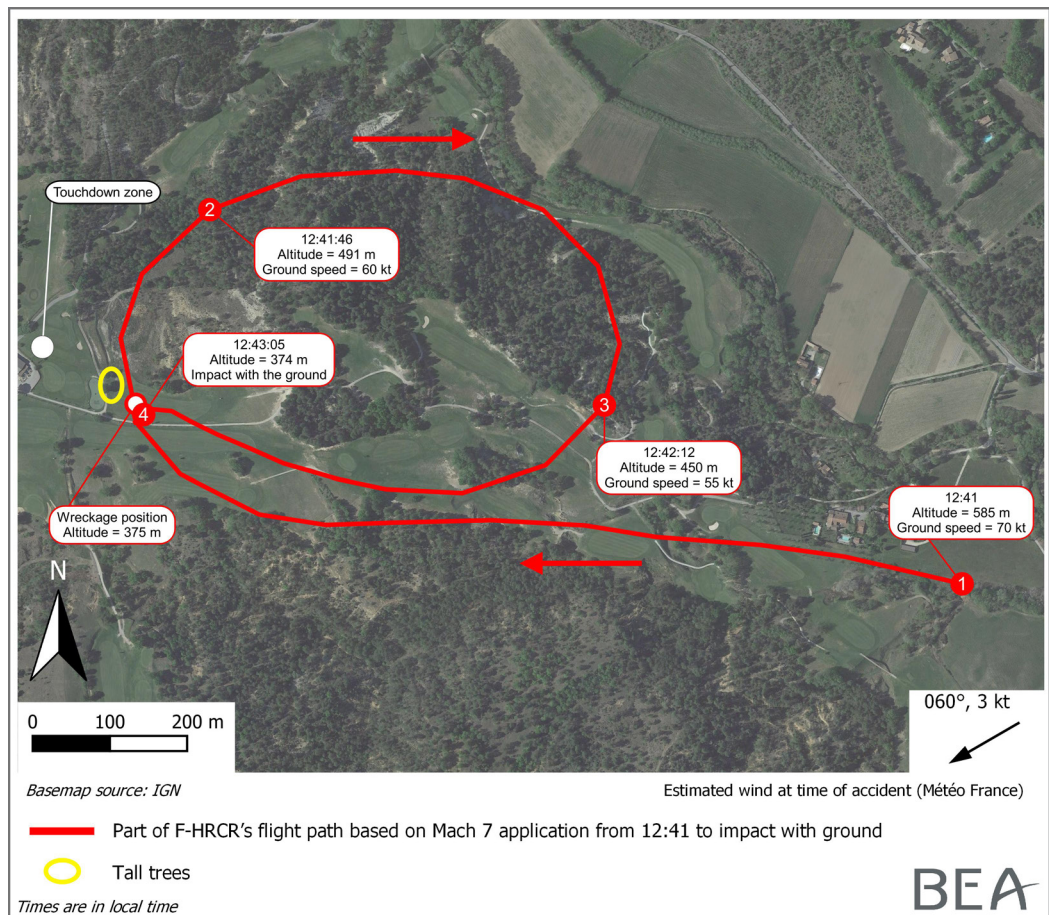
A portable electronic tablet was recovered. It was possible to reconstruct the flight path of the occurrence (see Figure 1) using the data recorded in the MACH7 application.

Figure 2: accident flight path

While approaching from the west, it is likely that the pilot saw the helipad and headed southward so that he could fly back towards the helipad in a west facing direction. Having already landed on this helipad, it is probable that he wanted to directly assess the factors required to make a decision about landing (air safety, ground safety, power, wind, approach path, etc.) while making a 360° turn, and then line up for final. This practice restricted his ability to evaluate the strength and direction of the wind and his choice of existing approach paths. On final, he did not modify his flight path to avoid flying over tall trees even though the environment allowed him to do so. At this point, he was flying at a low airspeed, out-of-ground effect, with a crosswind from the right with a tailwind component. These conditions were conducive to an uncontrolled departure in yaw.

The loss of yaw control was the result of the pilot not taking sufficient account of the wind on final and late or inappropriate action to counter it. The choice of flight path whereby the helicopter flew out-of-ground effect contributed to placing the helicopter in a position from which it was difficult to recover.
