Accident to the Cessna 172 registered D-EFZF

on 31 May 2019

at Tours Val de Loire (Indre-et-Loire)

Loss of control during go-around, collision with ground

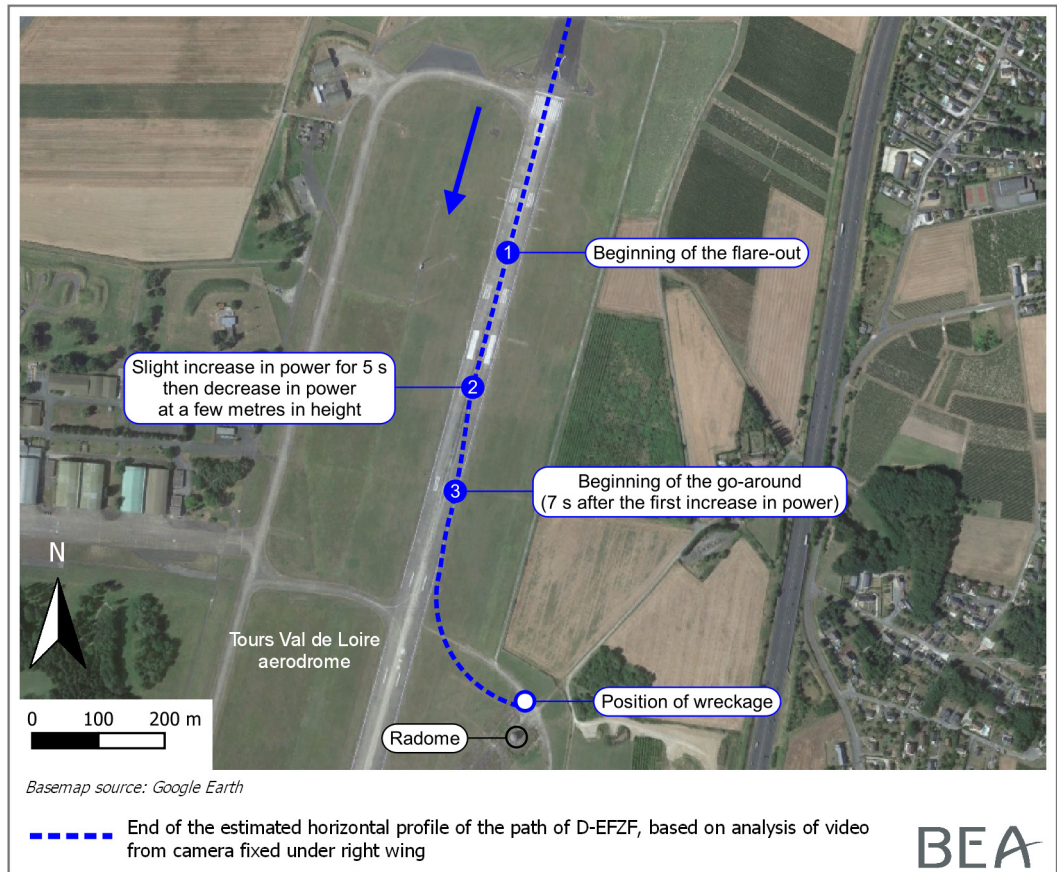
Figure 1: estimated path of D-EFZF based on video analysis

On final to land on runway 20 at Tours⁽²⁾, the pilot configured the aeroplane with a flap 30° setting and indicated that he adopted a speed of around 70 kt, with engine idle. During the flare and before touchdown, there was a slight increase in power for a few seconds (point 1 of Figure 1). The pilot then flew a go-around (point 2 of Figure 1).

The aeroplane veered left almost without gaining altitude, stalled at low height, and then collided with the terrain in the airfield grounds, close to a radome⁽³⁾ (see accident site in Figure 2).

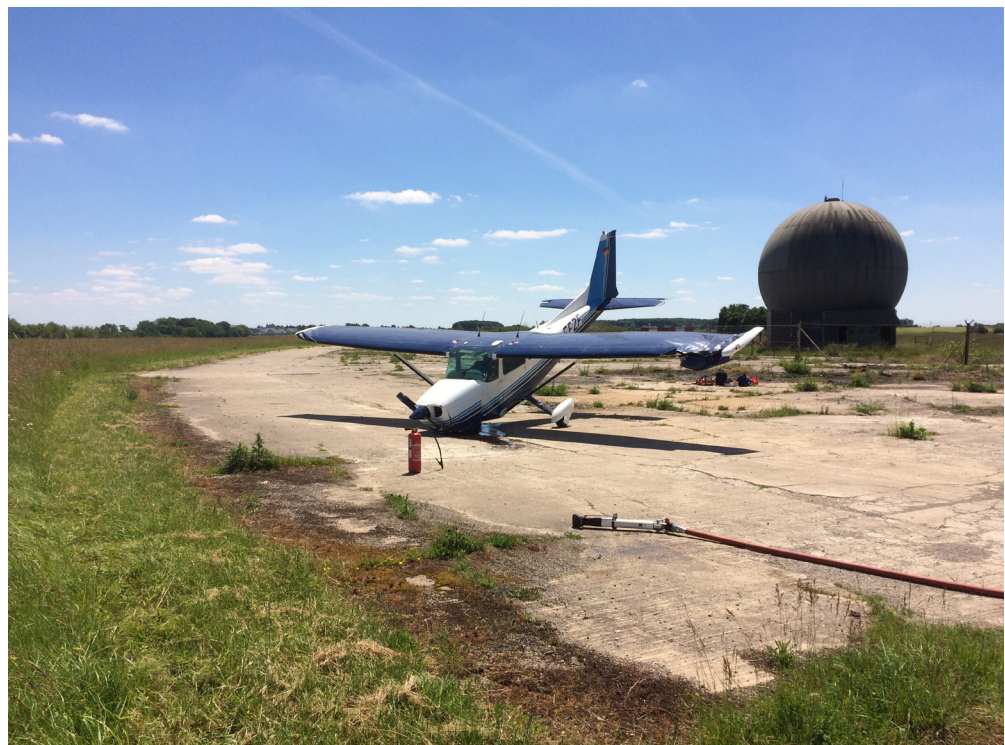
Figure 2: accident site

Following the go-around, the engine effects linked to the increase in power had an immediate impact on the aeroplane. The latter started to veer left with a slight nose-up attitude. The aeroplane stalled and collided with the ground, close to a radome.
