## Accident to the Cessna - 172RG registered F-GEJD

on 13 June 2019

at Saillagouse (Pyrénées-Orientales)

## Loss of control when turning during initial climb while flying in the critical area of the back side of the power curve, collision with ground, fire

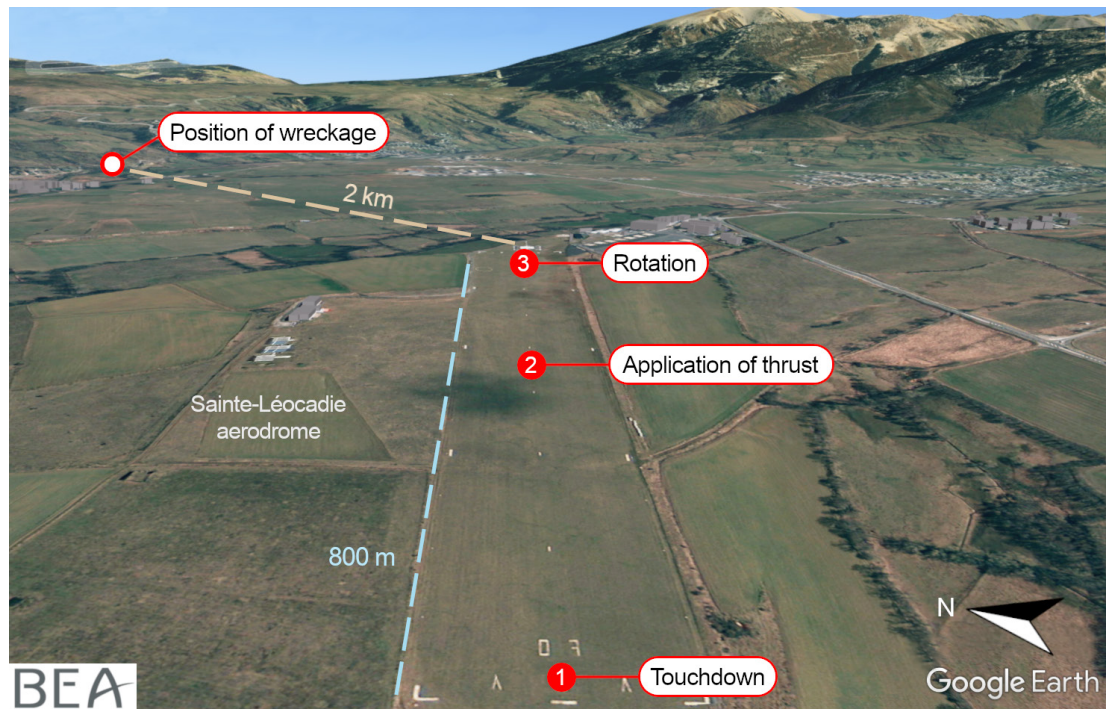
Figure 1: environment and history of the flight according to the statements

According to the statements, the pilot checked in on the radio frequency with a view to making an overhead evaluation of the installations at 6,000 ft. He then announced that he was on a right-hand base leg for a touch-and-go landing on runway 07. The aircraft touched down on the ground at the runway threshold (see point ① Figure 1), then the pilot applied engine power abeam the aero club (see point ② Figure 1). The aircraft rotated just before the helicopter landing pad (see point ③ Figure 1). The aircraft skimmed the trees at the end of runway 07 and lost altitude in the Saillagouse basin with a nose-up attitude. The pilot reported that he had power problems over the radio frequency. The aircraft turned left, still with a nose-up attitude. The pilot lost control of the aircraft during the turn. The aircraft hit the ground and immediately caught fire.

The aerodrome is located in a mountainous area. There is a small valley running in a south-east/north-west direction to the east of runway 07 (see Figure 1). The wreckage was located on a hillside about two kilometres north-east of Sainte-Léocadie aerodrome at an altitude of 1,295 m. The wreckage was all in one place and had been heavily damaged by the fire.

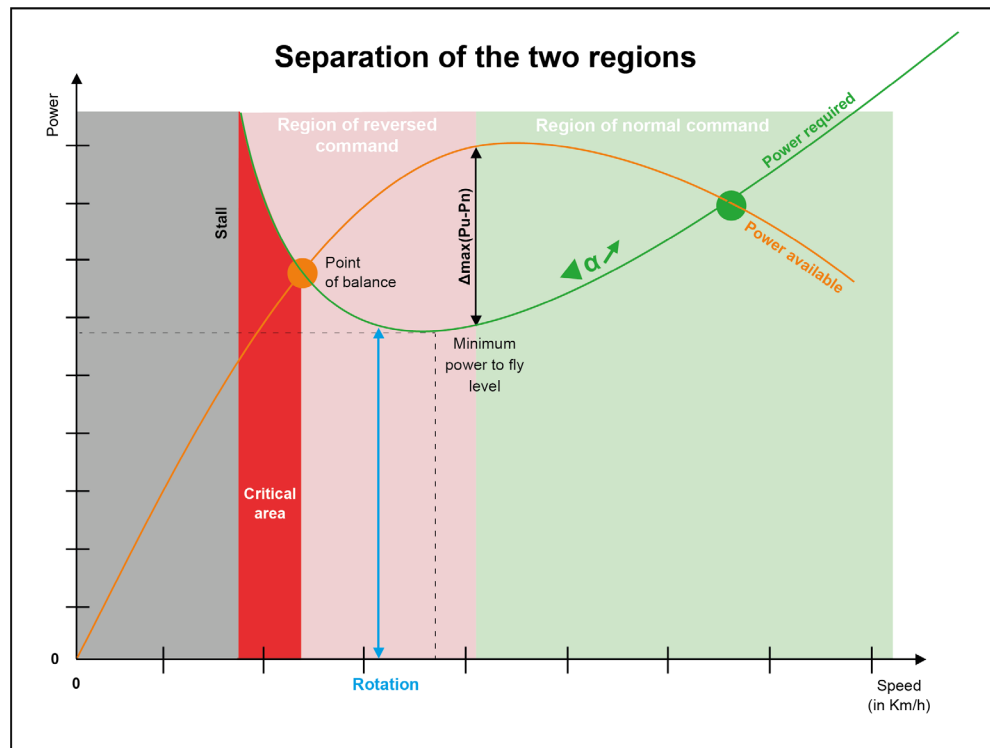
Figure 2: back side of power curve

The back side of the power curve is the part of the flight envelope situated at angles of attack above the angle of attack where excess power is at its maximum through to stall. It is characterized by an increase in the power required for flight and a decrease in available power as airspeed decreases. Between the power equilibrium point [red spot in Figure 2], when there is one, (intersection between the required power and power output curves) and the stall, the required power exceeds the power output. Level flight cannot be stabilised. This is called flying in the critical area of the back side of the power curve.

In other words, in the critical area of the back side of the power curve and without pilot input to increase airspeed (for example, through a change in nose-down attitude), the aircraft's airspeed will decrease until it stalls. This phenomenon can be perceived by the pilot as a decrease in engine power.

A pilot on take-off may thus find himself in a tricky situation where the aircraft has less power to accelerate to the region of normal command. The instinctive reaction may thus be to increase the attitude in an attempt to avoid obstacles. This action, which increases the angle of attack, exacerbates the phenomenon<sup>(14)</sup>.
