Accident to the ROBIN - DR400 - 140B registered F-GBIA

on 16 June 2019

at Saint Cyr l'École (Yvelines)

Engine shutdown on downwind leg, forced landing in a field, collision with a fence

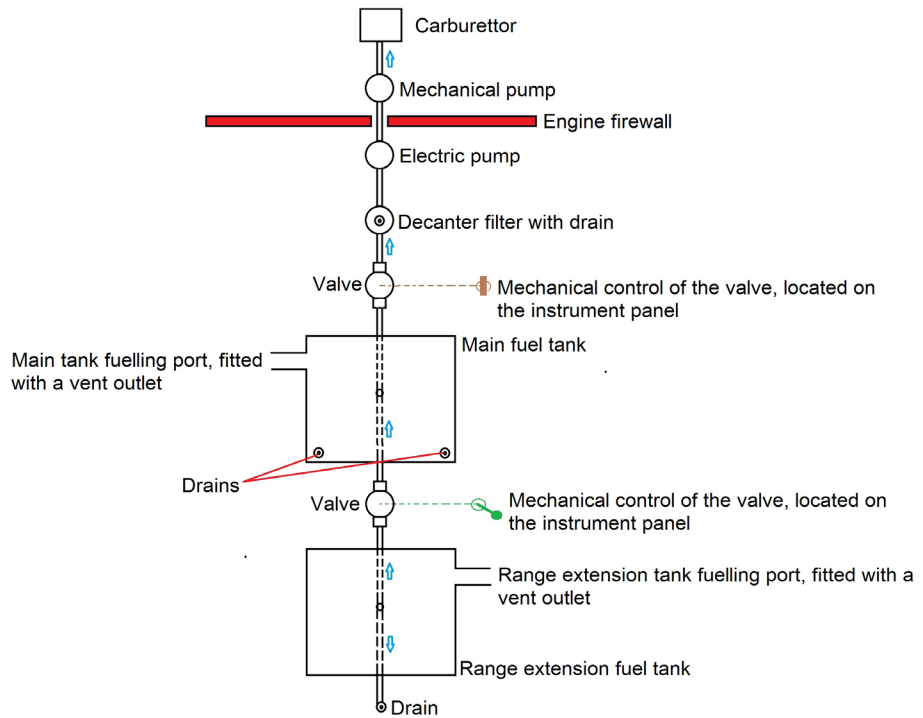
Figure 2: flow diagram of the fuel system

All fuel system components were in place and no leaks were detected.

No pollution was found in the various filters, strainers and drains on any of the components of the system or in the two fuel tanks.

The main fuel tank, which has a capacity of 110 l⁽⁴⁾, was undamaged and contained about 50 l of fuel.

The range extension fuel tank, which has a capacity of 50 l⁽⁵⁾, was not damaged and contained no fuel. Its drain was operational.

The valve for transferring fuel from the range extension fuel tank to the main fuel tank was operational.

The test performed on the wreckage showed that it took five minutes to transfer 10 l of fuel from the range extension fuel tank to the main fuel tank.
