Accident to the Lange Aviation ANTARES 20E⁽¹⁾ registered HB-2417

on 22 July 2019

at La Javie (Alpes-de-Haute-Provence)

Collision with mountainous terrain

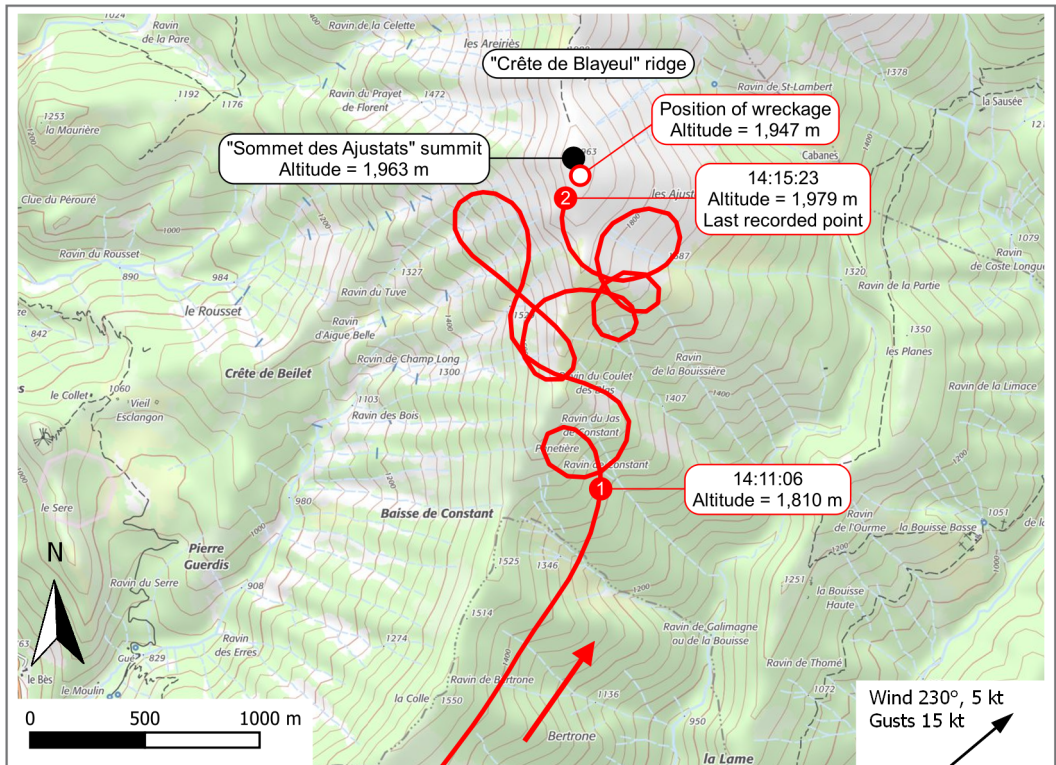
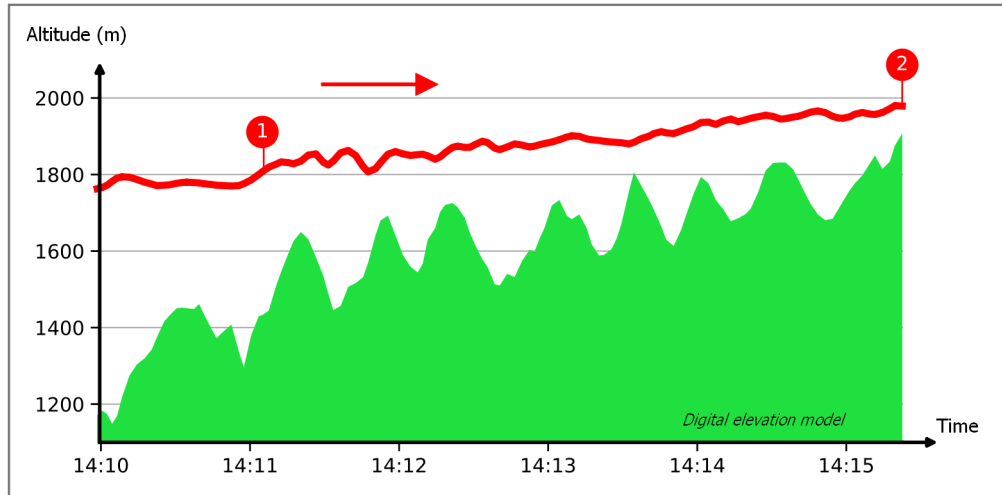
Glider flight path

— End of HB-2417's flight path based on iGlide lite application, from 14:10 to the last recorded point

The data from the iPod read-out was used to map the flight path, as seen in the figure above. At the last recorded point at 14:15, the glider was above the ridge at a height of approximately 70 m. The last few seconds of the flight were not recorded following the abrupt shutdown of the FLARM system upon impact.
