Accident to the B&F LIGHT AIRCRAFT FK9 MARK 4 identified 09BO

on 23 July 2019

at Calviac (Lot)

Loss of control during aborted landing, collision with trees

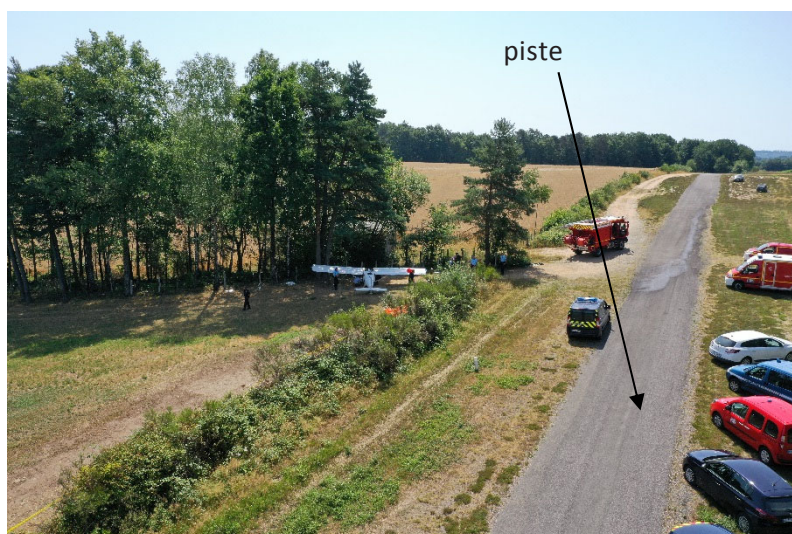
Figure 1: accident site

The wreckage was located to the east of runway 17 in a field near a row of trees perpendicular to the runway. A forest borders the runway to the west and north. A row of shrubs runs alongside the runway to the east. Based on observations, the microlight appeared to have struck the vegetation at a height of about six metres at a steep angle and in a left roll (close to 90°). It then fell to the ground. The engine was operating at the time of impact. The controls were continuous on all three axes and the flaps were extended (position undetermined).

An examination of the wreckage did not reveal any failure that could explain the event.
The pilot got out of the microlight after the impact.

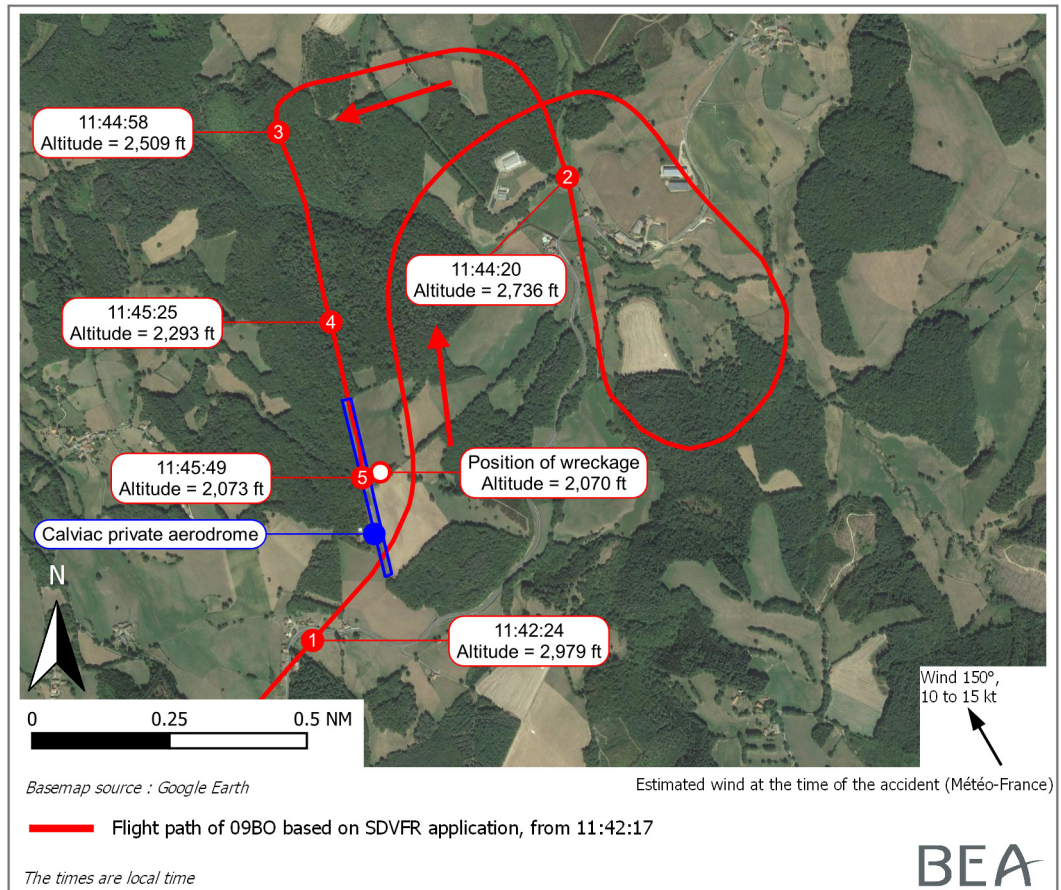
Figure 2: flight path based on GNSS data

An examination of the GNSS track shows that, after passing abeam the runway, the pilot positioned himself on a downwind leg for a circuit pattern into runway 17. From the beginning of the downwind leg, the pilot began a steady descent on an approximately 7 % slope. The ground speed on final was 90 km/h, then 70 km/h on short final. The flight path ended in the vicinity of the displaced threshold of runway 17. The recorded data show an altitude stabilization phase lasting a few seconds, which corresponds to the flare. At the end of this phase, a change in heading to the left and a slight increase in altitude can be noted.

The circuit pattern was completed in turbulent aerological conditions. Given the runway environment, the pilot had to adopt a steep approach path, probably with reduced engine power. An analysis of the flight path shows that it ended at a point near the displaced threshold. The distance remaining for a safe landing probably appeared insufficient. It is possible that the convex profile of the runway contributed to this perception.

The inspections of the site, the wreckage and the tablet suggest that, during the flare, the pilot initiated a go-around. He probably failed to control the engine effects and the flight path curved to the left towards the trees. At this point, it was no longer possible to avoid a collision.

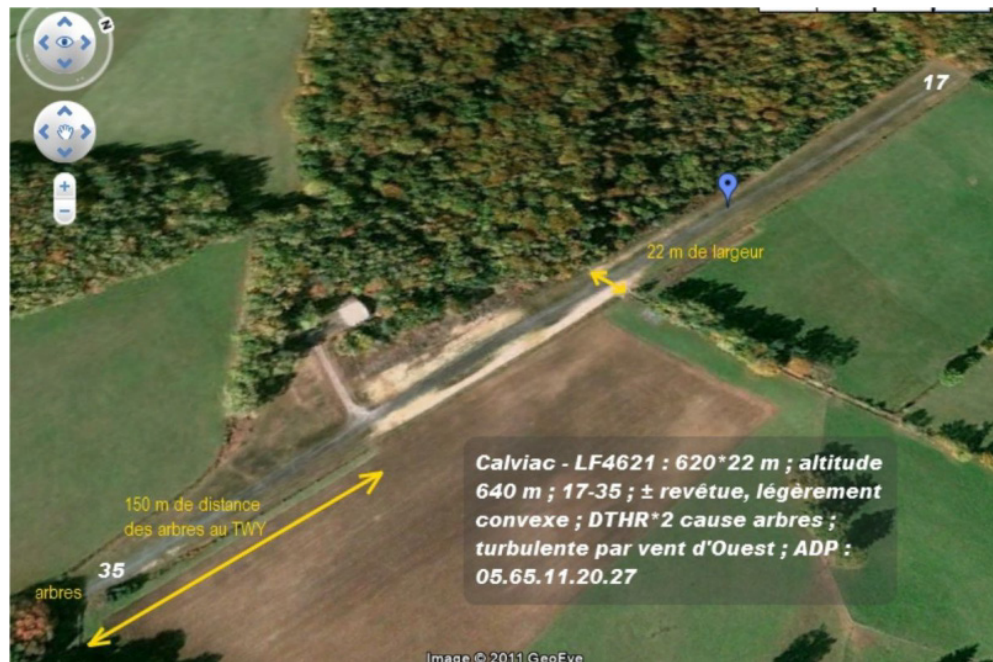
Figure 3: excerpt from the aerodrome information sheet

- the runway is very narrow (five metres);
- the trees adjacent to the runway can generate special aerological conditions;
- on runway 17, a 220-m displaced threshold allows for a 7% glide path, in which case the remaining landing distance is 400 m.
