**Accident** to the EVEKTOR AEROTECHNIK - EV97 - Eurostar  
registered **G-SJES**  
on 24 July 2019  
at Larche (Alpes-de-Haute-Provence)

<b>Time</b>	Around 09:50 <sup>(1)</sup>
<b>Operator</b>	North East Aviation Limited
<b>Type of flight</b>	Cross-country
<b>Persons onboard</b>	Pilot and one passenger
<b>Consequences and damage</b>	Pilot and passenger fatally injured, ultralight destroyed

**Loss of control while turning around,  
in mountainous region**

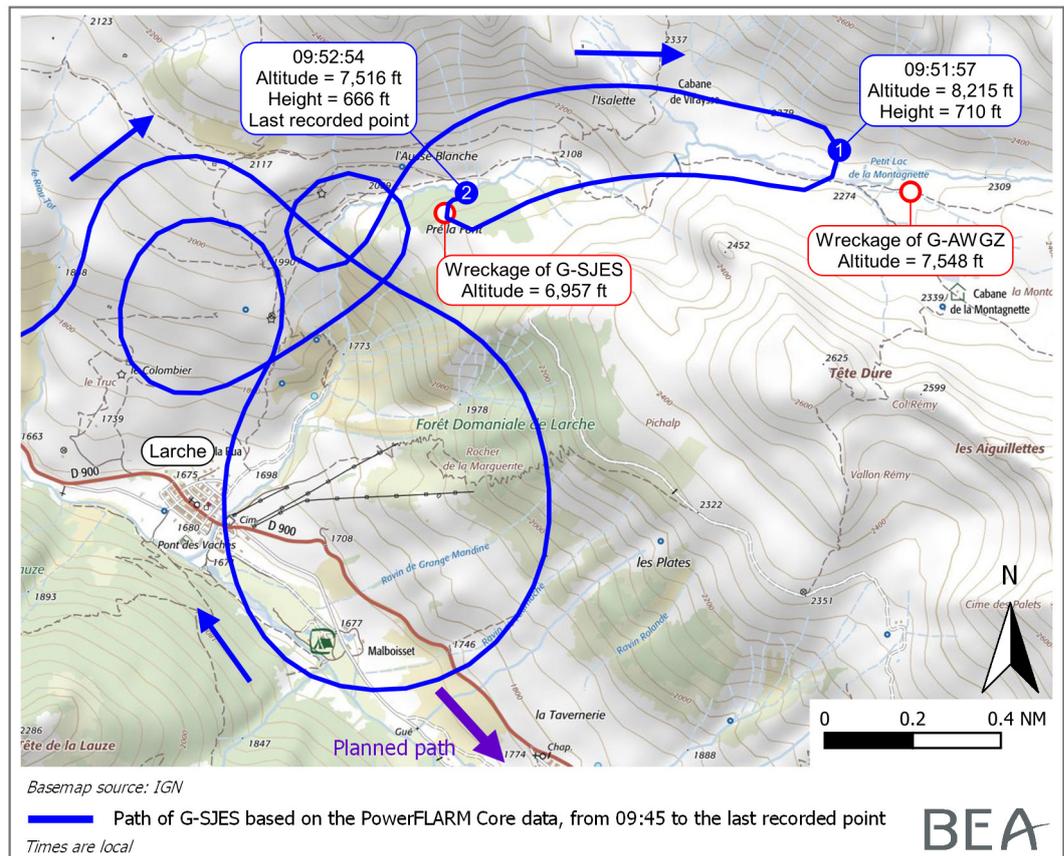
Figure 1: path of G-SJES based on FLARM data

As the ultralight, G-SJES, returned to the beginning of the valley, one of the Monoplane pilots saw it make a steep turn, enter a spin and then collide with the ground (point 2 of figure 1). No message from the ultralight pilot was heard on the radio by the other pilots.
