Accident to the Robin - DR400 - 140B registered F-GJZT

on 10 August 2019

at Ceyszac (Haute-Loire)

In-flight engine shutdown, forced landing

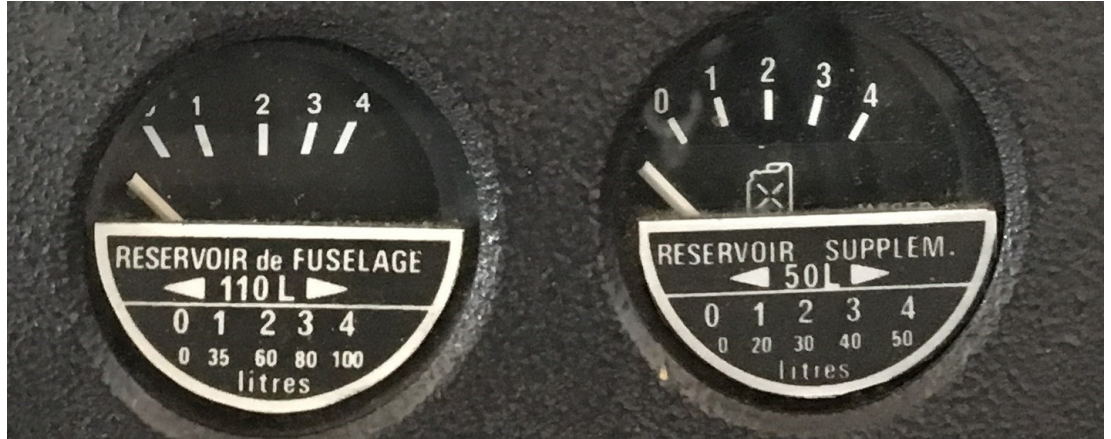
Figure 1: fuel quantity indicators for both tanks

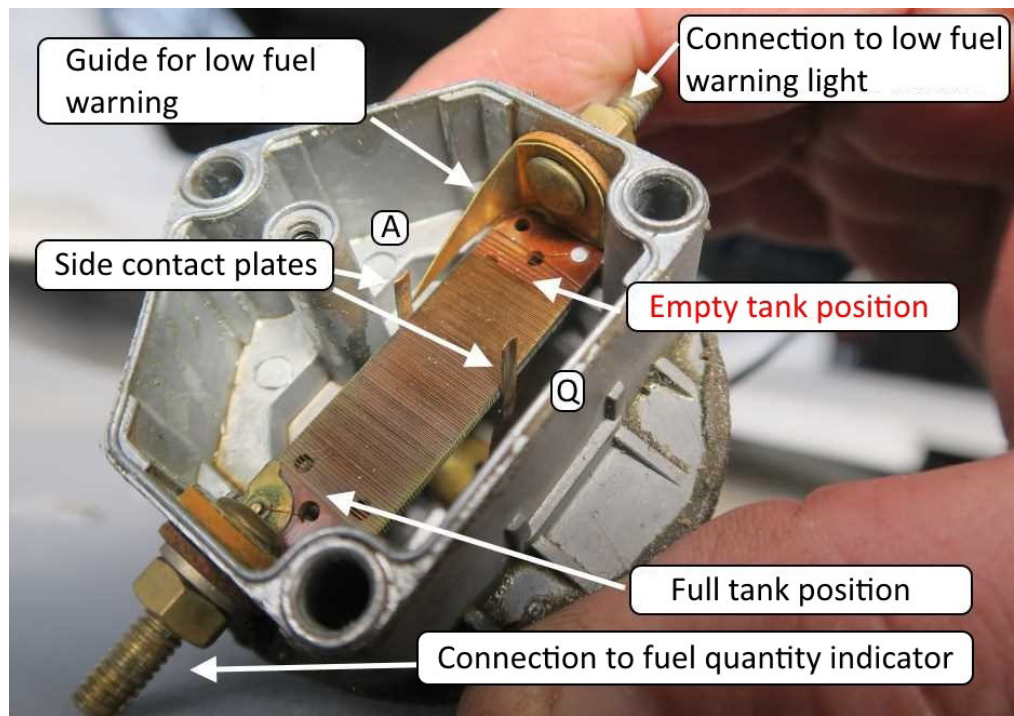
The operating principle of the transmitter is based on the measurement of a variable resistance. The resistance value depends on the position of the contact between a copper wire wound round a plate and two side contact plates that slide along the side of this plate. These two side contact plates are connected to the float arm rotation mechanism. Over the last quarter of the stroke of the arm, one of the two side contact plates (A) slides along the outside of a guide, ensuring a continuous electric contact that lights up the low fuel warning light, while the other side contact plate (Q) continues to slide along the plate and transmits the fuel quantity indication.

Figure 2: inside of the fuel quantity transmitter

An internal examination of the transmitter showed that the contact plate (A) (see figure 2) abuts against the tip of the guide that provides the low fuel level contact instead of sliding along it. Since both contact plates are joined to the float arm, the position of the second contact plate (Q), which transmits the fuel quantity information, is also stuck. The information transmitted to the indicator was stuck at approximately one-quarter of the tank capacity even though the actual fuel quantity was lower.

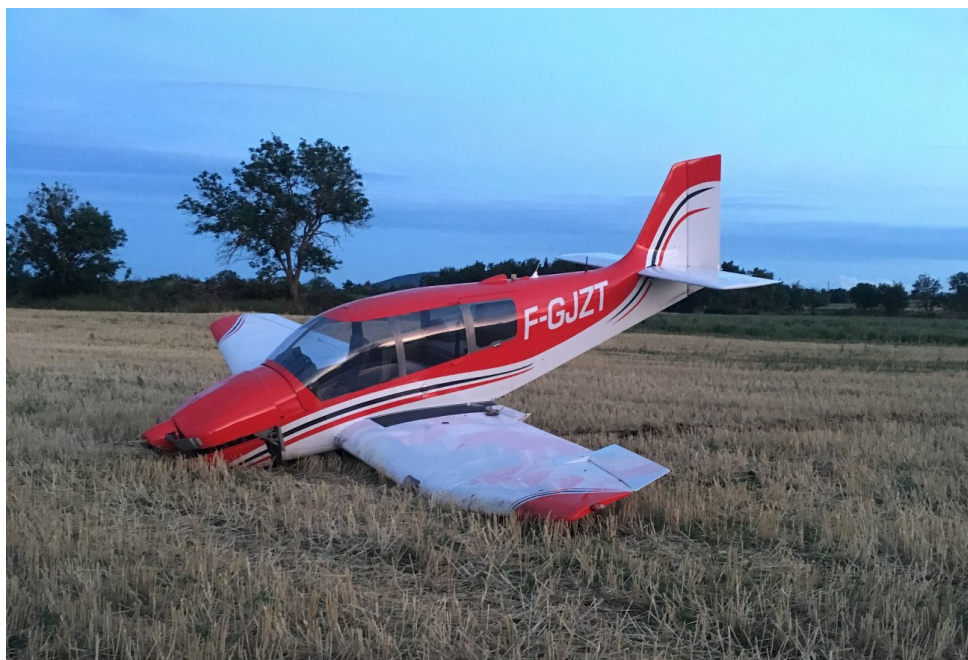
The accident site was located in a recently harvested wheat field at an altitude of 2,800 ft. The marks left by the aircraft in the loose soil when it landed were facing the north-east. The distance from the initial point of impact to the aircraft's final position was approximately 20 m.

Figure 3: aircraft at the accident site

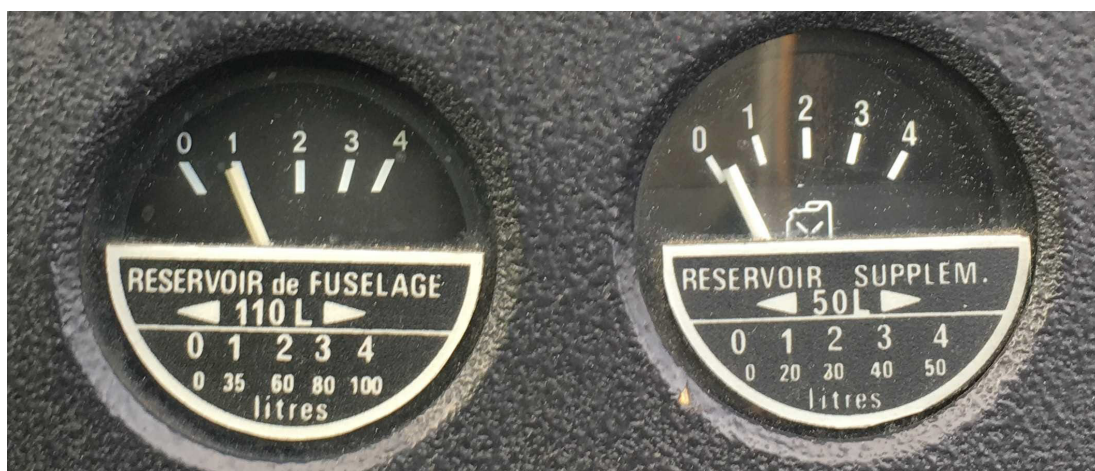
An examination of the aircraft showed that the engine was not delivering power on landing and that the main and range extension fuel tanks were both empty. The needle on the fuel quantity indicator for the main tank was just below "1" and the needle on the indicator for the range extension tank was pointing to "0".

Figure 4: position of the needles on power-up with both tanks empty

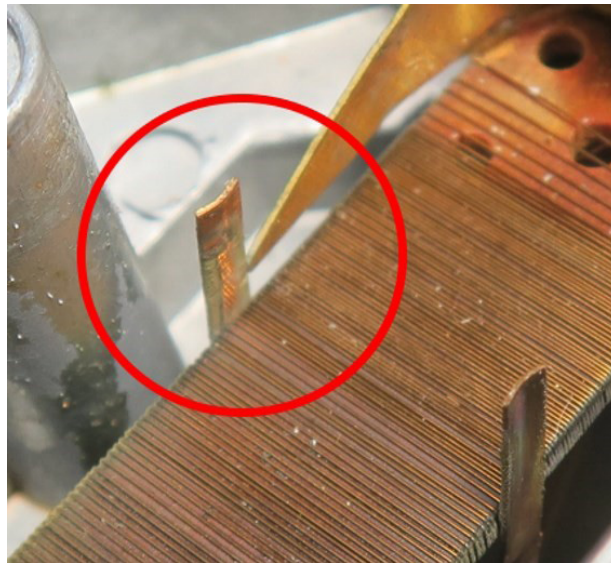
An examination of the fuel gauge revealed a malfunction. The float arm was not travelling through its normal full travel range. The arm remained stuck during the last quarter of its stroke.

Traces of oxidation were also visible on the edges of the contact plates and on the tip of the guide that provides the low fuel level warning signal. This oxidation probably prevented electrical conductivity and stopped the low fuel warning light from lighting up.

Figure 5: detailed view of the malfunction
