Accident to the JODEL D18 registered 89WP

on 25 August 2019

at La Selle-en-Hermoy microlight strip (Loiret)

Loss of control on final, collision with the ground

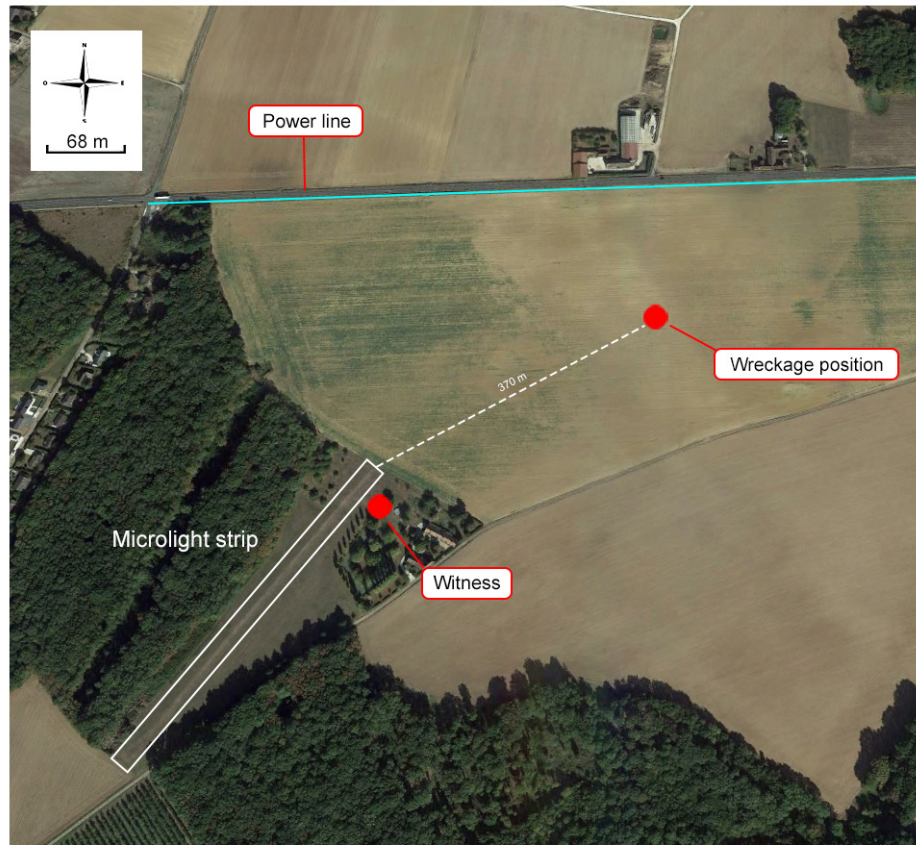
Accident site

The microlight was lying approximately 370 m upstream from the threshold of runway 22 in a harvested field.

Examination of the site and the wreckage showed that the microlight struck the ground in a left-bank, nose-down attitude with a flight path heading of approximately 115°. No technical faults were found that could have contributed to the loss of control.
