Accident to the Adventure Flexrace 22 identified 03AHB

on 31 August 2019
at Lusigny (Allier)

Loss of control during take-off, collision with ground

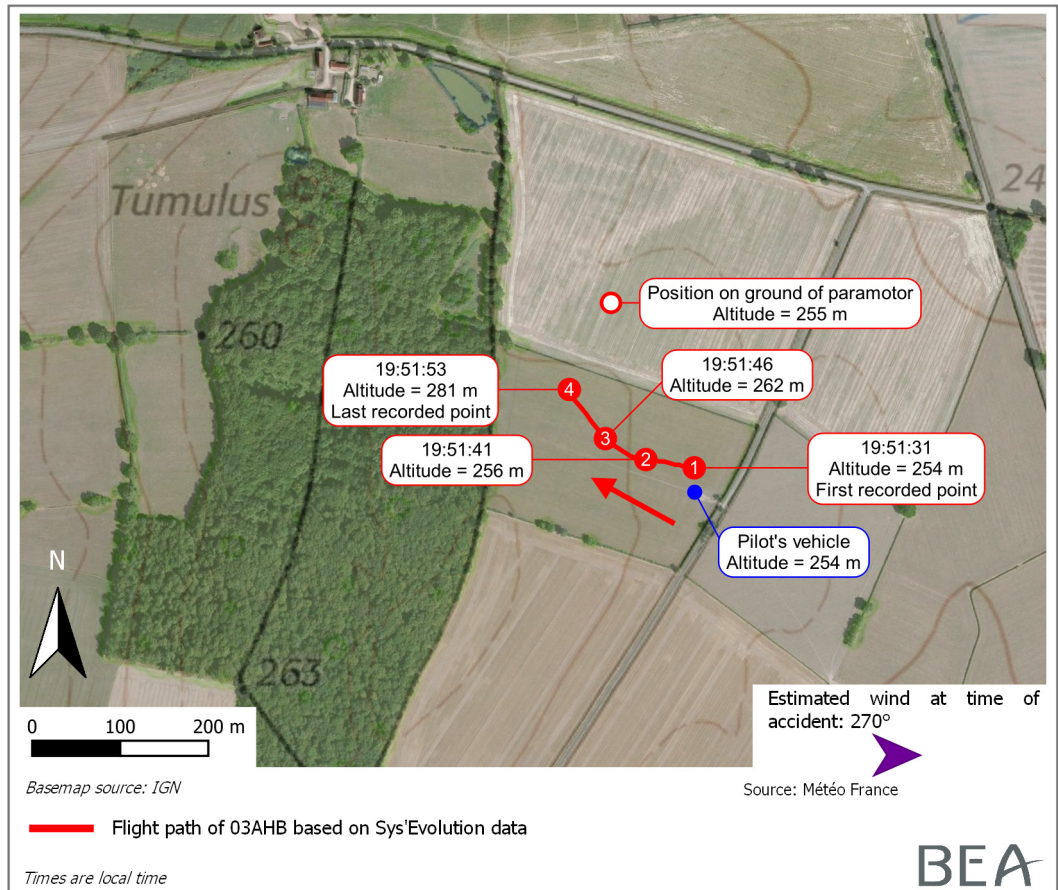
Take-off flight path

The accident site was located in the adjoining field north of the field used by the pilot for take-off (as seen in the figure above). Both fields are bordered to the west by a forest. This forest is located on a hilltop. In the direction of take-off, facing west, the field is slightly uphill.

An examination of the site found that the pilot had collided with the ground with great energy while making a right turn. An electronic tablet⁽²⁾ used to navigate was found at the site. The position data was extracted from it and used to determine the pilot's flight path prior to the accident.

Note: point ❶ of the flight path corresponds to the start of the take-off run.
