**Rotor mast bumping during cruise, in turbulence, in-flight break-up,
collision with the ground**

Aircraft	Robinson R44 helicopter registered EC-IVT
Date and time	3 September 2012 at about 10 h 35 ⁽¹⁾
Operator	Private
Place	Valouse (26), in cruise at 4,200 ft
Type of flight	General aviation
Persons on board	Pilot and one passenger
Consequences and damage	Pilot and passenger fatally injured, helicopter destroyed.

This is a courtesy translation by the BEA of the Final Report on the Safety Investigation. As accurate as the translation may be, the original text in French is the work of reference.

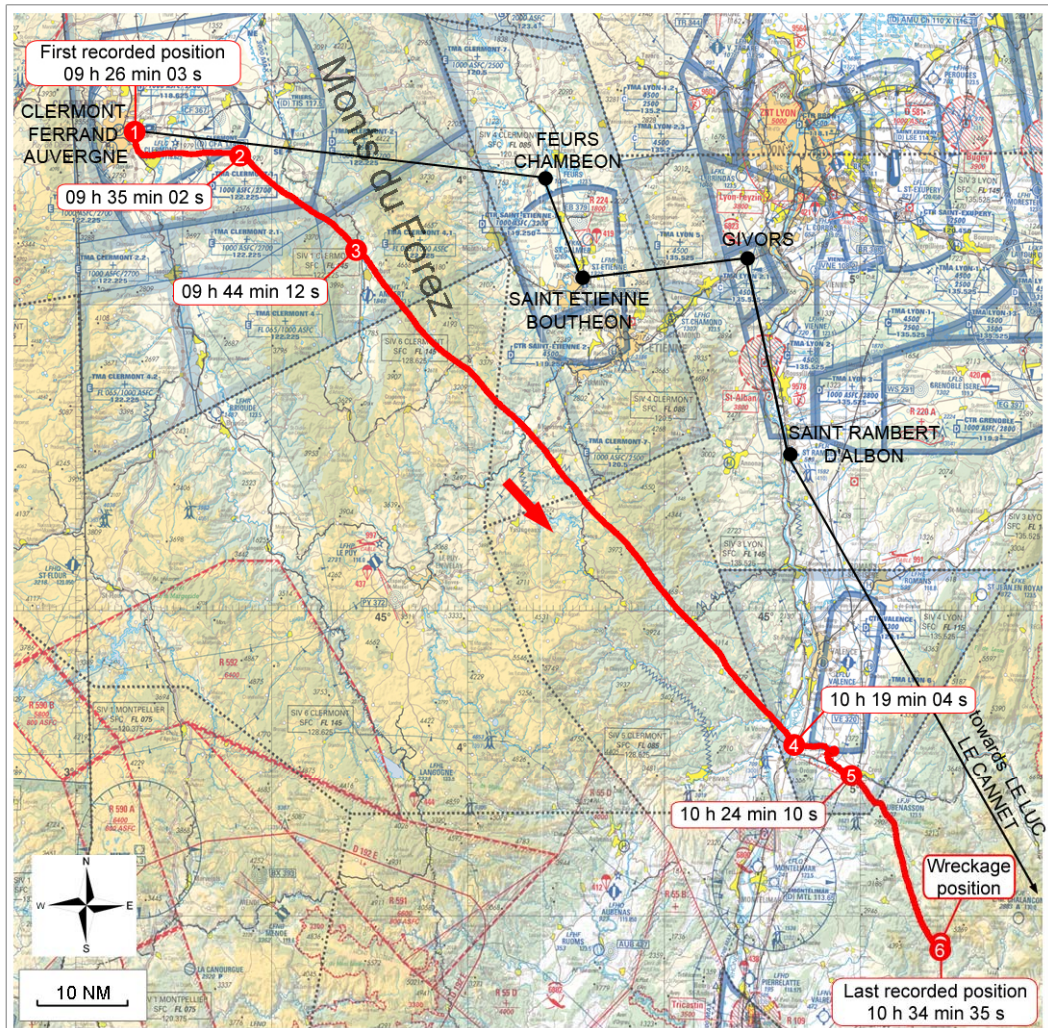
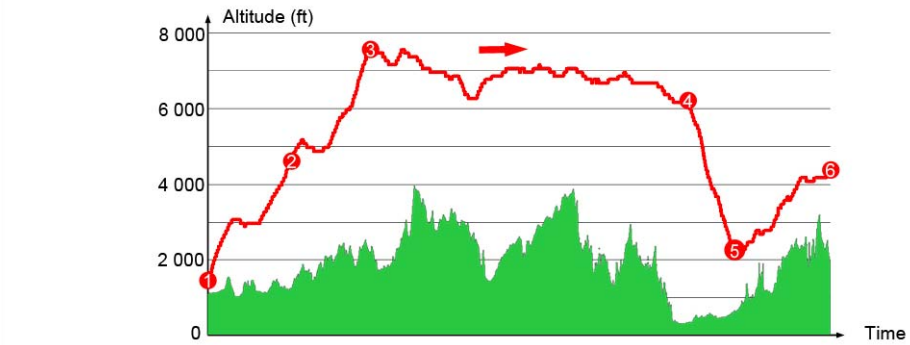
The pilot, accompanied by a passenger, took off from Clermont Ferrand Auvergne (63) aerodrome at 9 h 24 for Luc Le Cannet (83) aerodrome. The pilot had entered a route in a touch-screen tablet which went via Feurs (42), Saint Etienne (42), Givors (69), Saint Rambert d'Albon (26) and then Le Luc. He performed cruise at an altitude of 7,000 ft. At 10 h 19, at the level of the Rhône valley and 25 km north of Montélimar, he began descent, carried out a 360° turn and halted descent at an altitude of about 2,300 ft. He then continued south-east and went back into climb.

At about 10 h 35, at an altitude of about 4,200 ft (height of 1,500 ft) and at a ground speed of 115 kt, the helicopter broke up in flight and collided with the ground.

— Flight path of EC-IVT based on Lyon Radar system data

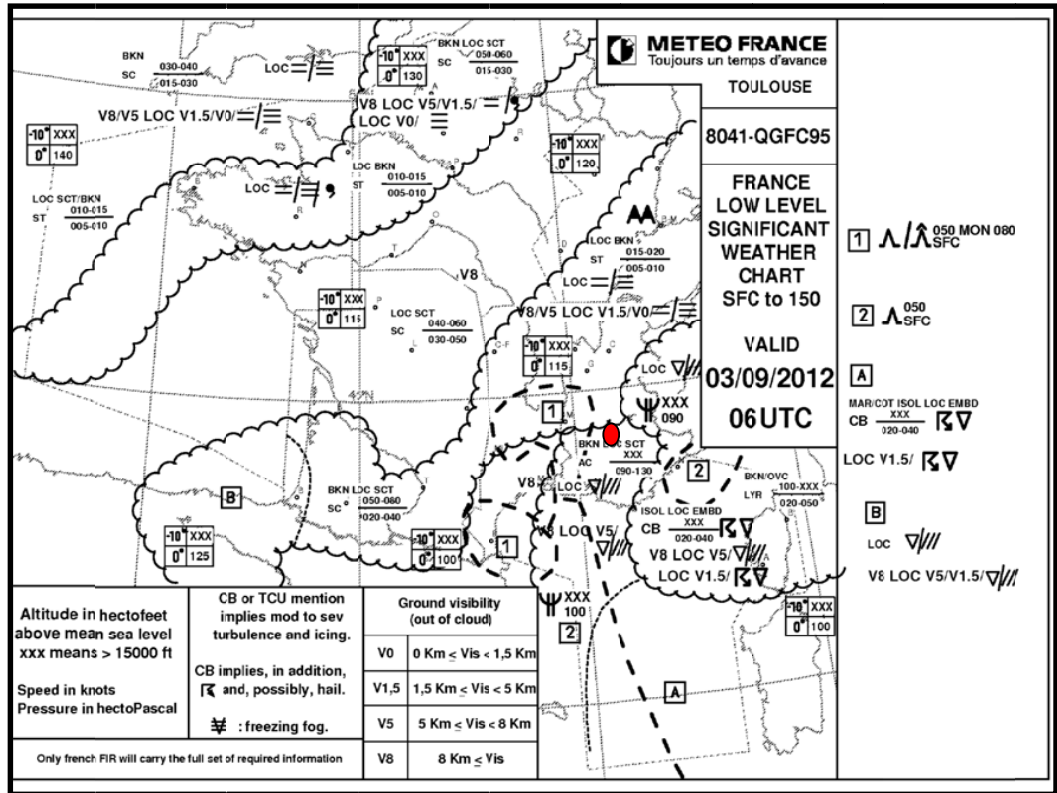
The TEMSI chart indicates a moderate to strong area of turbulence in the accident area.

TEMSI chart for 06 h UTC (in red: the accident site)
