INVESTIGATION REPORT

Accident to Schroeder Fire Balloons G50/24
registered **F-HCCG**
on 5 October 2014
at Cazes-Mondenard (82)
operated by **Quercy Pluriel**

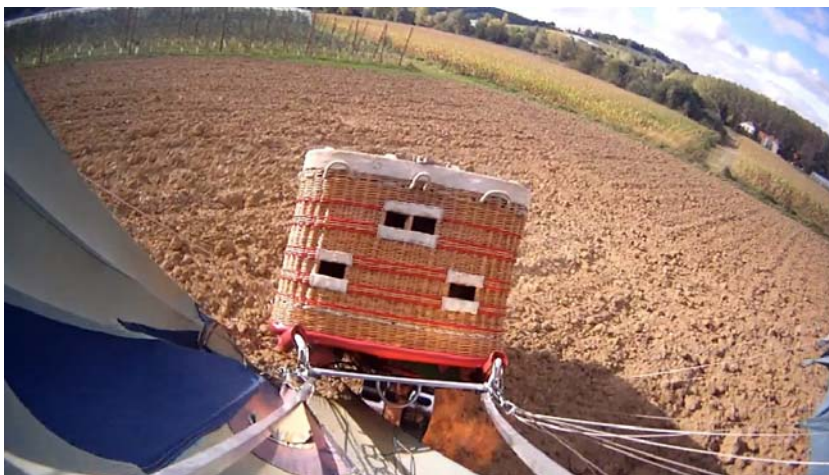
At T-2 s, the basket turned completely over. The burner frame uprights bent under the weight of the basket. The burners were directed towards the ground. Some of the occupants were in contact with the frame. A brief but large flame was visible from the burners.

Figure 1: photo of situation of basket at T
the maize field overflow is in background

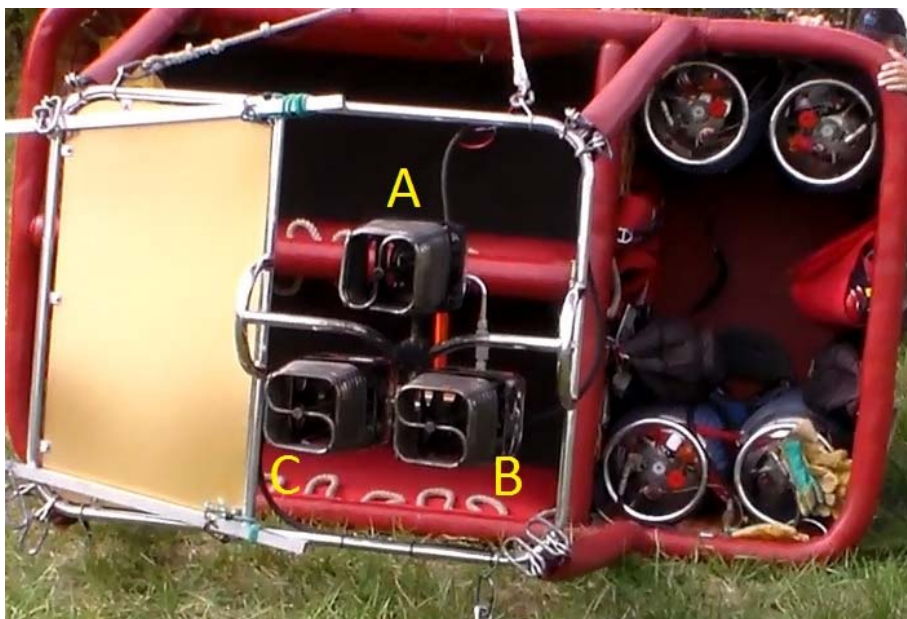
Figure 3: general view of basket

- ❑ the lower left burner (called C in this report) was supplied by the two lower tanks through a T-coupling system;
- ❑ the two other burners (called A and B) were supplied by the two upper tanks through a double T-coupling (*figure 4*). This configuration is not proposed by Cameron Balloons, the manufacturer. The DGAC and OSAC stated that this type of assembly is not in accordance with the type certificate⁽⁹⁾. Cameron Balloons considered that it was possible that this assembly reduced the heating power of the two burners when activated simultaneously, according to the characteristics of the couplings and the simultaneous opening or not of the two tanks. The pilot said that he had bought the balloon in this configuration from the previous owner and that it was in place when he asked for the renewal of the ARC in April 2014. He had never observed abnormal operation linked to this assembly.

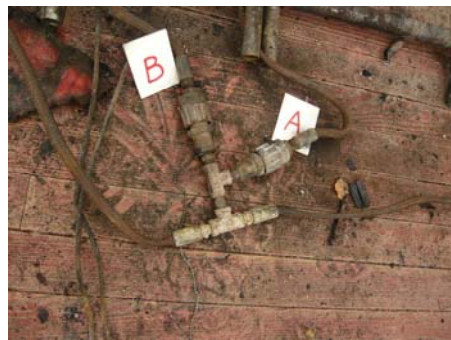
Figure 4: double T-coupling supplying burners A and B

The inspection report and ARC renewal report do not provide confirmation as to whether this was the configuration on that date. The workshop stated that according to the various manufacturer maintenance documents, these additional connections [author's note: between the bottles] are not officially part of the aircraft which meant that it is not able to require a specific assembly during the ARC renewal inspection. The DGAC and OSAC stated that they did not support this point of view.

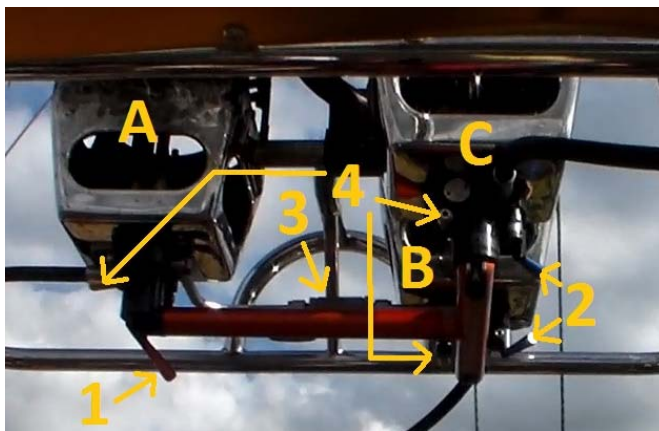
The heating valve on burner A could also be activated via a control identified as 1 in Figure 5. This control had two "closed" positions: that shown in Figure 5, where the control is at 45 degrees to the red support bar, and the "straight" position where the control is aligned with this bar. All other control positions were unstable and caused the ignition of the main burner, as did the application of pressure on the control in the 45 degree position.

Figure 5: installation of the burner blocks on F-HCCG. Item 2 indicates the whisper burner controls on blocks B and C (not visible for block A) and item 4 indicates the pilot light controls. Item 3 indicates the connecting valve (partially visible) of main burners A and B. The "double-action" control bar is not visible, being located on the upper part of the small red bar on the T support, between blocks B and C.

Examination of the burners showed that the three pilot light controls were open. The whisper burner controls were partially open on the B and C burner blocks, and closed or slightly open on block A. The control of main burner A, item 1 on Figure 5, was in the "straight" position, aligned with the T-support bar, that is to say closed.
