Report

Accident on **4 August 2010**
at « **Croisée d'Apatou** » (French Guyana)
to the **AS 350 B2** helicopter
registered **F-OIEL**
operated by **Yankee Lima Helicopters**

BEA

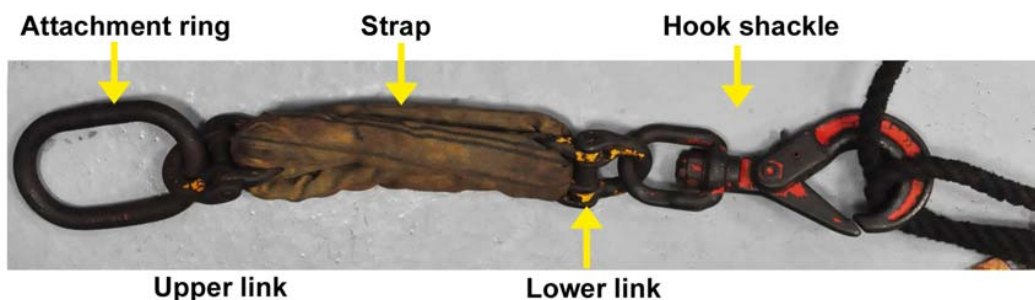
Figure 3 - sling used during accident flight

- ❑ the sling was old and had no manufacturer's plate or markings;
- ❑ it included textile sling parts associated with metal sling parts;
- ❑ the textile strap was yellow, a colour associated with maximum strand load weight of 3,000 kg. There were no identifying marks;

- ❑ the connecting shackles were designed for metal slings with a diameter of 10 mm (maximum load weight 3.15 t). They were not designed for textile slings⁽³⁾.

- ❑ the upper shackle had significant play at the level of the axle. The lower shackle had a crack in the ring around the axle;
- ❑ the hook shackle was designed to be used with a metal sling with an 8 mm diameter (maximum weight 2 t);

- **EASA and the DGAC ensure that sling equipment to transport inert external loads be designed and used according to the safety standards defined by the European Directive on machinery (or its transposition into French law in the “Code du Travail”). [Recommendation FRAN-2012-028]**

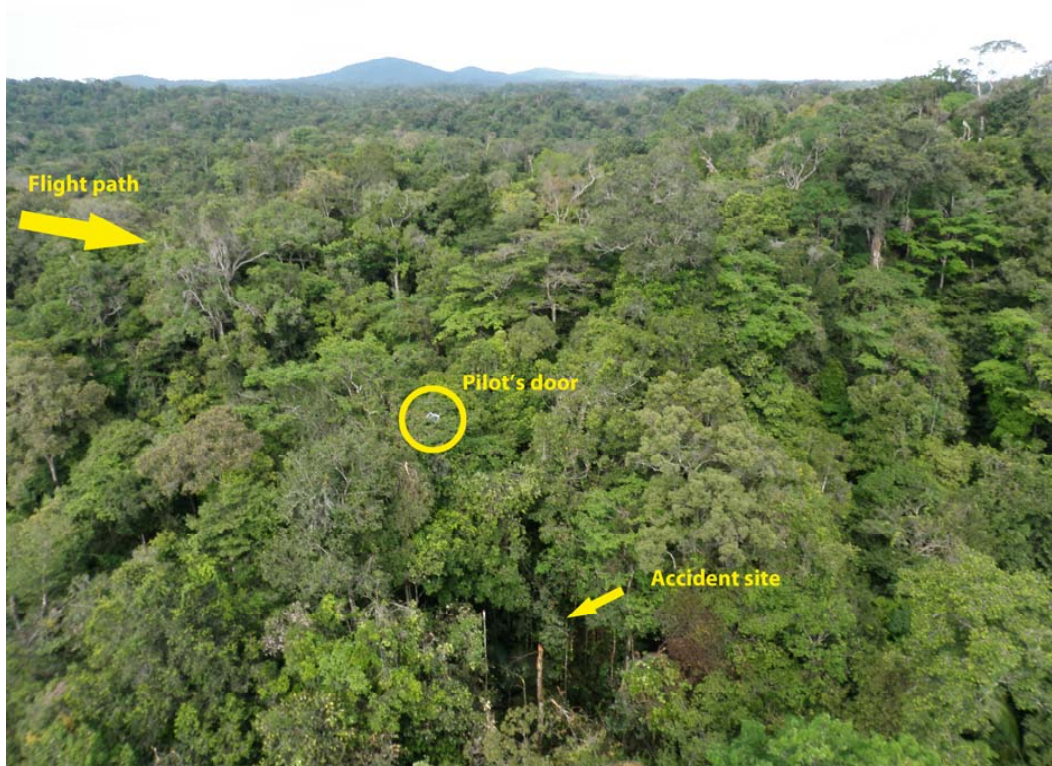
Figure 5 - aerial photograph of the accident site

The wreckage was broken up and the debris was spread over 200 m.

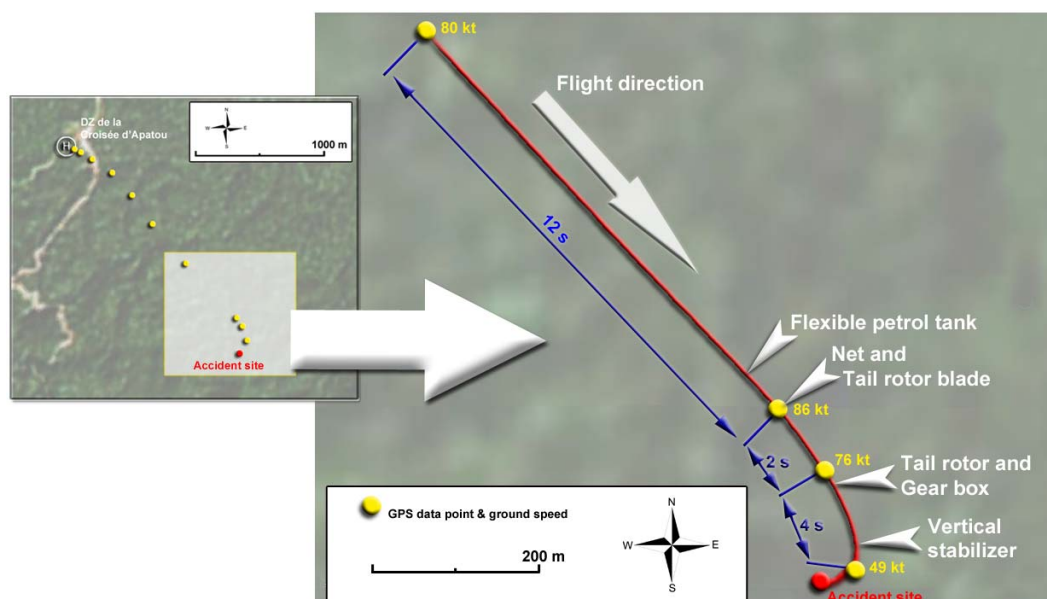
- the flexible container;
- the net, which was laying on the forest canopy and a blade from the tail rotor, broken off at the root, found on the ground;
- the rear gearbox - tail rotor hub assembly connected to the second tail rotor blade;
- the vertical fin;
- the right door, at the top of a tree and the airframe on the ground, partially burned out.

Figure 6 - localisation of the main parts of the wreckage found along the helicopter flight path

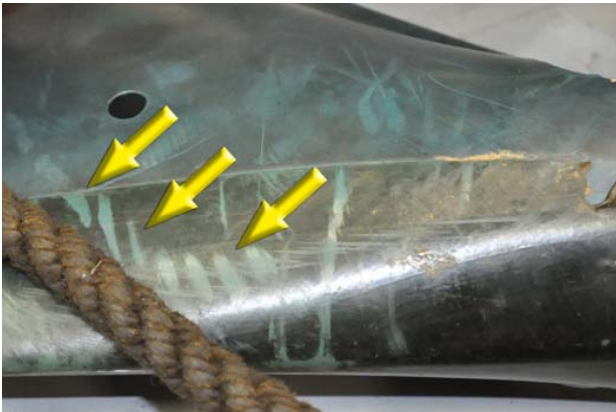
- that the engine was supplying power at the time of impact;
- that the marks observed on one of the tail rotor blades corresponded to markings from the net (*see figure 7*);
- that the net showed some damage that could have been due to interference with the tail rotor and that two of the four buckles on the net were still linked to the lifting accessory, the two other buckles being free (*see figure 8*);
- that the damaged condition of the releaser did not make it possible to check on its operation (*see figure 9*).

Figure 7 - marks from the net on the broken tail rotor blade

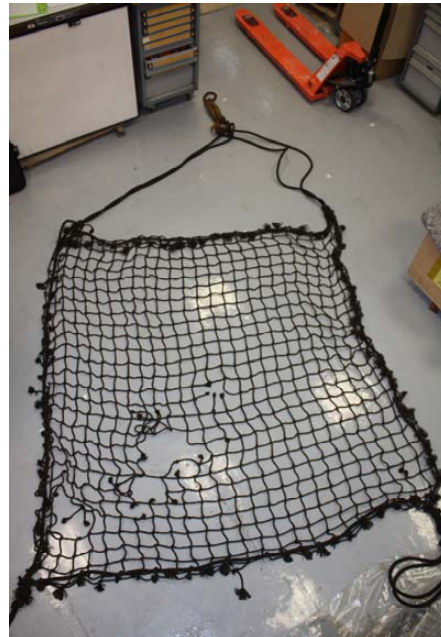
Figure 8 - damaged net attached to the lifting accessory via two buckles

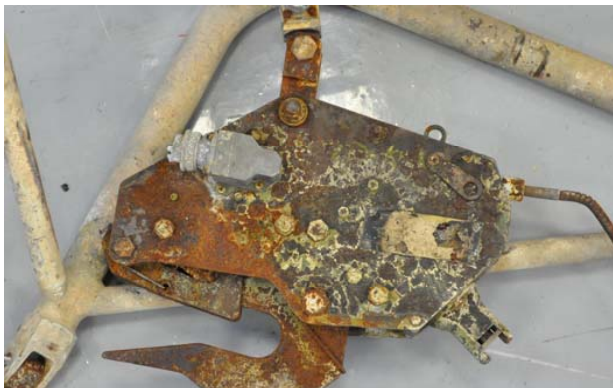
Figure 9 - burnt load releaser

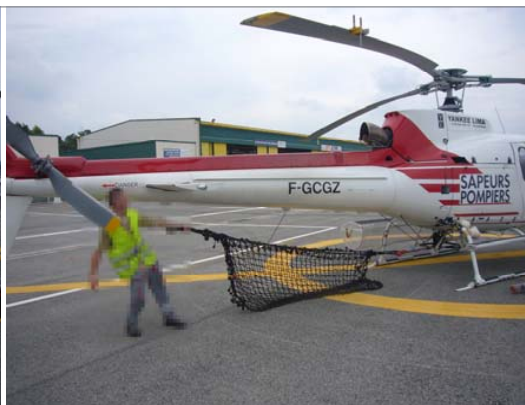
A reconstitution confirmed that this length prevented any contact with the tail rotor, even when only two of the four buckles remained in place in the hook.

Figure 11 - configuration with the 2 buckles in place

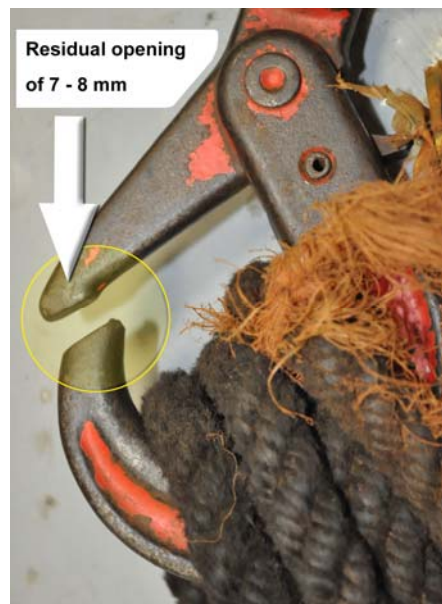
- ❑ the shackle was not equipped with a roller-ball type device that would allow it to turn round and limit the mechanical constraints during the flight;

- ❑ the hook shackle had a load-induced self-locking yoke. It could be unlocked by pulling the lock. Designed before 2001, it had not been manufactured since 2007.

Figure 12 - hook shackle

The hook found at the site of the accident had a residual opening of 7 to 8mm when locked. According to the manufacturer's documentation, the play must not exceed 3mm (see appendix 1).

A tomography examination of the hook showed that the body of the hook had suffered deformation of 0.5mm.

The lock was extremely worn. In places, the loss of material had reached 0.5 mm.

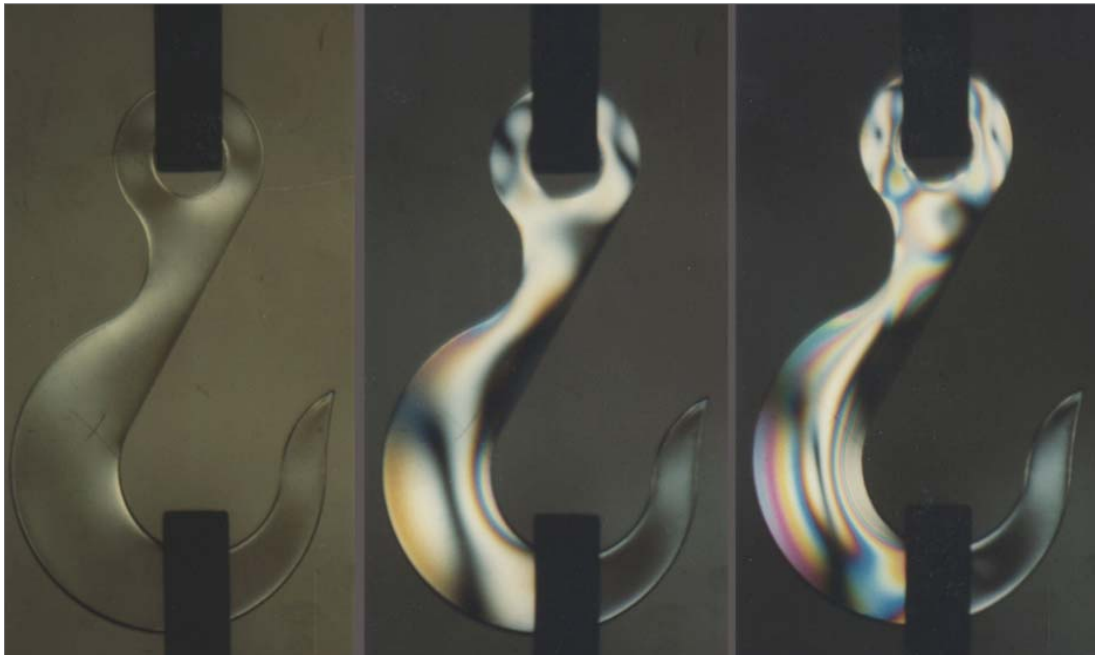
Figure 13 - visualisation of the stress zones on a sample hook

Photos taken under polarized light represented the behaviour of a sample hook, made of plexi-glass and subjected to various loads (no load, moderate and heavy loads). The coloured zones indicate the zones of the same value or the same stress orientation. It is notable that the tip of the hook suffers no stresses. Its role is to prevent the load from slipping.

In the case of the assembly used during the accident, a part of the load was supported by the tip of the hook, which probably contributed to the deformation of the hook.
