## **Serious incident** to the Cessna Citation 525B registered **F-HCIC** on 22 July 2013 at 10 NM north west of Paris Orly airport climbing through FL 180

### **Smoke in cockpit, emergency descent and flight in a prohibited area for low altitude flight, in a commercial air transport positioning flight**

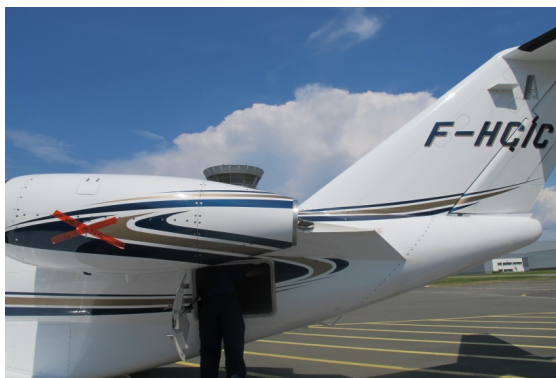
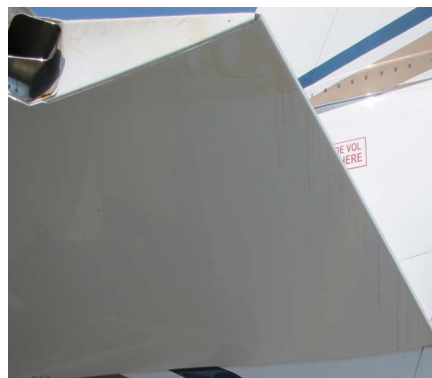
Left engine of F-HCIC

After the incident, there was no sign of external damage on the left engine. There were faint traces of oil on the rear of the aeroplane.

An initial visual examination of the engine found that there was no oil and that the magnetic plugs on the reduction gearbox and oil tank had metal particles on them.

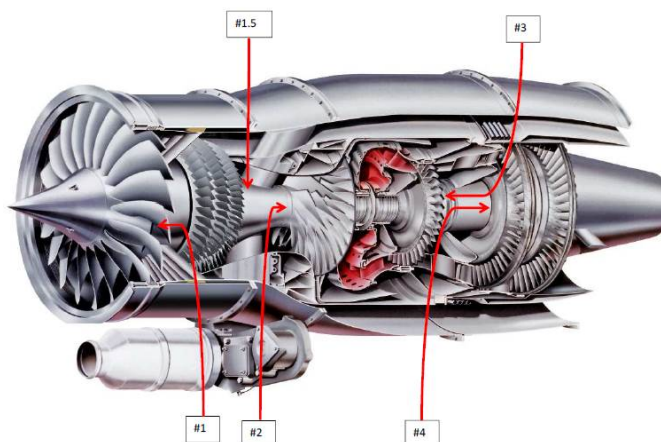
During disassembly, failure of the No. 2 bearing was detected.

The No. 2 bearing holds the N2 high pressure shaft. The failure of this bearing resulted in the shaft moving. The consequences of this movement included secondary damage to the components of the high pressure shaft and the bearing seals.

Metal particles spread through the lubrication system and damaged all the engine bearings.

It was not possible to determine the cause of the failure of the No. 2 bearing due to the extent of the damage resulting from the incident.

The damage to the bearing seals led to an oil leak in the engine body. On coming into contact with the hot parts, the oil burnt and the smoke produced spread into the cabin through the air conditioning system.

The manufacturer said that the No. 2 bearing P/N 55666 can have high amounts of unbalance which can then lead to its premature wear. This bearing should be replaced in Check 4 (general overhaul) of the engine.

An intermediate solution with a bearing P/N 79026 was designed. The manufacturer issued a Mandatory Service Bulletin stipulating that the bearing had to be replaced with this new type (P/N 79026) in the next Hot/Cold Section Inspection or when the bearing was accessible. At the time of the incident, one in five engines had this bearing. F-HCIC was not equipped with it. Today, there are around 1,000 engines of the same type as the F-HCIC engine. The manufacturer then introduced a new bearing P/N 118017; no failure of this bearing had been reported on the date of issue of this report. They accelerated the replacement of the original bearing by publishing a Service Bulletin requiring the replacement of the bearing in check 3 (hot section). The replacement of the bearing remains mandatory in check 4 (general overhaul). The manufacturer specified that in February 2017, 53% of the original bearings had been replaced.
