Collision with ground during final turn

Aircraft	Robin DR400-160 registered F-GGQF
Date and time	21 September 2014 at around 17 h 35 ⁽¹⁾
Operator	Club
Place	Vitry-en-Artois (62, France)
Type of flight	General Aviation, pleasure flight
Persons on board	Pilot and three passengers
Consequences and damage	Pilot and one passenger injured, aircraft destroyed

This is a courtesy translation by the BEA of the Final Report on the Safety Investigation. As accurate as the translation may be, the original text in French is the work of reference.

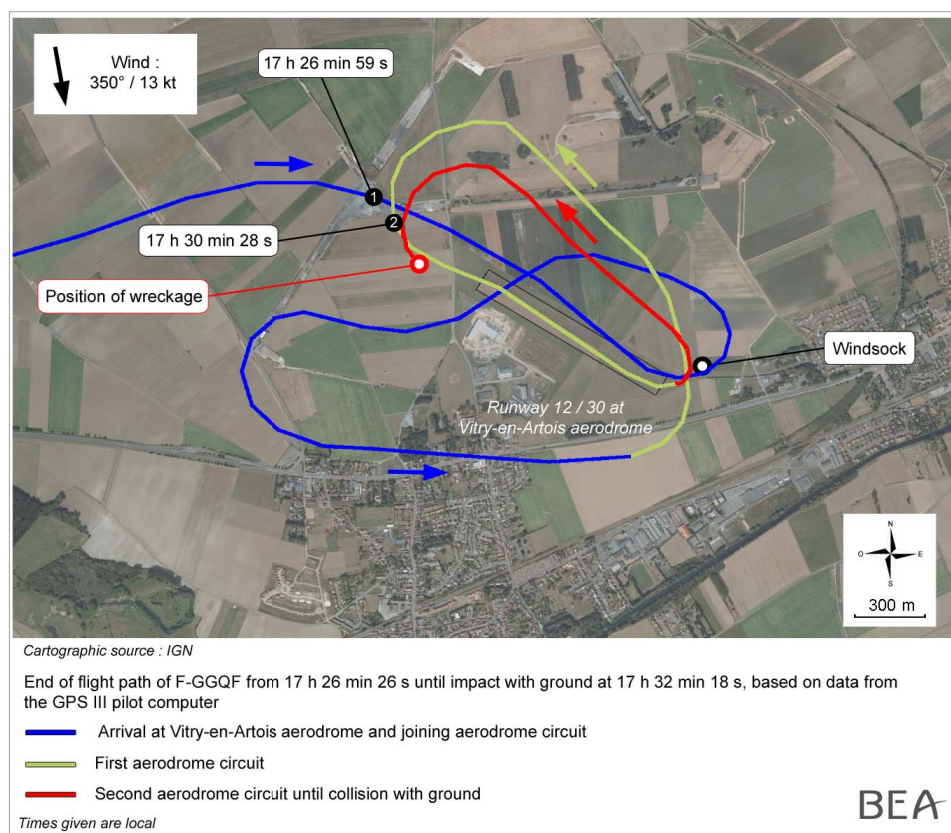
Figure 1: accident flight

The flight path of the accident flight showed that the pilot flew over the windsock to the right the first time. He then flew away before joining the left hand downwind leg for runway 12. He then made two circuit patterns. The accident occurred on the final turn.

The average calibrated airspeed on the left hand downwind leg was 140 km/h during the first circuit and 120 km/h on the second circuit. During the two circuits, the pilot turned to the left at the end of the downwind leg 10 seconds after overflying the runway threshold, taking him about 0.2 NM from the displaced threshold at the end of the final turn.

On the final turn of the second circuit, the pilot had probably focused on the speed and endpoint at the expense of overseeing the aeroplane's flight attitude. Examination of the GPS flight paths showed that the radius of the final turn of the second circuit pattern was tighter than during the previous one. At the end of the turn the aeroplane probably had a significant pitch-down attitude and bank angle. During the turn, the aeroplane changed from a headwind situation to a tailwind situation. This development may have been interpreted by the pilot as a vertical gust of wind. Given the height, the pilot estimated that he could not avoid a collision with the ground. He decreased engine power, put the wings virtually flat and commanded a pitch-up attitude before impact.

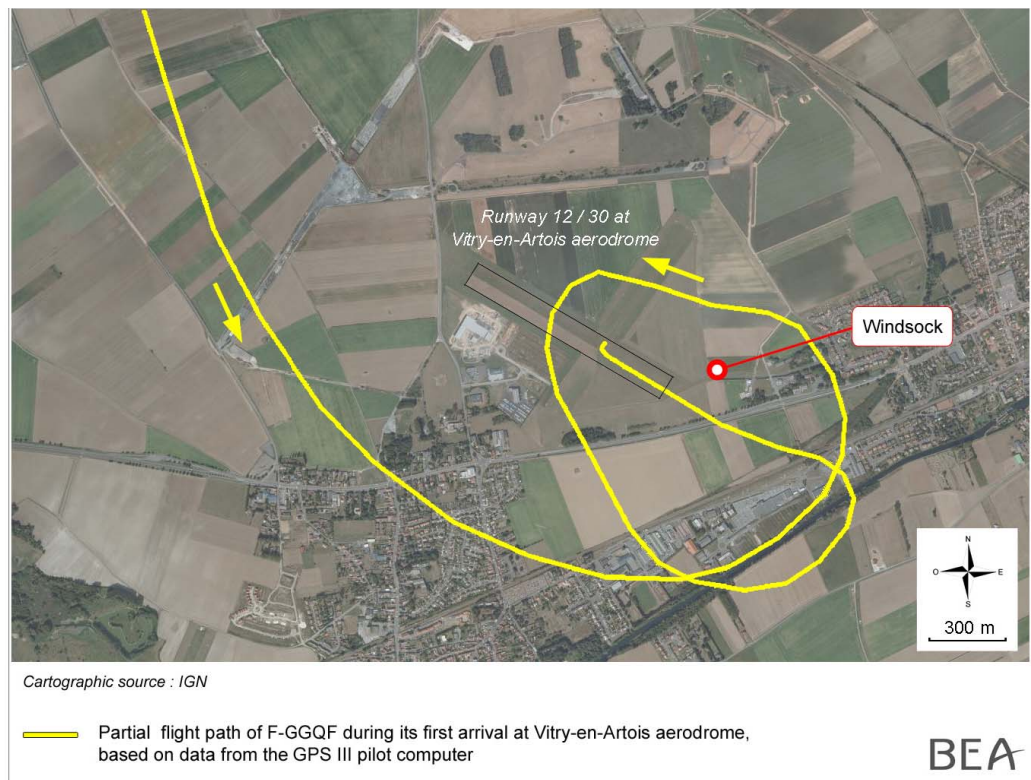
Figure 2: Flight preceding the accident, landing on runway 30 at Vitry-en-Artois

Readout of the GPS also made it possible to reconstitute the flight paths of two flights performed by the pilot at the start of September on a DR360 from the club as well as the flight that preceded the accident. During these flights the pilot made complete landings at Vitry-en-Artois and at Lens. The integration and the aerodrome circuits were not standard.

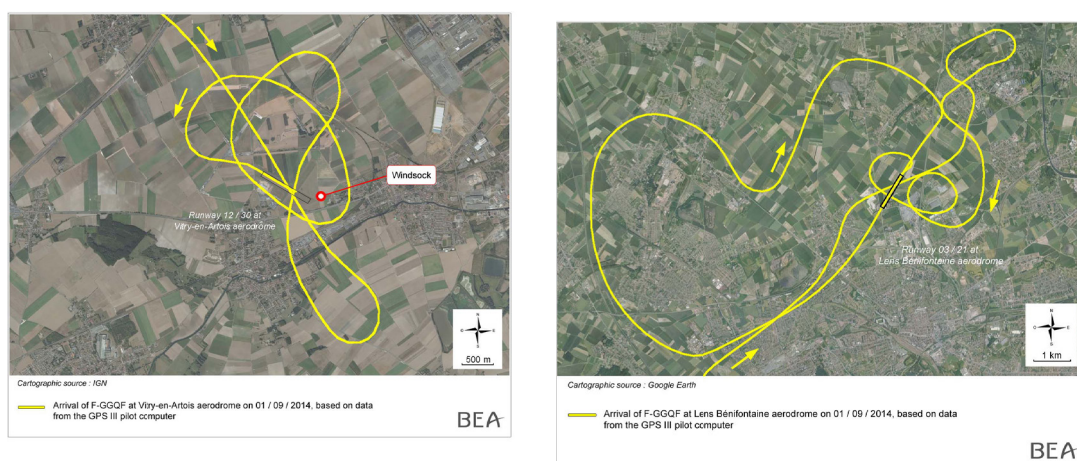
Figure 3: landings made in September 2014 based on GPS data

The pilot indicated that he was not used to doing standard circuit patterns at non-controlled aerodromes when there was no other traffic. He followed flight paths similar to that of an engine failure procedure approach (U-shaped path) and performed his approaches at a speed between 170 and 180 km/h⁽⁶⁾ with flaps extended to 10°. He specified that he always checked his speed and that it was important to *"maintain speed"*. He added that given his experience he did not feel the need to perform standard patterns and preferred to shorten flight paths.
